**SB-10043893-9986**

Bulletin No.: PI0699B

## **Service Bulletin**

**Subject:** Gauge Fluctuation, Various DTCs, Wiring Harness Chafing/Rubbing on A/C Line

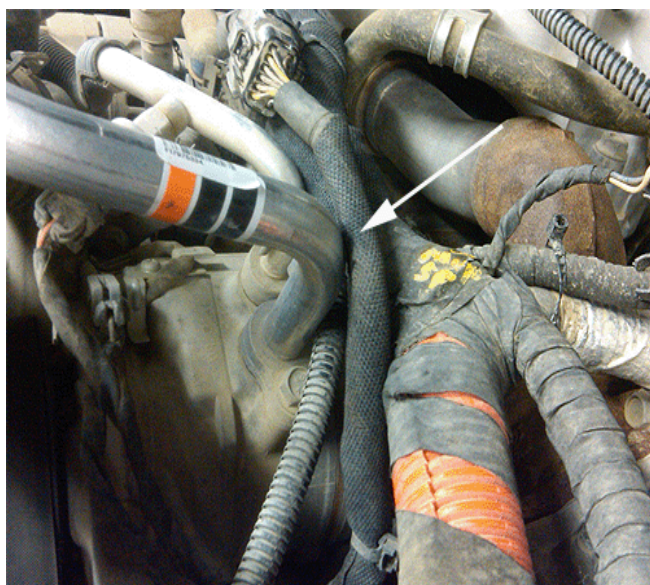
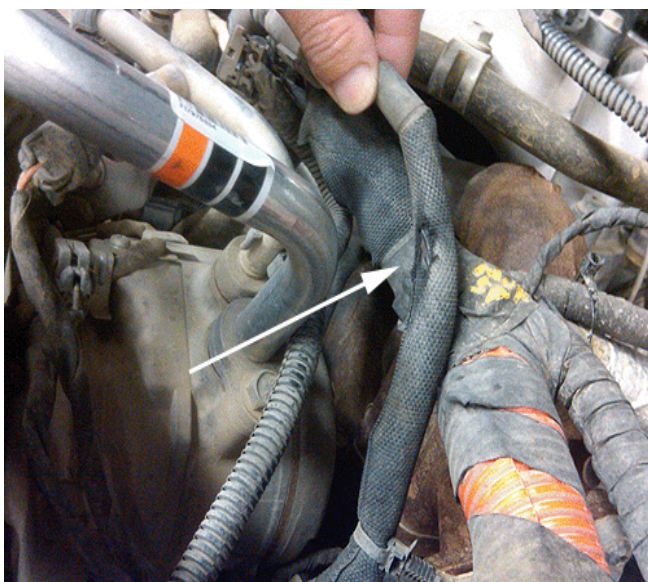
2787005

The engine wiring harness may be rubbing on the A/C line.

Repair the wiring harness and install a tie strap to the area shown above.  
Refer to SI for wiring repairs.
