Program Bulletin

CUSTOMER SATISFACTION PROGRAM

SUBJECT: Rear Axle Grinding Noise, Vibration - Inspect Rear Axle

MODELS: 2011-2012 Chevrolet Express
2011-2012 Chevrolet Silverado, Suburban 2500 Series
2011-2012 GMC Savana
2011-2012 GMC Sierra, Yukon XL 2500 Series
Equipped with a 10.5" Rear Axle

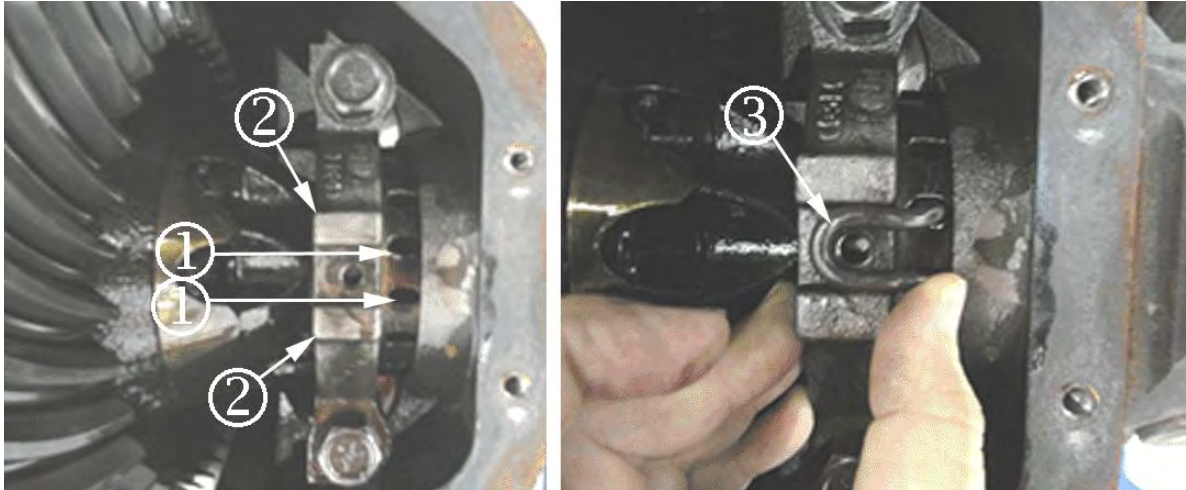
2790908

Visually inspect the adjuster nut slot alignment (1) and then use a new adjuster clip (3) to verify slot alignment. The adjuster clip (3) must be seated between the cap bolt ribs (2) and into the adjuster nut holes as shown in illustration.

11. Inspect the adjuster nut slot location in reference to the cap bolt ribs (2).
- If the adjuster nut slots are aligned (1) as shown in illustration, no adjustment is required. Proceed to Step 13.
 - If the adjuster nut slots do NOT align, proceed to Step 12.
