Program Bulletin

SB-10044218-4654

CUSTOMER SATISFACTION PROGRAM

SUBJECT: Rear Axle Grinding Noise, Vibration - Inspect Rear Axle

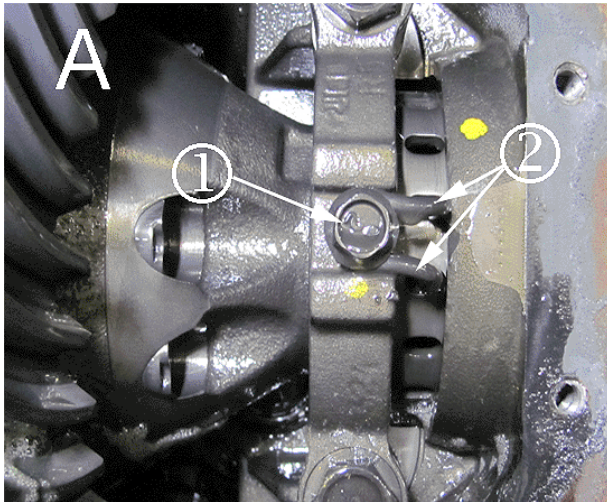
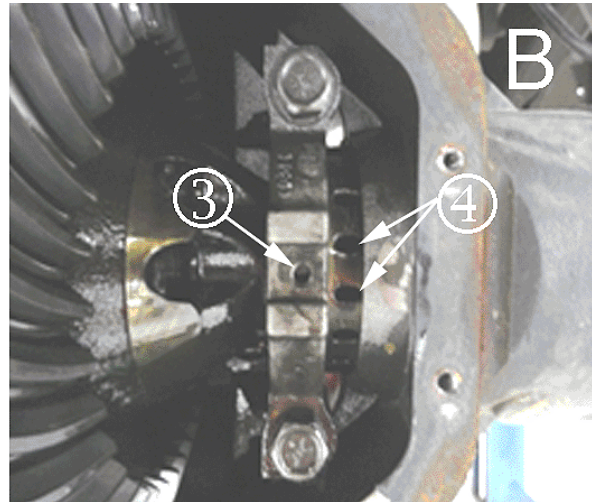
2790899

Adjuster Bolt (1) and (2) Clip Present. (B) Adjuster Bolt and Clip Not Present (3) and (4).

10. Determine if the passenger side (right) adjuster bolt (1) and clip (2) are present.
- If the passenger side adjuster bolt and clip are present (A), remove the adjuster bolt and clip. Discard only the clip. Refer to illustration. Proceed to Step 11.

- If the passenger side adjuster bolt and clip are NOT present (B), replace the drive pinion, ring gear, differential side bearings, adjuster bolt and adjuster clip. Refer to *Differential Replacement (10.5 Inch Axle)* in SI. Proceed to Step 14 after replacing the drive pinion, ring gear, pinion bearings and differential side bearings. Refer to illustration.

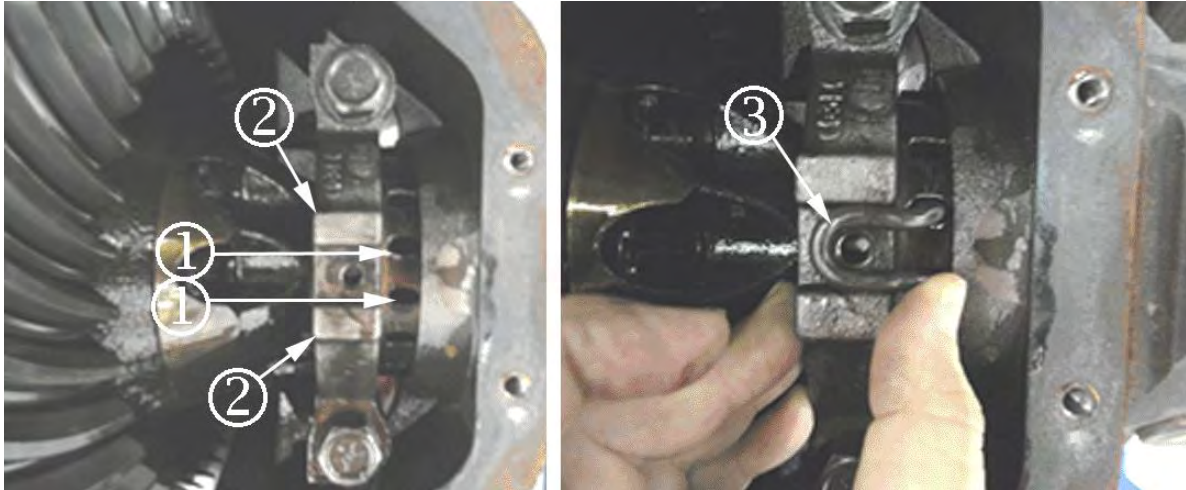
2790908

Visually inspect the adjuster nut slot alignment (1) and then use a new adjuster clip (3) to verify slot alignment. The adjuster clip (3) must be seated between the cap bolt ribs (2) and into the adjuster nut holes as shown in illustration.

11. Inspect the adjuster nut slot location in reference to the cap bolt ribs (2).
- If the adjuster nut slots are aligned (1) as shown in illustration, no adjustment is required. Proceed to Step 13.
 - If the adjuster nut slots do NOT align, proceed to Step 12.

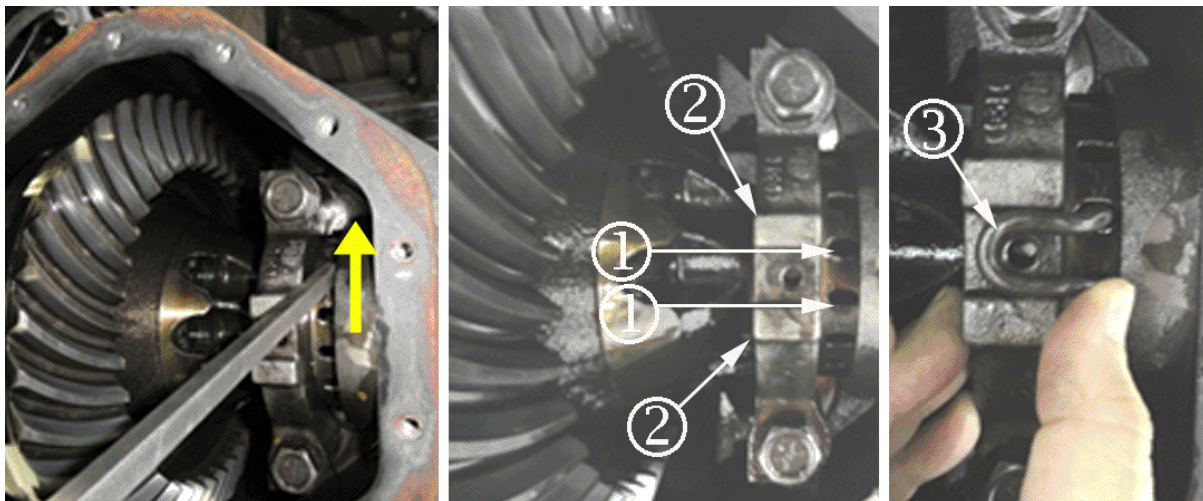
2790914

Caution: If indexing the adjuster is required, the adjustment direction is critical. The passenger side adjuster **MUST** be rotated in an upper direction to the nearest slot. If an upper direction is **NOT** used, bearing preload is lost.

12. Using J-24429 spanner (or equivalent) in the adjuster nut slot (1), rotate the adjuster nut enough to center the clip between the cap bolt ribs. Only rotate the adjuster nut in an upward direction.
