Bulletin No.: 12050B
Date: April 2014

Program Bulletin

SUBJECT: Rear Axle Grinding Noise, Vibration - Inspect Rear Axle

MODELS: 2011-2012 Chevrolet Express
2011-2012 Chevrolet Silverado, Suburban 2500 Series
2011-2012 GMC Savana
2011-2012 GMC Sierra, Yukon XL 2500 Series
Equipped with a 10.5" Rear Axle

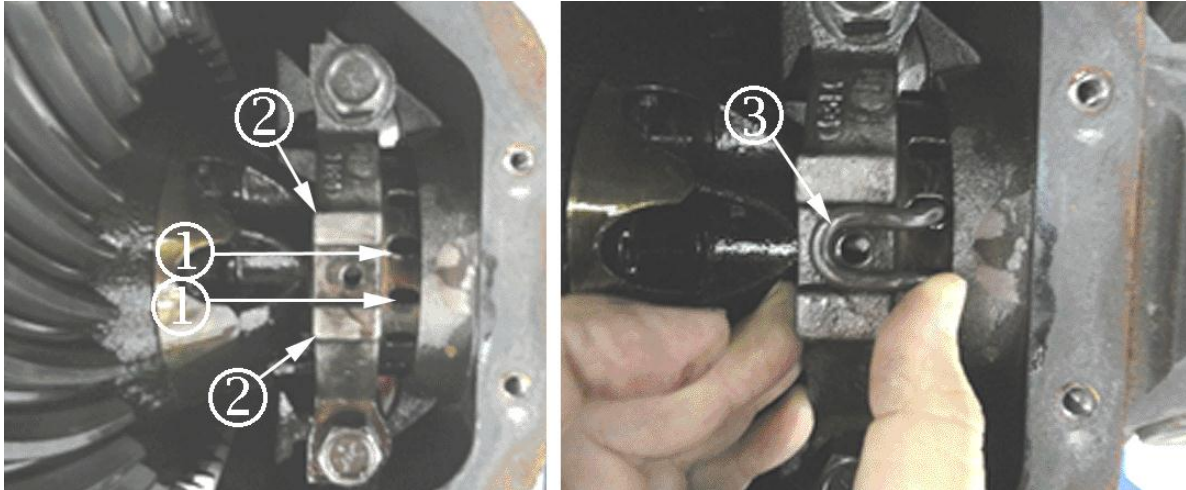
2790908

Visually inspect the adjuster nut slot alignment (1) and then use a new adjuster clip (3) to verify slot alignment. The adjuster clip (3) must be seated between the cap bolt ribs (2) and into the adjuster nut holes as shown in illustration.

11. Inspect the adjuster nut slot location in reference to the cap bolt ribs (2).
- If the adjuster nut slots are aligned (1) as shown in illustration, no adjustment is required. Proceed to Step 13.
 - If the adjuster nut slots do NOT align, proceed to Step 12.
