Bulletin No.: 12050
Date: April 2012

Program Bulletin

CUSTOMER SATISFACTION PROGRAM

SUBJECT: Rear Axle Grinding Noise, Vibration - Inspect Rear Axle

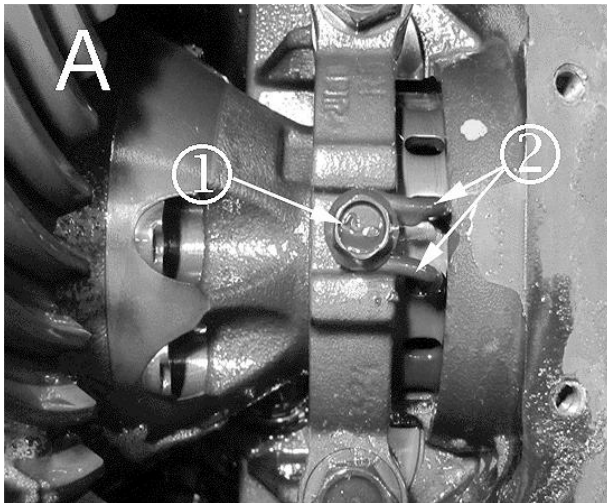
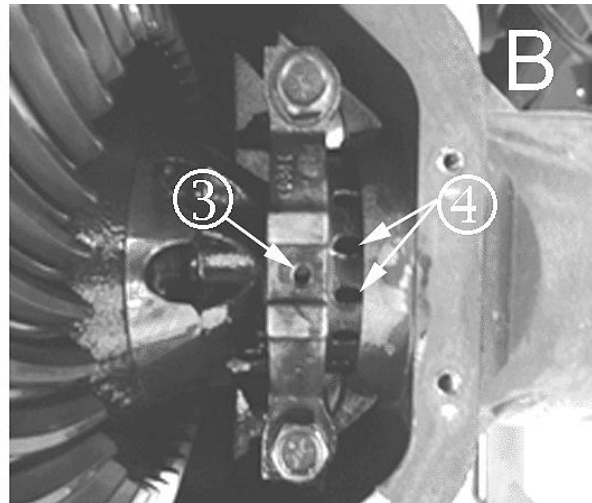
2790899

Adjuster Bolt (1) and (2) Clip Present. (B) Adjuster Bolt and Clip Not Present (3) and (4).

10. Determine if the passenger side (right) adjuster bolt (1) and clip (2) are present.
- If the passenger side adjuster bolt and clip are present (A), remove the adjuster bolt and clip. Discard only the clip. Refer to illustration. Proceed to Step 11.

- If the passenger side adjuster bolt and clip are NOT present (B), replace the drive pinion, ring gear, differential side bearings, adjuster bolt and adjuster clip. Refer to *Differential Replacement (10.5 Inch Axle)* in SI. Proceed to Step 14 after replacing the drive pinion, ring gear, pinion bearings and differential side bearings. Refer to illustration.

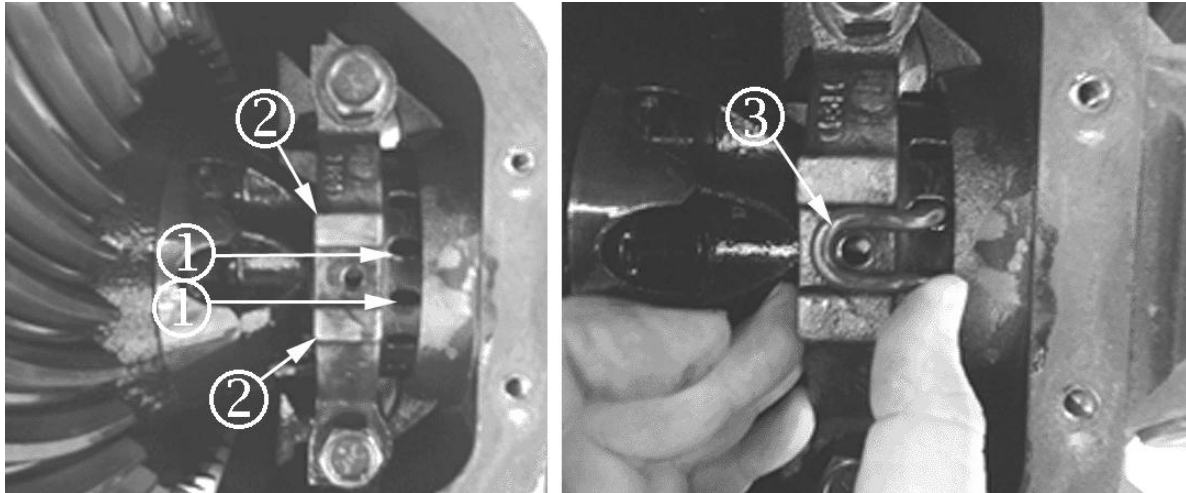
2790908

Visually inspect the adjuster nut slot alignment (1) and then use a new adjuster clip (3) to verify slot alignment. The adjuster clip (3) must be seated between the cap bolt ribs (2) and into the adjuster nut holes as shown in illustration.

11. Inspect the adjuster nut slot location in reference to the cap bolt ribs (2).

- If the adjuster nut slots are aligned (1) as shown in illustration, no adjustment is required. Proceed to Step 13.
- If the adjuster nut slots do NOT align, proceed to Step 12.

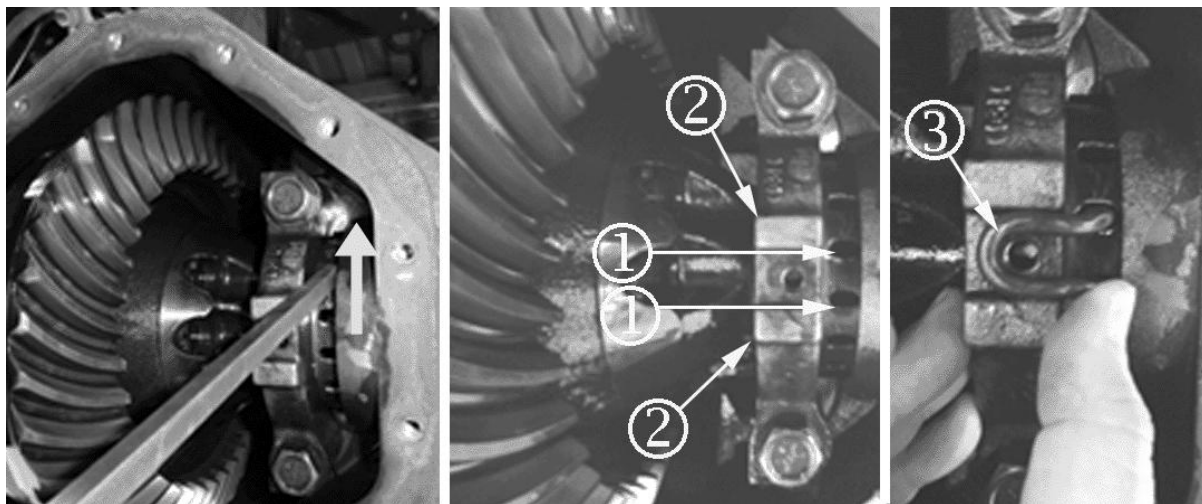
2790914

Caution: If indexing the adjuster is required, the adjustment direction is critical. The passenger side adjuster MUST be rotated in an upper direction to the nearest slot. If an upper direction is NOT used, bearing preload is lost.

12. Using J-24429 spanner (or equivalent) in the adjuster nut slot (1), rotate the adjuster nut enough to center the clip between the cap bolt ribs. Only rotate the adjuster nut in an upward direction.

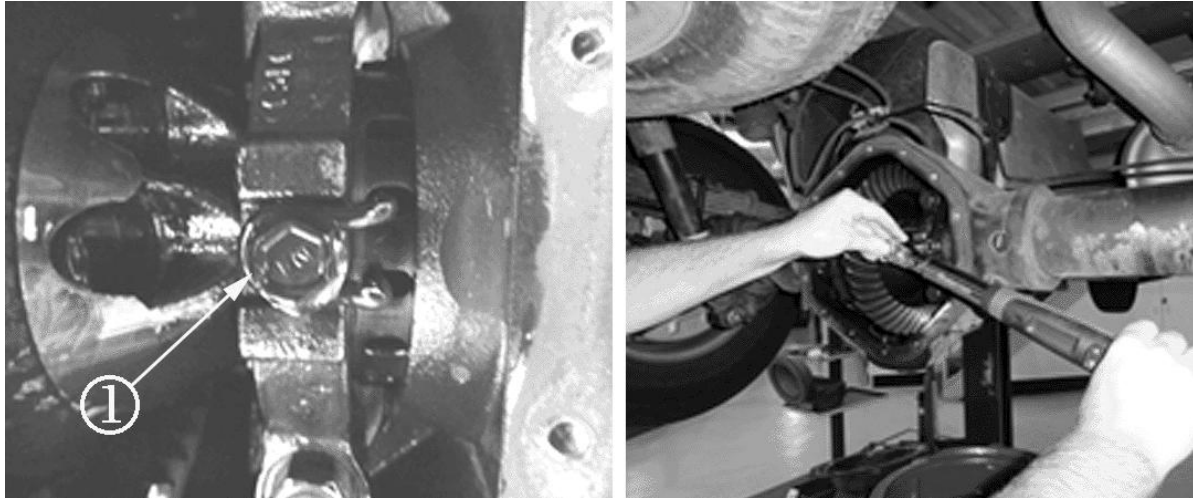
2790927

Caution: To avoid damaging the differential, ensure the adjuster clip is aligned properly BEFORE installing the adjuster bolt and clip.

13. Use a new adjuster clip (3) to verify alignment. The adjuster clip (3) must be seated between the cap bolt ribs (2) and into the adjuster nut slots as shown in illustration.
