Service Bulletin

Subject: Service Stability - Traction - ABS Rear Wheel Speed DTC Or Chassis Expansion Bus Communication Fault

Models: 2010 - 2012 Chevrolet Equinox
2010 - 2012 GMC Terrain
With Any Combination of DTC's U0074 U0125 C0196 C0287 C0186 C056D C0045 C0050
Symptom 00 06 3B 4A 4B 5A 39 42 54 71

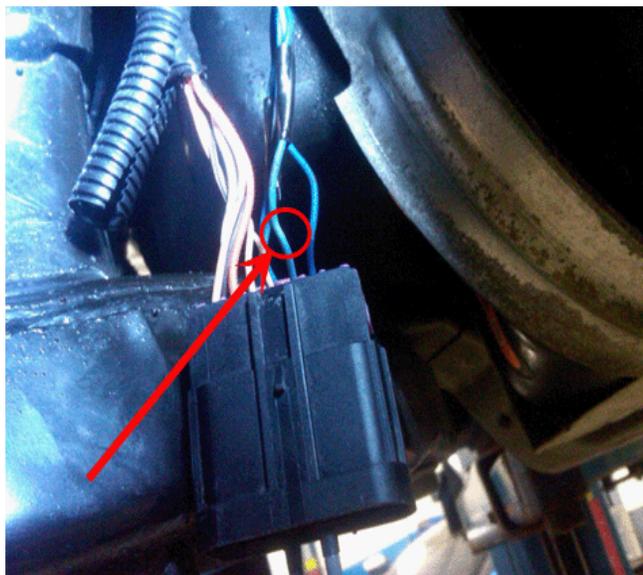
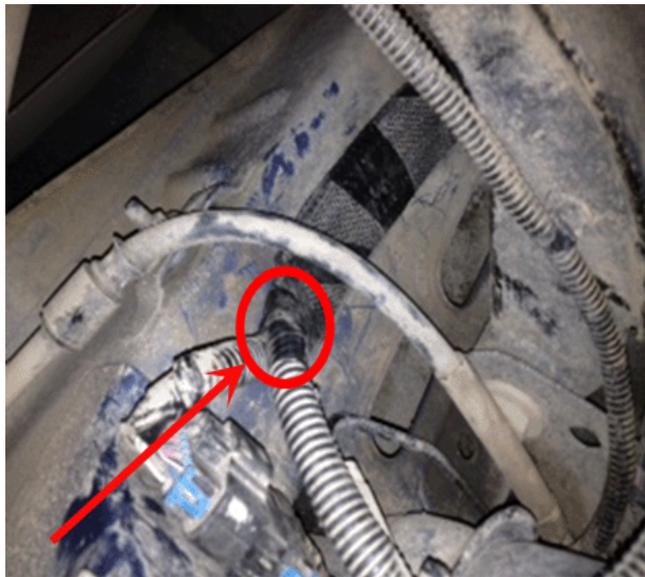
During inspection you may notice a discoloration in insulation in one spot. If you pull the wire near that area the insulation it will break exposing the broken wire. Repair the circuit to complete the procedure.

Note: Wire broken within the insulation has also been found high up in the harness X411. Reference the following photos:

Identified is the most probable area. Inspect the wire harness insulation within 1 inch of the X411 before and after connector.

Remove the tape and conduit from the wire harness and inspect the ckt 6105 and 6106 for chassis bus wires or circuit 884, 885, 882, and 883 if related to wheel speed sensor codes C0045 or C0050.
