Service Bulletin

Bulletin No.: PIT5171B

Subject: Service Stability Traction ABS Rear Wheel Speed DTC Or Chassis Expansion Bus Communication Fault

Models: 2010 - 2012 Chevrolet Equinox
 2010 - 2012 GMC Terrain
 With Any Combination of DTCs U0073 U0074 U0125 C0196 C0287 C0186 C056D C0045
 C0050 Symptom 00 06 3B 4A 4B 5A 39 42 54 71

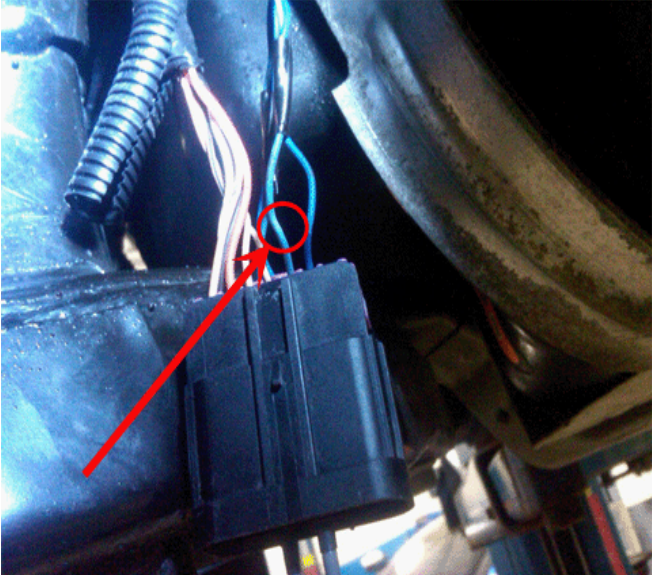
2893988

Note: Wire broken within the insulation has also been found high up in the harness X411. Reference the following photos:

Several conditions and symptoms have been found to be related to a wire harness at the left rear under vehicle. Inspect the wire harness insulation within 1 inch of the X411 before and after connector. It may be necessary to remove the tape and conduit from the wire harness for inspection upstream from the X411 connector. Some Issues have been found with circuits 6105 and 6106 for chassis bus wires and serial enable circuit 5986 and 120 ohm opens in 2500 and 2501 or 6106 and 6106. Other circuits 884, 885, 882, and 883 when related to rear wheel speed sensor codes C0045 or C0050. During inspection you may notice a discoloration in insulation in one spot of the wire. If you pull the wire near that area the insulation will break exposing the broken wire. Repair the circuit to complete the procedure.
