# Service Bulletin

Bulletin No.: PIT5171D

**Subject:** Service Stability – Traction – ABS Rear Wheel Speed DTC Or Chassis Expansion And High Speed Bus Communication Fault

**Models:** 2010 - 2015 Chevrolet Equinox  
2010 - 2015 GMC Terrain  
With Any Combination of DTC's U0073 U0074 U1826 U1827 U18A2 U0125 C0196 C0287  
C0186 C056D C0045 C0050 Symptom 00 06 3B 4A 4B 5A 39 42 54 71

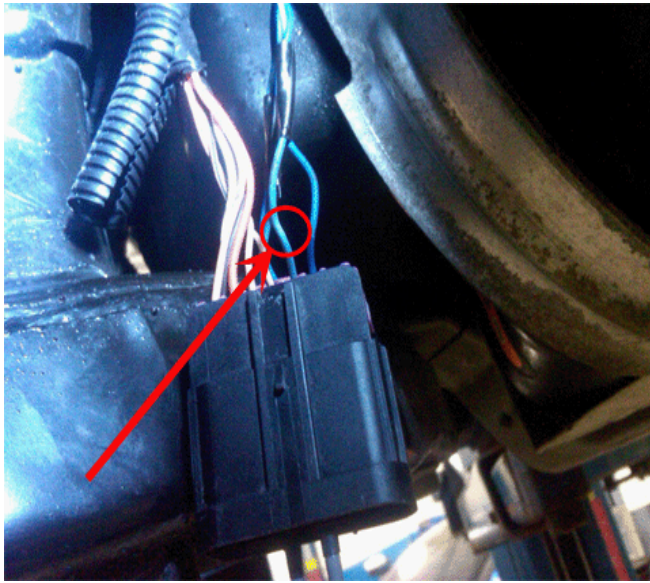
2893988

**Note:** Wire broken within the insulation has also been found high up in the harness X411. It will be necessary to lower the harness to gain access. Reference the following photos:

If you pull the wire near that area the insulation it will break exposing the broken wire and possible corrosion or rodent damage. Repair the circuit to complete the procedure.

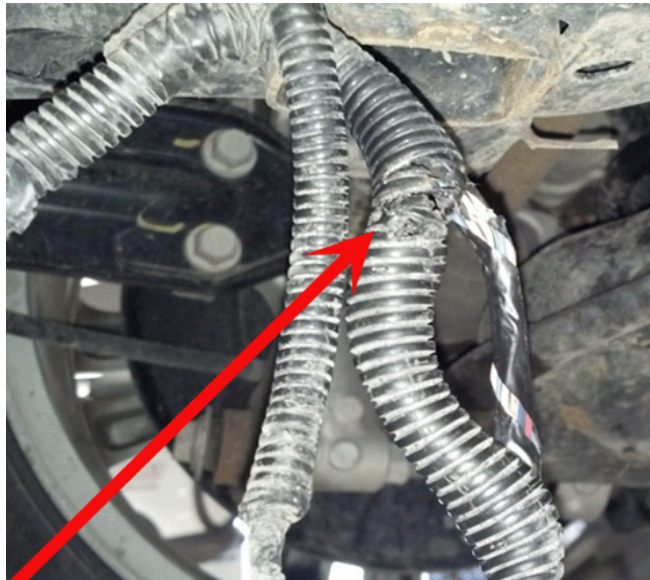
3420854

During inspection you may notice chewed up conduit or a discoloration in insulation in one spot of the wire.

Damaged conduit

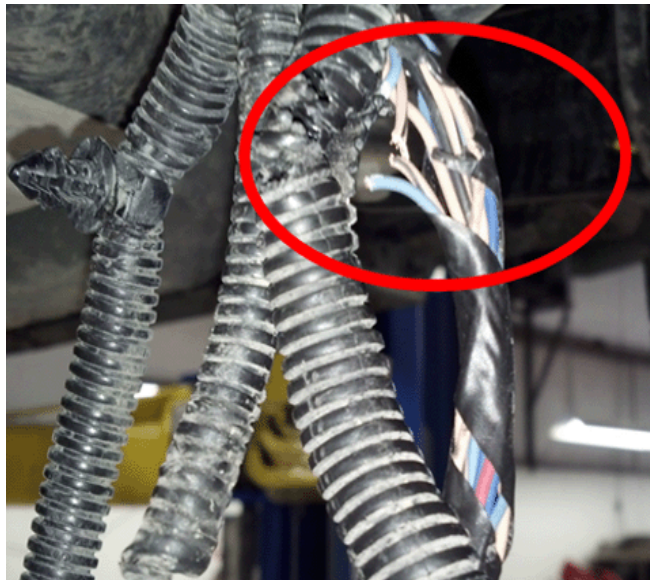
3420856

This may be related to an internal wire break inside the wire harness insulation to the X411 connector due to rodents. (Location in the left rear under the vehicle).

Wires chewed through
