# Service Bulletin

## **SB-10051936-5477**

**SUBJECT: Special Coverage Adjustment – Fuel Odor or Spotting on Ground – Replace Fuel Pump Module**

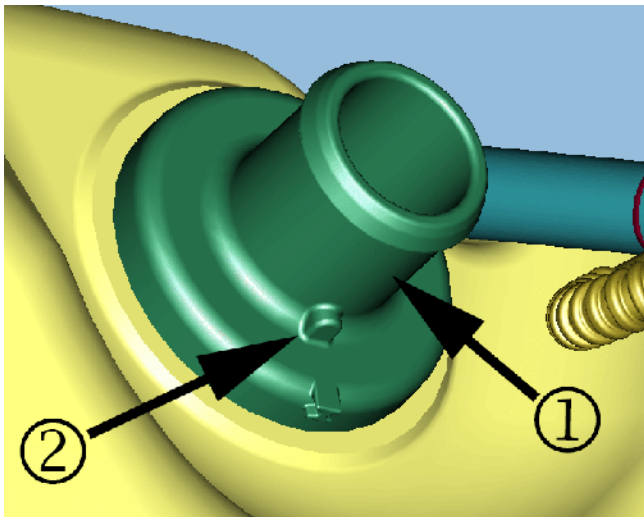
4093630

#### **Identifying the 20870462 or 25947828 fuel tank.**

The fuel tank hose connection (1) will have an index feature (2) at the bottom 6 O'clock position where the hose joins the tank. Older style tanks have this feature on top at the 12 O'clock location. The fuel tank may also have an identifying tag displaying the part number.

- If the part number *is* 20870462 or 25947828, and has the bottom index, **do not** replace the fuel tank or fill pipe.
3. If the part number *is not* 20870462 or 25947828, and has the top index, **replace the fuel tank and fill pipe or fill hose as applicable** .For 2006-2008 Chevrolet Cobalt, Pontiac Pursuit, G5: Remove the fuel tank filler pipe. Refer to *Fuel Tank Filler Pipe Replacement* in SI.
