SB-10052371-2891

Service Action Campaign

Code: 20T8 REVISION

Subject: Certain 2009-2012 Model Year Vehicles with TDI[®] Clean Diesel Engine **Install Misfueling Guard** September 12, 2013

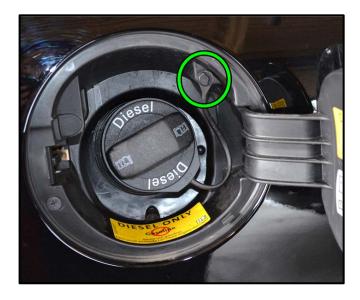
- Open the fuel filler door
- Remove the fuel cap and the fuel cap tether \leftarrow <circle> from the vehicle.

Tip: If the customer has installed their own locking or aftermarket fuel filler cap, be sure to return the old fuel cap to the customer.

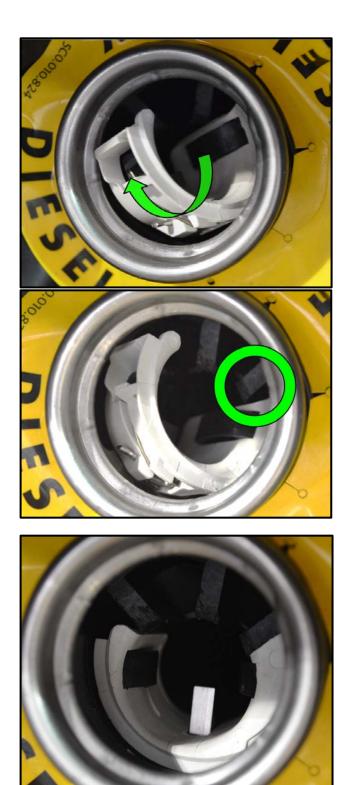
\leftarrow The misfueling guard kit p/n - 5K0 201 400 consists of five pieces <left>.

NOTE: DO NOT INSTALL the spring loaded flap insert (#1)

Install all other kit parts in the following order:

- 1. Spring Loaded Flap Insert (NOT USED)
- Fuel filler lockout mechanism. 2.
- 3. Plastic retaining ring.
- Replacement fuel cap w/tether. 4.
- Mounting pin for fuel cap tether. 5.

(!)Note: On SportWagen and Golf Wagon models the tether is attached to a permanent anchor inside the fuel filler housing. On Jetta sedans the tether is mounted to the fuel filler door hinge using a plastic mounting pin (#5 above). A replacement pin is included in every misfueling guard kit, but is not used on some models.
