Service Action Campaign – U.S. ONLY

REVISION**Code: 20U3**

**Subject: 2010-2012 Model Year Audi A3 with TDI® Clean Diesel Engine
Install Misfueling Guard**

May 29, 2015

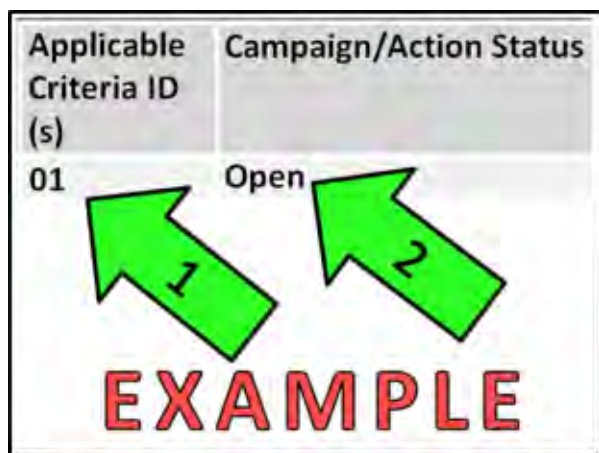
Section A – Identify Criteria and Check for Open Status

⇐ Ensure that the Status is “Open” <arrow 2>.

⇐ Note the Applicable Criteria ID <arrow 1> for use in determining the correct work to be done and associated parts.

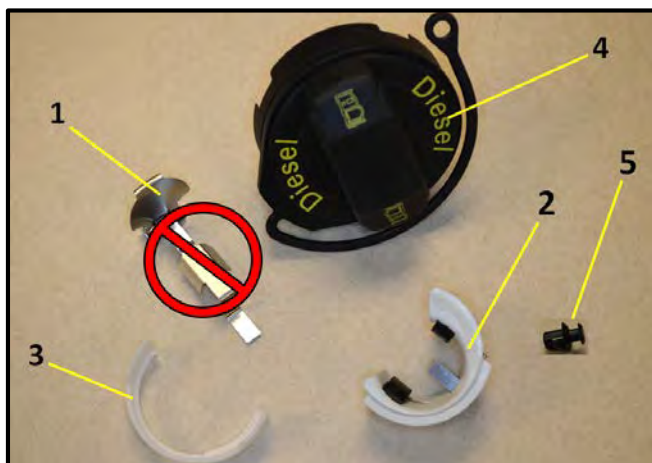
- ⇐ The misfueling guard kit p/n - 5K0 201 400 consists of five pieces (left) which must be installed in the following order:

NOTE: DO NOT INSTALL the spring loaded flap insert <1>.

1. Spring loaded flap insert. (**NOT USED**)
2. Fuel filler lockout mechanism.
3. Plastic retaining ring.
4. Replacement fuel cap w/tether.
5. Mounting pin for fuel cap tether (not used on A3 models).
