Service Action Campaign

REVISION
Code: 20U3

**Subject: 2010-2012 Model Year Audi A3 with TDI® Clean Diesel Engine
Install Misfueling Guard**

September 12, 2013

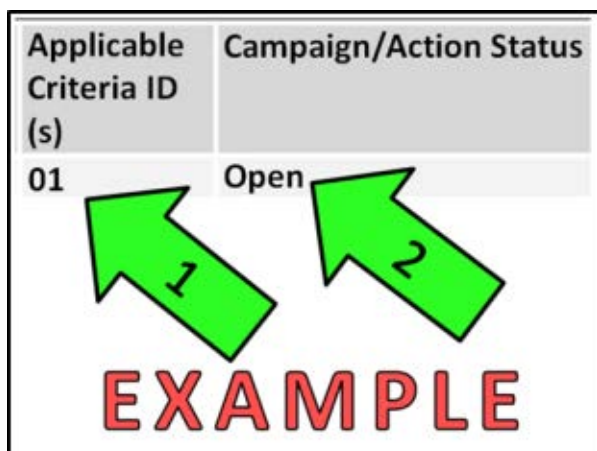
- Enter the VIN in ElsaWeb and proceed to the “Campaign/Action” screen.
- ⇐ Ensure that the Status is “Open” <arrow 2>.
- ⇐ Note the Applicable Criteria ID <arrow 1> for use in determining the correct work to be done and associated parts.

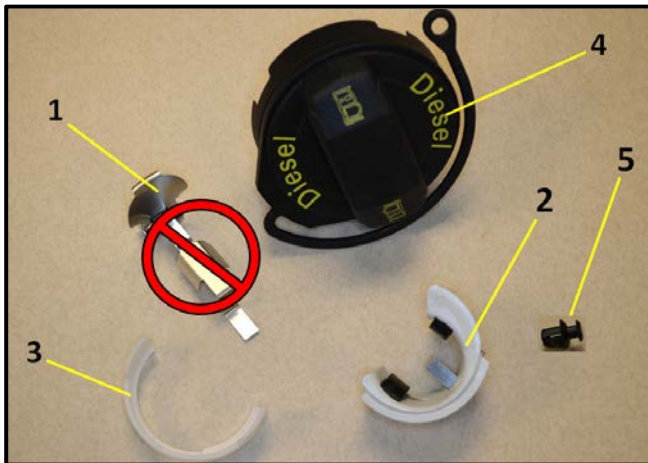
- ⇐ The misfueling guard kit p/n - 5K0 201 400 consists of five pieces (left) which must be installed in the following order:

NOTE: DO NOT INSTALL the spring loaded flap insert <1>.

1. Spring loaded flap insert. (**NOT USED**)
2. Fuel filler lockout mechanism.
3. Plastic retaining ring.
4. Replacement fuel cap w/tether.
5. Mounting pin for fuel cap tether (not used on A3 models).
