# SB-10055241-5109

**Title: Stumble or misfire on acceleration and setting cam codes on I6 engines from 1995 to present.\***

**Applies To: DT466 DT530 DT570**

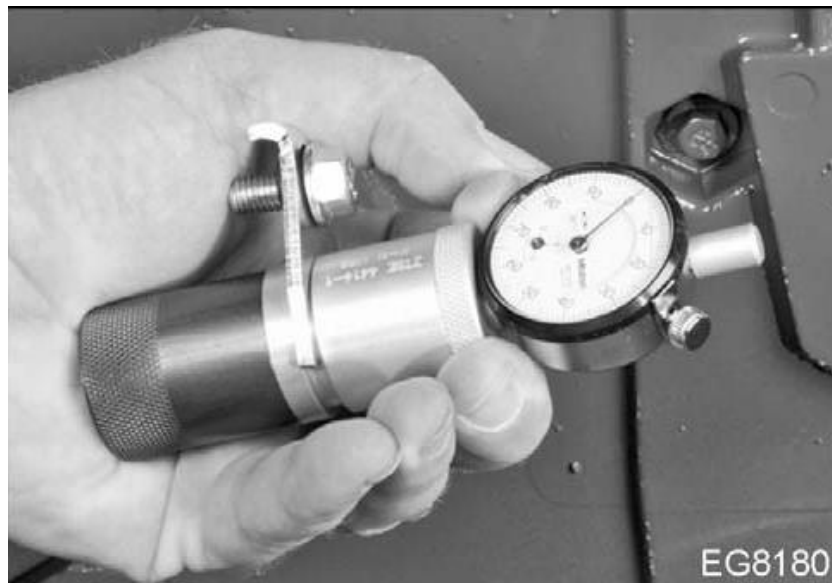
1. These cam codes can be set due to camshaft end play out of spec and may not even set a code at all but the truck is experiencing a surge, stumble, or misfire under a load during acceleration.
2. The camshaft end play will need to be checked, to do this you will need tool ZTSE4414 on pre EGR engines.

The front cover will have to be removed and the cam gear will have to be replaced.

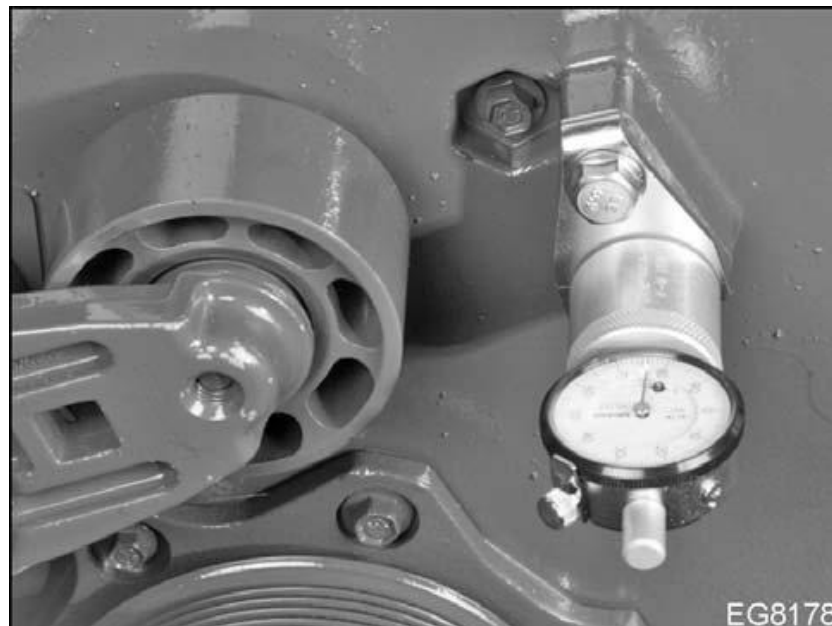
3. Remove the cam sensor and install the camshaft end play tool. Once the tool is installed rotate clockwise by hand 14 times and stop to zero out the tool. Next rotate the engine by hand 14 times counter clockwise and record the reading. The end play should be 0.005-0.013in, if it is higher than this the cam gear has walked off the camshaft.
