Program Bulletin

SB-10056598-4235

CUSTOMER SATISFACTION PROGRAM

SUBJECT: Navigation Radio Loss of Customer Settings

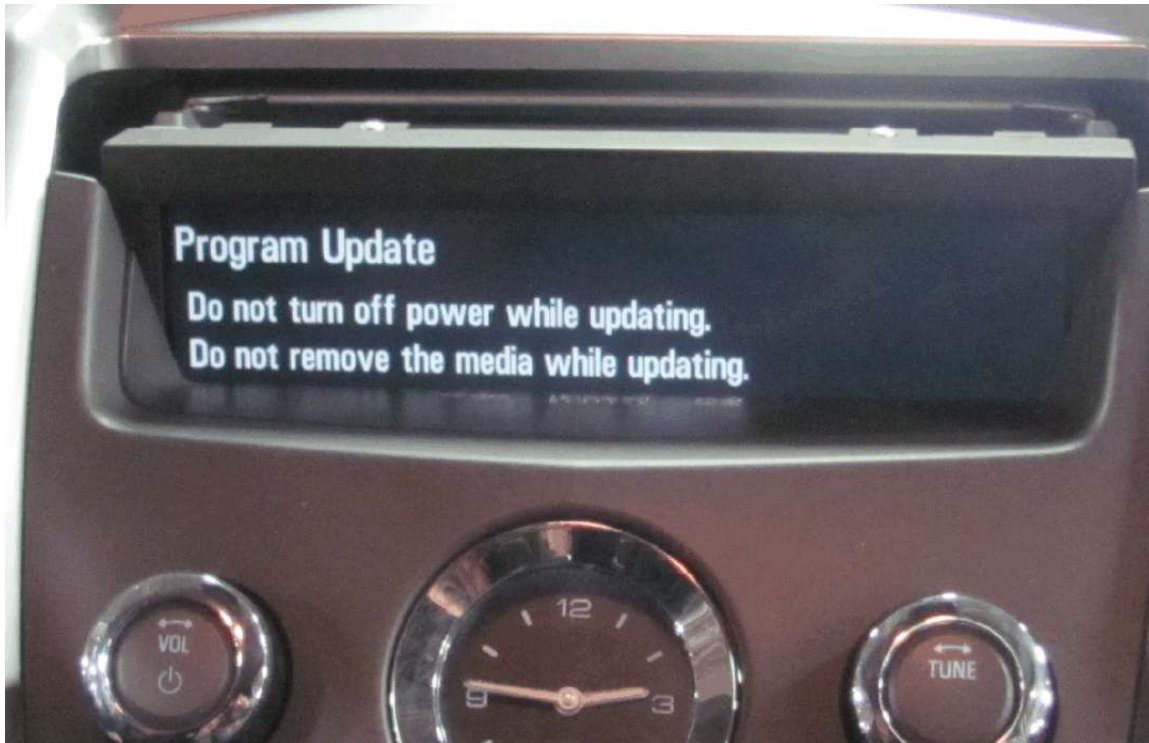
11. Insert the USB flash drive into the USB port of the vehicle. The radio will display the title “Program Update” along with warnings not to interrupt power or remove the media. A bar graph will form indicating progress and an “OK” button will appear. PRESS the appropriate radio button or area of the screen to activate the “OK” command and begin programming.
