# Program Bulletin

## SB-10056598-7889

# CUSTOMER SATISFACTION PROGRAM

**SUBJECT:** Navigation Radio Loss of Customer Settings

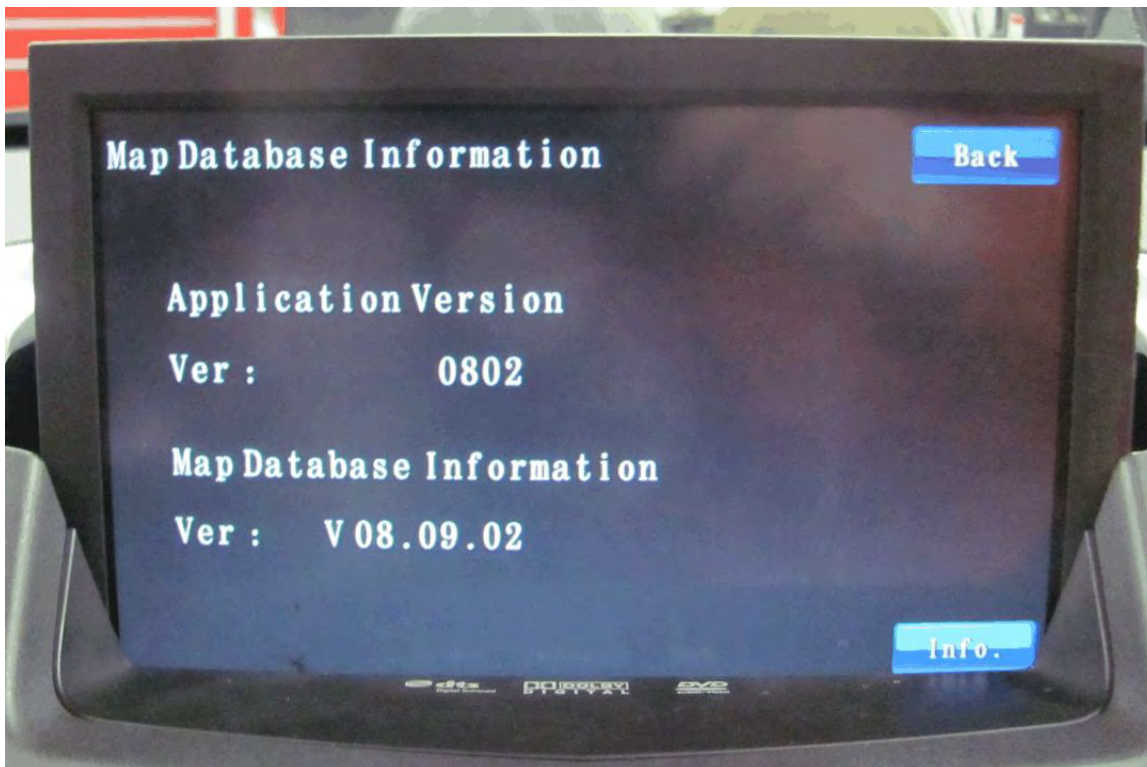
4068017

To determine the radio control module software version, navigate to the Map Database Information screen using the radio. Use the following navigation path: CONFIG>NAV>Map Database Information. Refer to the Application Version field on screen to determine the software version. Refer to photograph.

**Note:** The software version will appear on the screen in one of the following formats: U0802 or 0802. The “U” may NOT be present. Refer to the table below to determine if a software update is required.

- If an update is required, refer to Radio USB Programming for Navigation Software in this bulletin.
- If an update is NOT required, no further action is required.

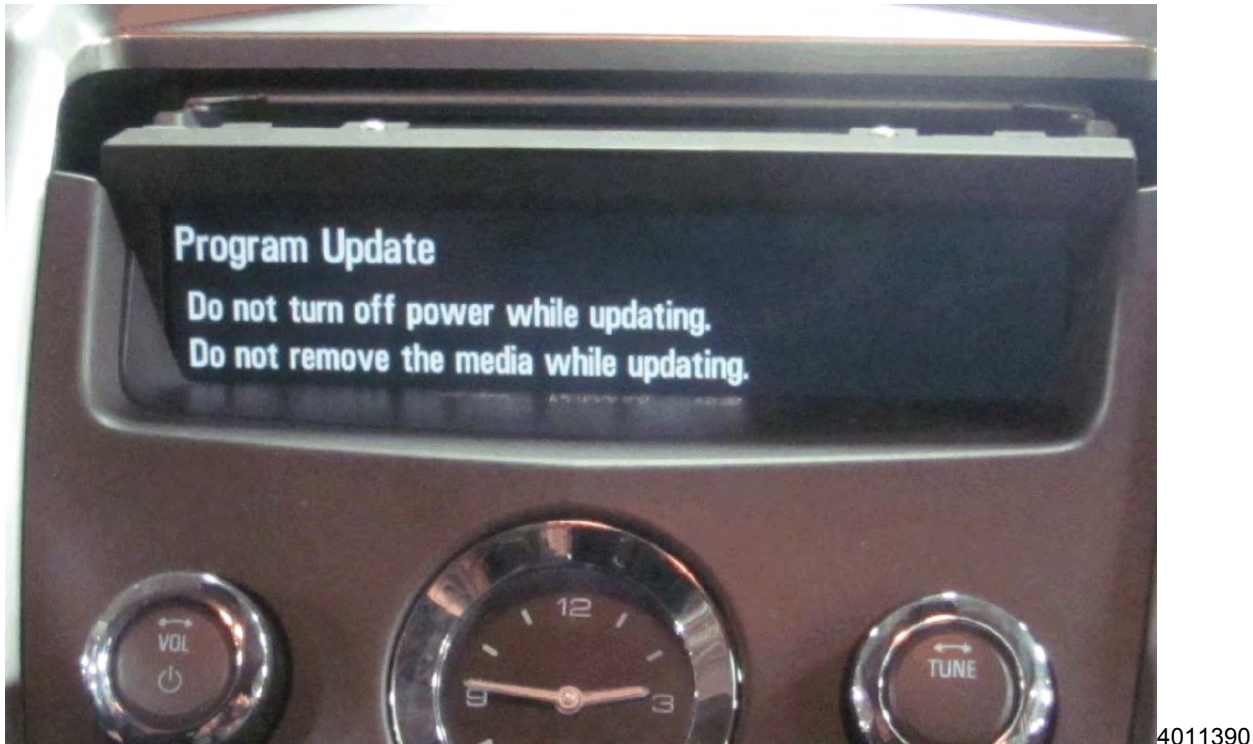
11. Insert the USB flash drive into the USB port of the vehicle. The radio will display the title “Program Update” along with warnings not to interrupt power or remove the media. A bar graph will form indicating progress and an “OK” button will appear. PRESS the appropriate radio button or area of the screen to activate the “OK” command and begin programming.

**Note:** Typically the programming event will take about 45 minutes to complete. The programming event may require more or less time to complete. Wait for the programming to complete BEFORE performing any action. The SRX viewscreen will lower and the program status bar will NOT be visible during programming. The partially raised viewscreen will be blank but have a white hue during programming. It is normal for the white hue progress bar to stay stationary for several minutes before it initially moves. Once the programming files have been transferred from the USB flash drive to the radio module, the SRX viewscreen will partially raise and display the following message: Program Update. Do not turn off power while updating. Do not remove the media while updating. Disregard the message on the screen.

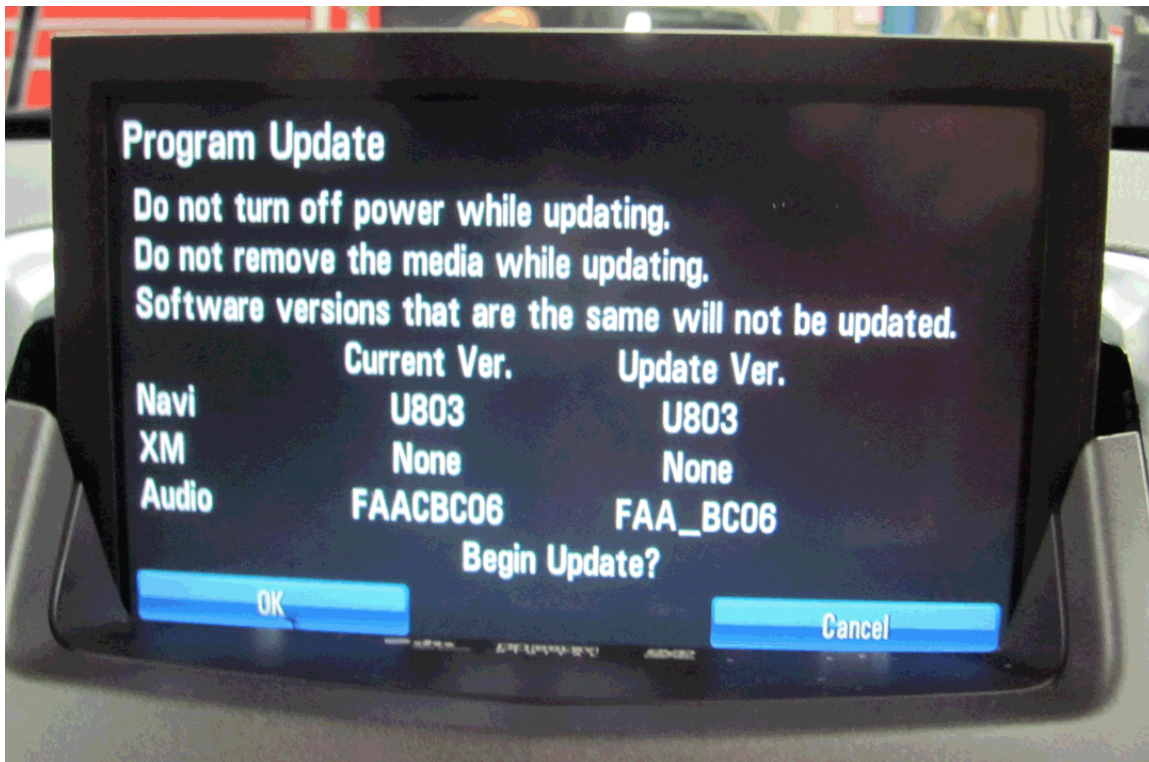
4068016

12. When the programming event has completed, the radio will display Download Complete.

**Note:** The Download Complete screen appears and disappears in a short period of time. If you are not present when the screen appears, the Program Update screen appears. If the Program Update Screen appears and the current software version field and the update software version field are the same or None or "Same" is listed in the software version fields, select "Cancel" and proceed to step 13.

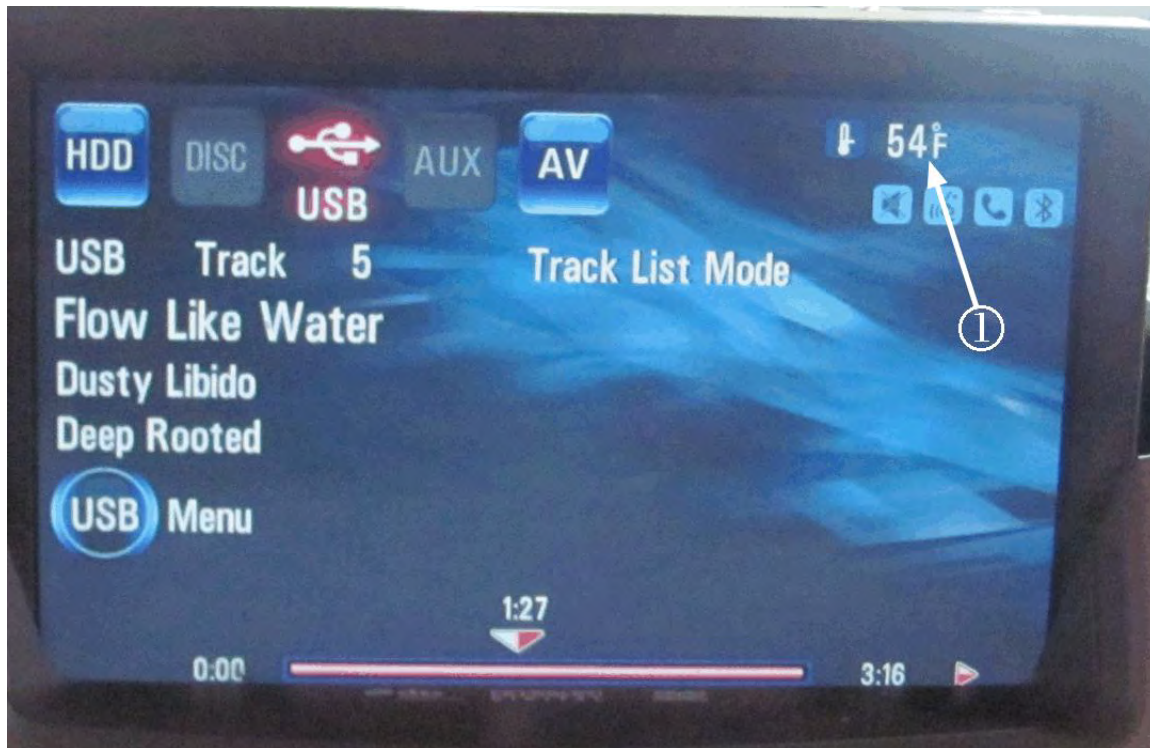
4011389

16. Determine if the temperature (1) is displayed on the radio and map screens.
  - If the temperature (1) is displayed on the radio and map screens, no further action is required.

- If the temperature (1) is NOT displayed on the radio and map screens, a radio calibration MUST be performed. Proceed to step 17.
17. Document the current radio settings so they can be re-entered into the radio after the radio calibration update has been completed.
