# Program Bulletin

## SB-10056598-8037

## CUSTOMER SATISFACTION PROGRAM

**SUBJECT:** Navigation Radio Loss of Customer Settings

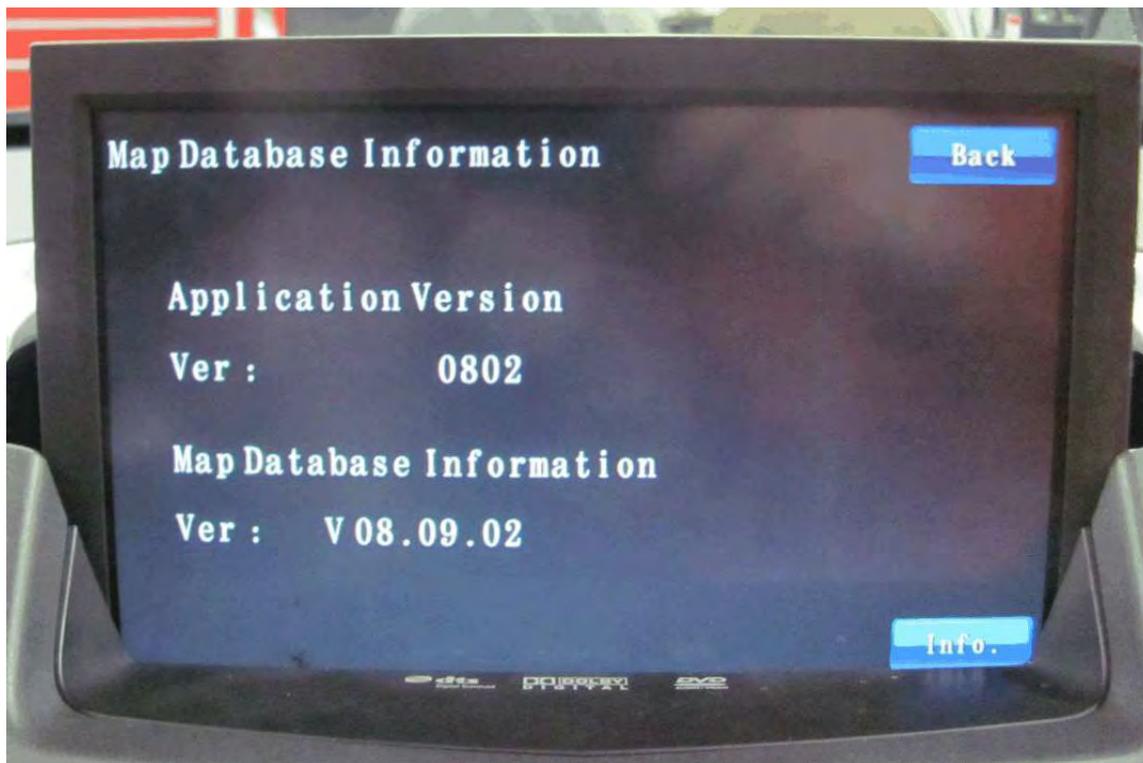
4068017

To determine the radio control module software version, navigate to the Map Database Information screen using the radio. Use the following navigation path: CONFIG>NAV>Map Database Information. Refer to the Application Version field on screen to determine the software version. Refer to photograph.

- If an update is required, refer to Radio USB Programming for Navigation Software in this bulletin.
- If an update is NOT required, no further action is required.

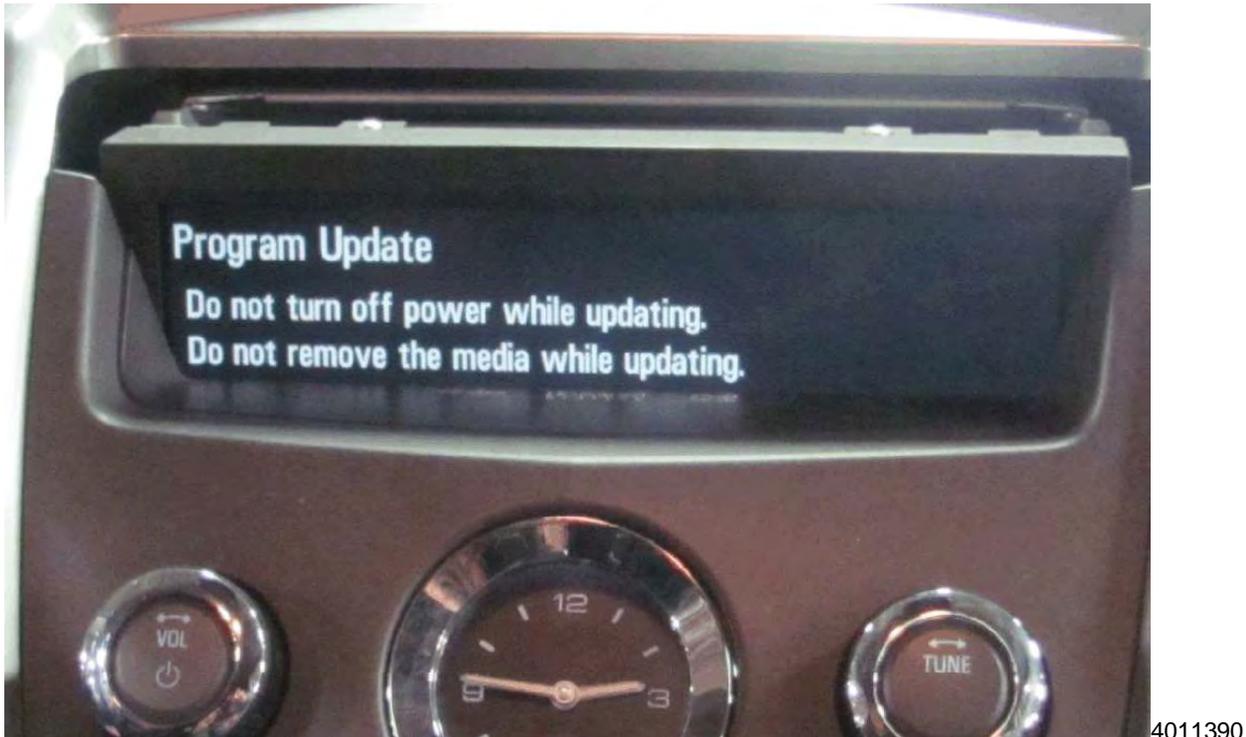
11. Insert the USB flash drive into the USB port of the vehicle. The radio will display the title “Program Update” along with warnings not to interrupt power or remove the media. A bar graph will form indicating progress and an “OK” button will appear. PRESS the appropriate radio button or area of the screen to activate the “OK” command and begin programming.

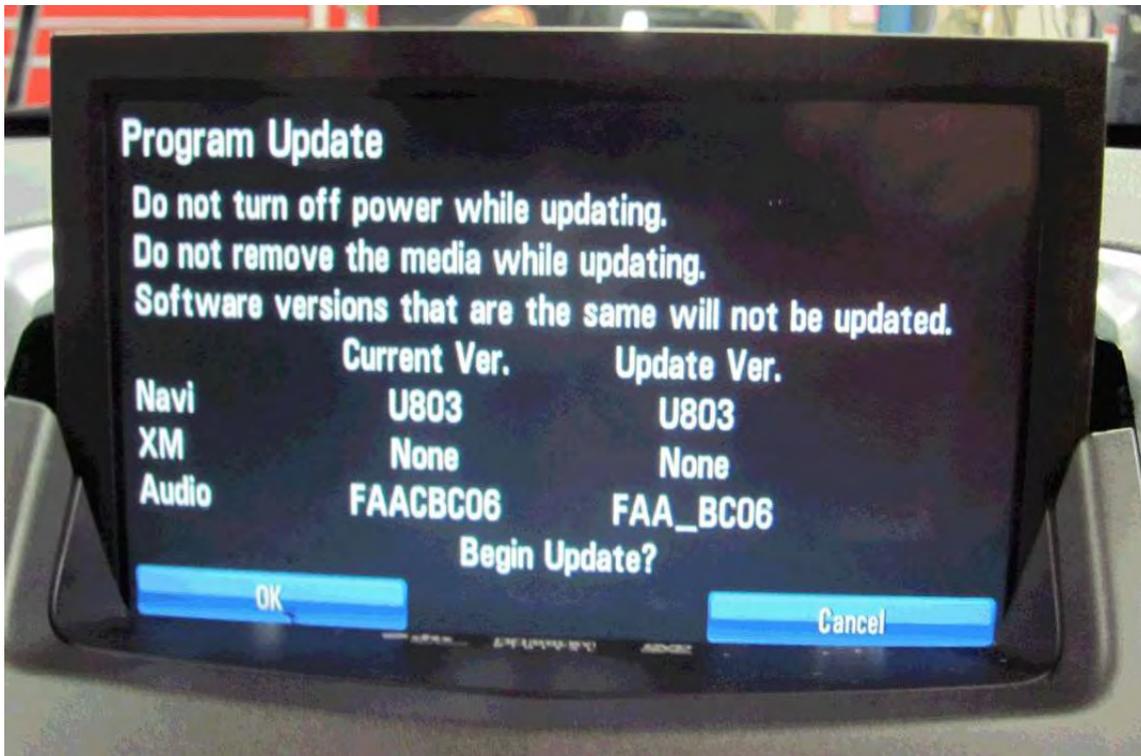
4068016

12. When the programming event has completed, the radio will display Download Complete.

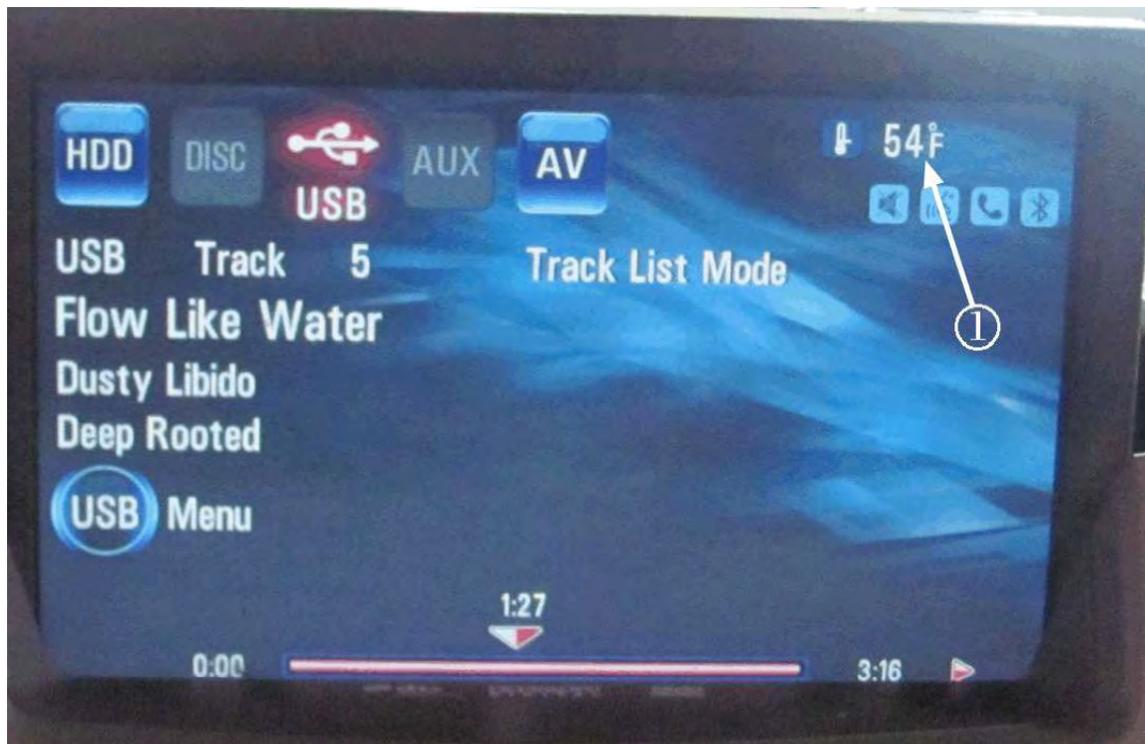
4011389

16. Determine if the temperature (1) is displayed on the radio and map screens.

- If the temperature (1) is displayed on the radio and map screens, no further action is required.
- If the temperature (1) is NOT displayed on the radio and map screens, a radio calibration MUST be performed. Proceed to step 17.
