Technical Service Bulletin Number	Revision Level	Date	Group Number
TSB140117	SB-10056718-9944

Fault Codes 555 and 556 Caused by Dust/Debris Ingestion on Ford F-650/F-750 Chassis

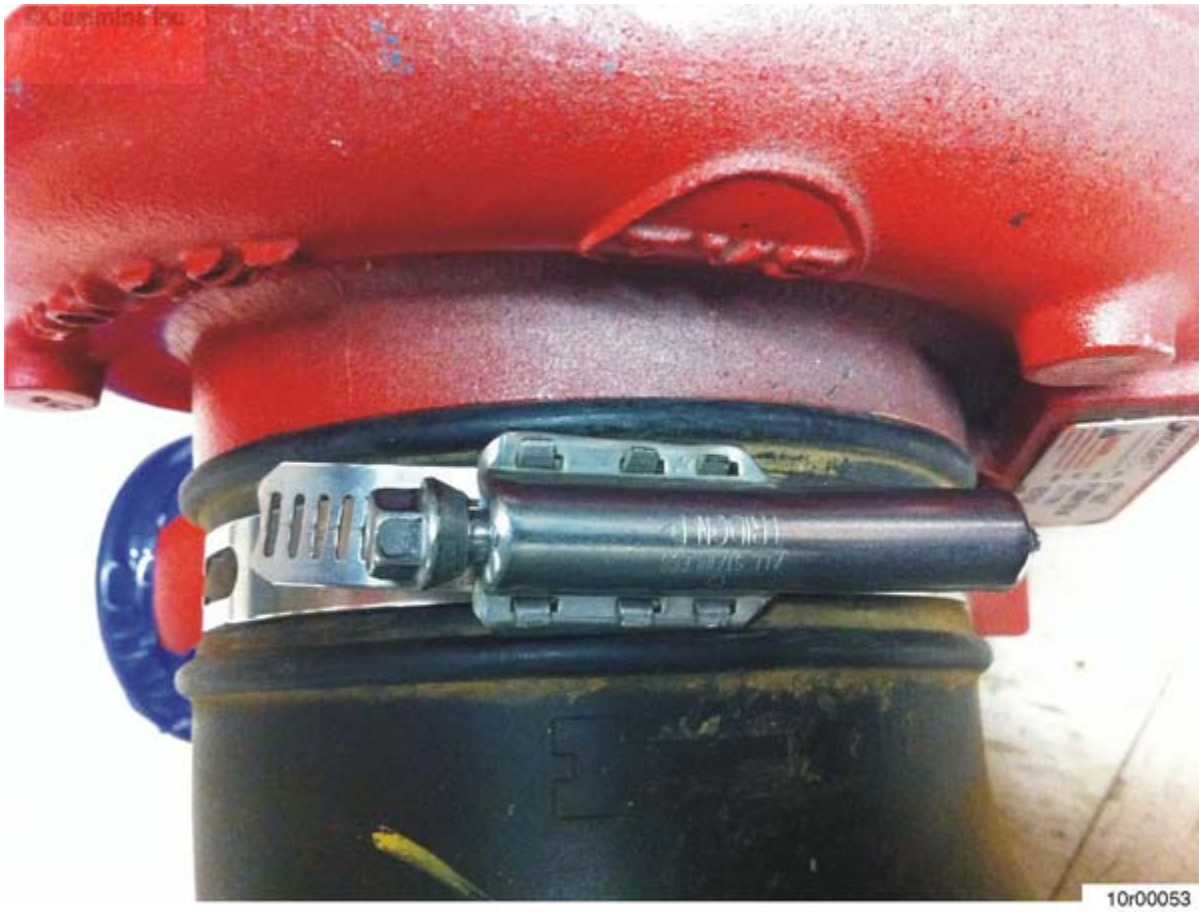
Inspect the air intake hose clamp at the turbocharger compressor inlet for the bolt **not** being at proper torque. If the clamp is **not** at proper torque, there will be a visible gap between the clamp tightening bolt and the spring case of the clamp. Reference Figure 1 to see a clamp **not** at proper torque. Reference Figure 2 to see a clamp at proper torque.

Figure 1: The gap indicating a clamp not at proper torque.

Reference QuickServe® Online to determine proper repair instructions.

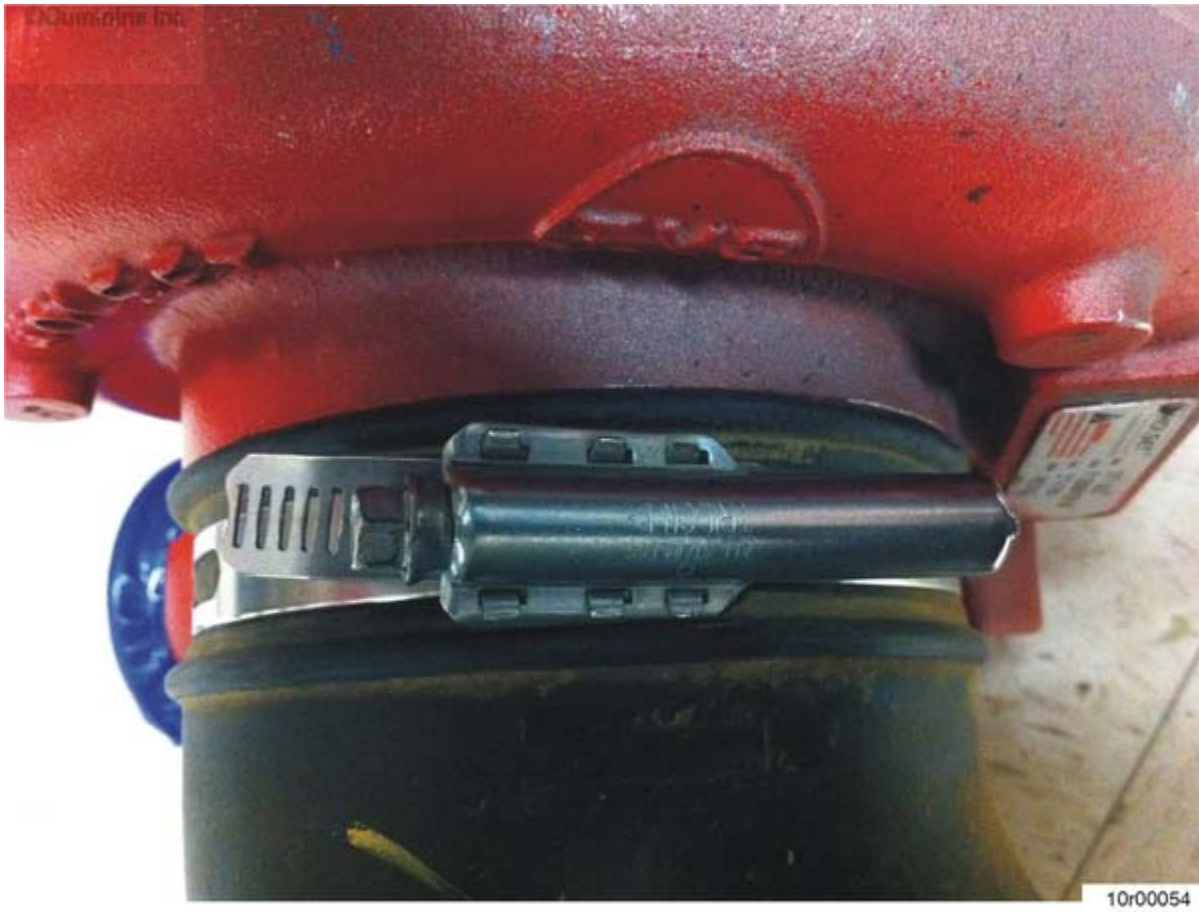
Figure 2: No gap present when clamp is at proper torque.

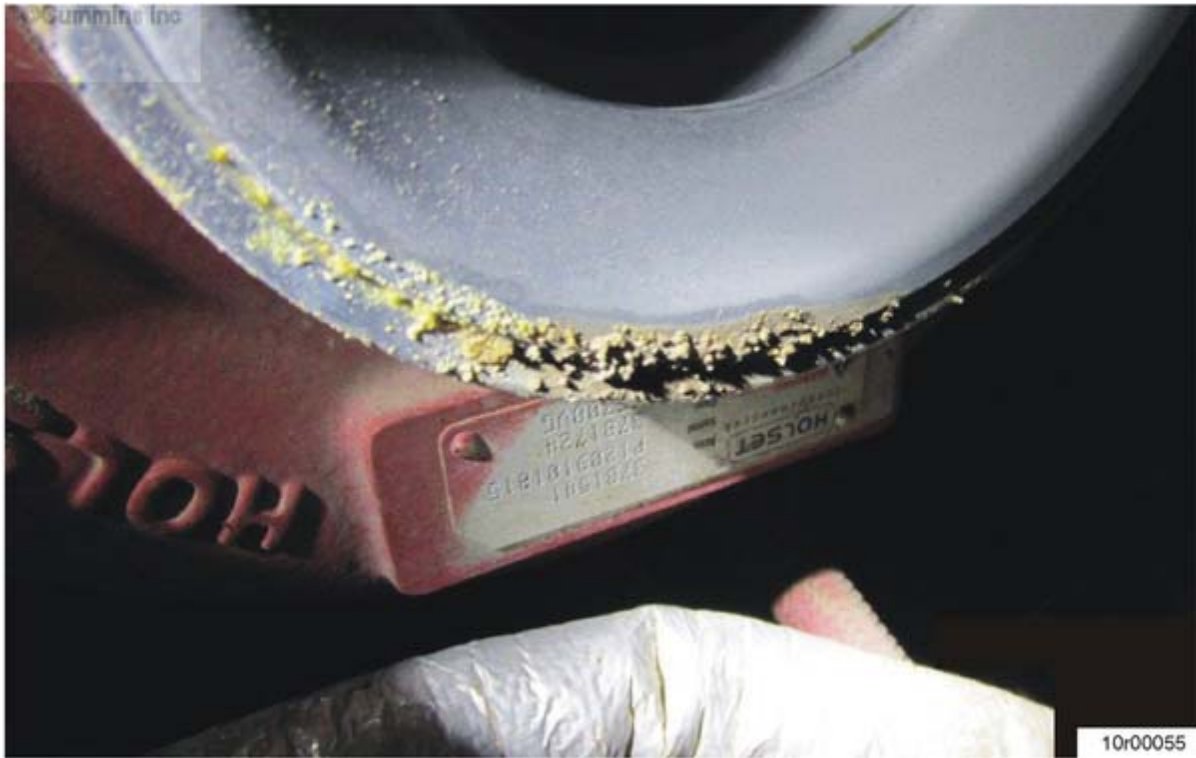
If the clamp has already been removed, reference Figures 3 and 4 that show dust/debris build-up where the clamp seals at the turbocharger compressor inlet. With a clamp at proper torque, the area under the clamp would be clean.

Figure 3: Buildup of dirt/debris at the 6 o'clock position on the turbocharger compressor inlet.

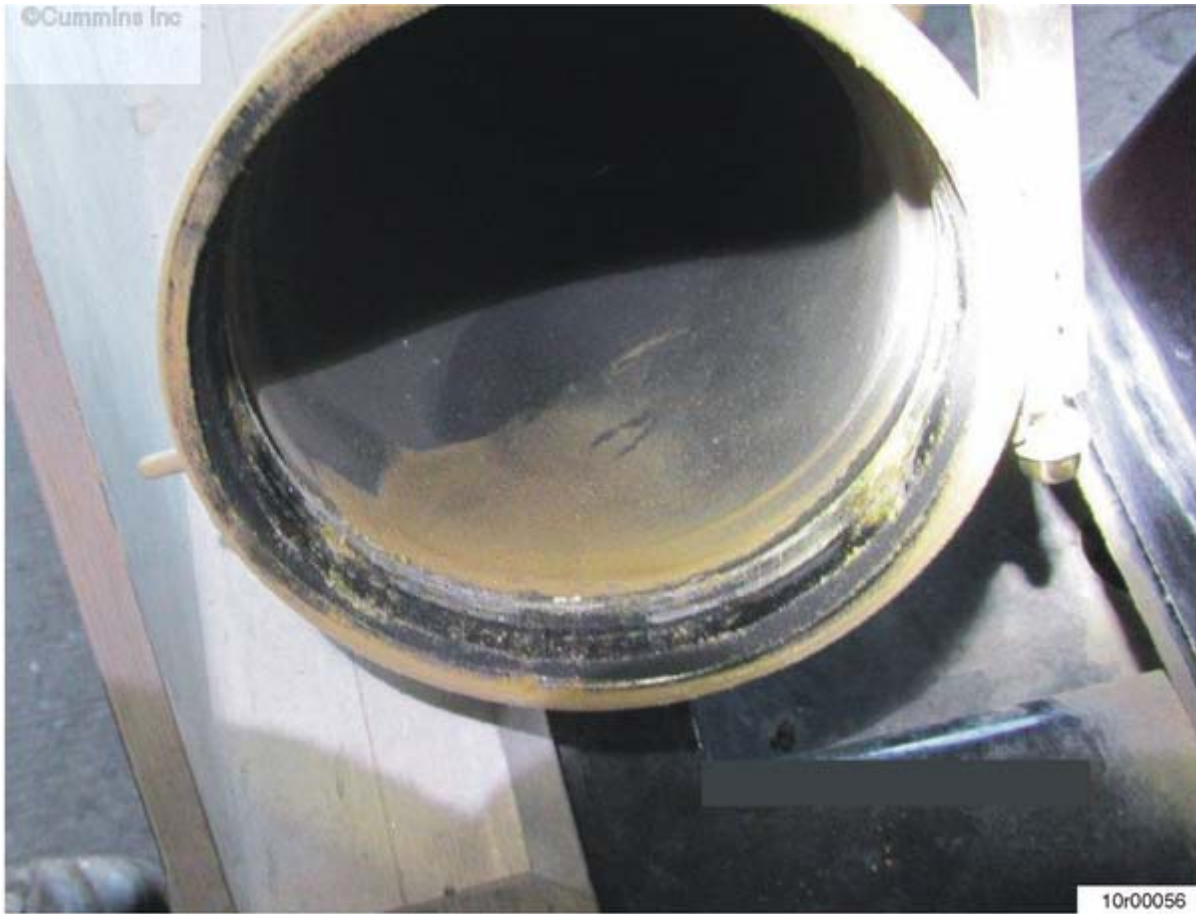
The ISB6.7 CM2250 and CM2350 B101 engines in 2012 and 2013 model year Ford F-650/F-750 chassis have experienced Fault Codes 555 and 556 for high crankcase pressure, which are found to be caused by worn or broken piston rings. The piston rings have worn or broken due to dust/debris entering at the connection point between the turbocharger compressor inlet and the clean air intake hose. It was found that the clamp at this connection point was **not** properly tightened. With time and vibration, the clamp would eventually loosen to free torque (6-8 in-lb for this clamp design) and the seal at the turbocharger compressor inlet would be compromised.

Figure 4: Dust/debris entering the connection point at the turbocharger compressor inlet (the bottom of the hose is the 6 o'clock position).
