SERVICE CAMPAIGN BULLETIN

SUBJECT: SB-10056921-8103		No: SC-14-003REV	
i-MiEV UNDERCARRIAGE RUST –		DATE: April, 2015	
SERVICE CAMPAIGN – REVISED		MODEL: 2012 i-MiEV	
CIRCULATE TO:	<input checked="" type="checkbox"/> GENERAL MANAGER	<input checked="" type="checkbox"/> PARTS MANAGER	<input checked="" type="checkbox"/> TECHNICIAN
<input checked="" type="checkbox"/> SERVICE ADVISOR	<input checked="" type="checkbox"/> SERVICE MANAGER	<input checked="" type="checkbox"/> WARRANTY PROCESSOR	<input checked="" type="checkbox"/> SALES MANAGER

Certain 2012 MY i-MiEV Models

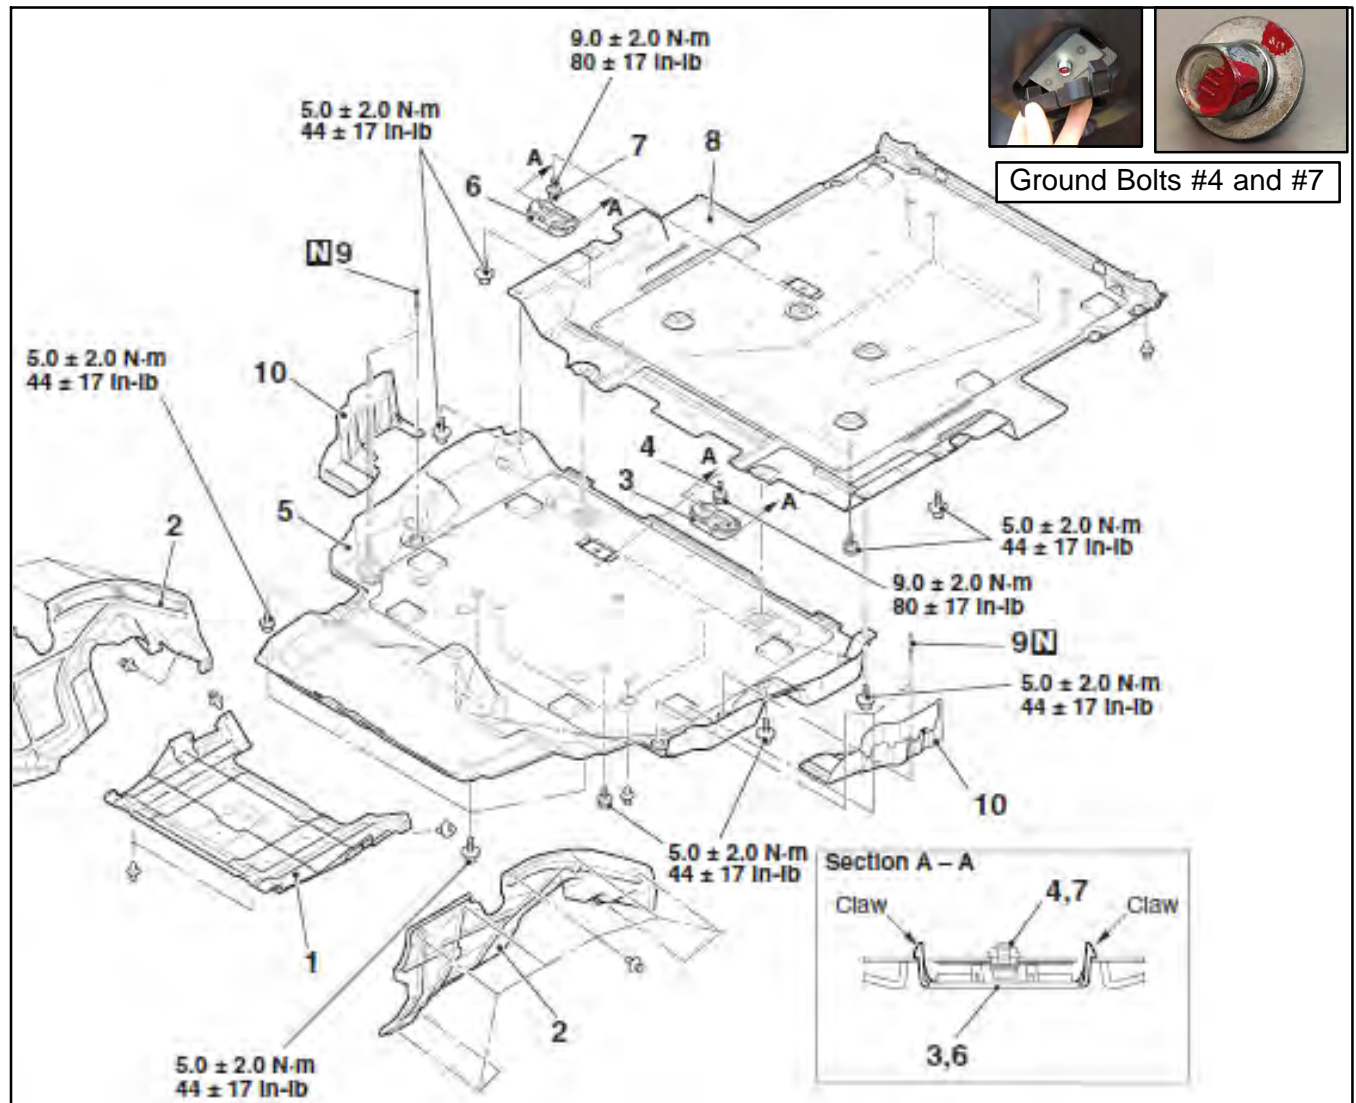
1. Place the vehicle on a lift, shift the selector to PARK, set the parking brake, and turn the electric motor switch to the OFF position. Raise the vehicle.
2. Remove the front and rear plug covers (#3 and #6 – refer to the diagram below) and the non-essential ground bolts (#4 and #7 – refer to the diagram below).
3. Remove the front under cover (#5 – refer to the diagram below), then remove the rear under cover (#8 – refer to the diagram below).

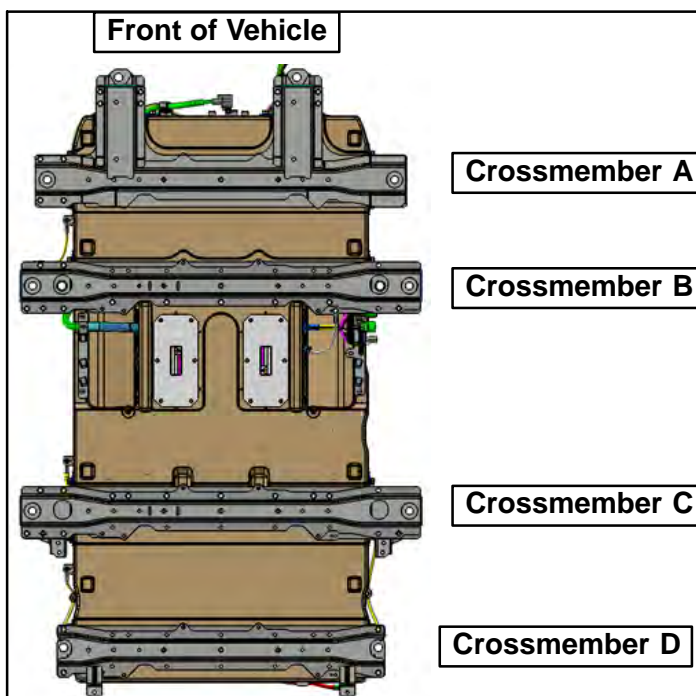
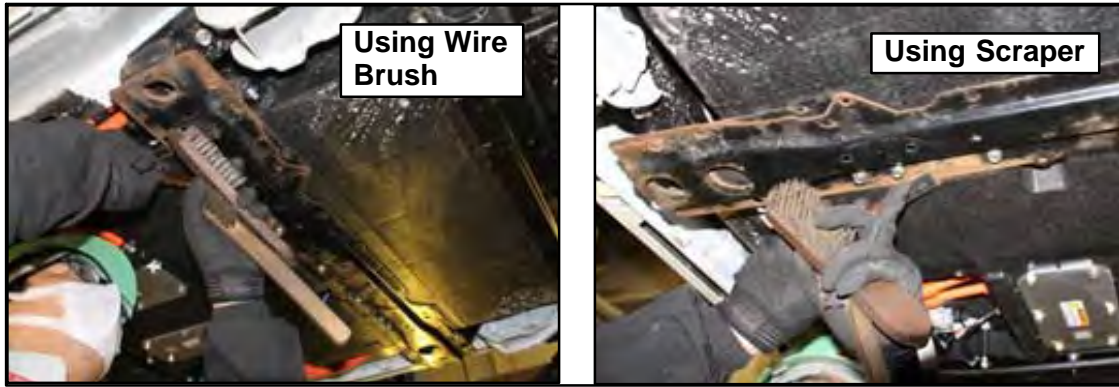
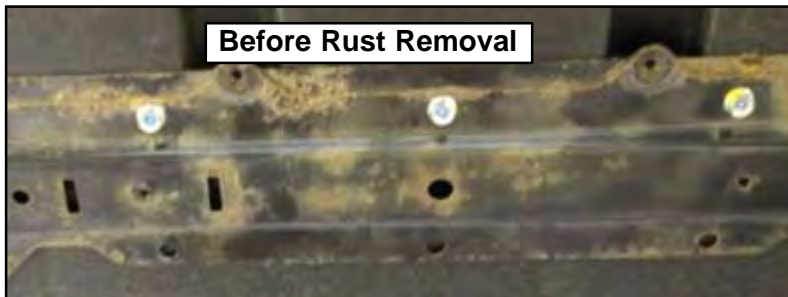
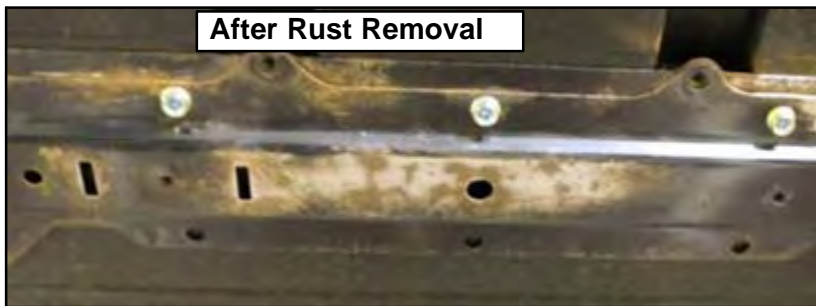
6. Inspect Crossmember A. If rust is present, remove 50% or more of the rust using hand tools such as a wire brush, flat head screwdriver and a scraper.

7. Repeat Step 6 for Crossmember B, C, and D and remove rust if required.

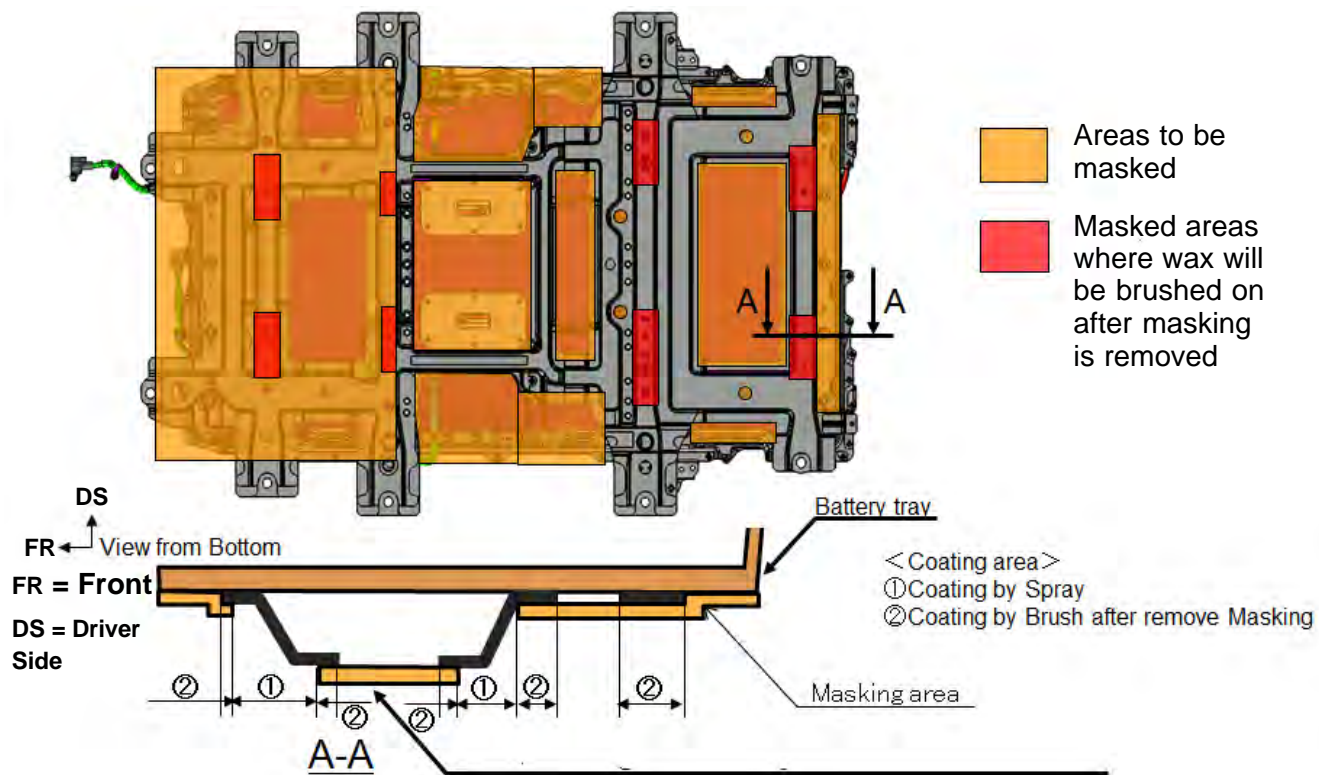
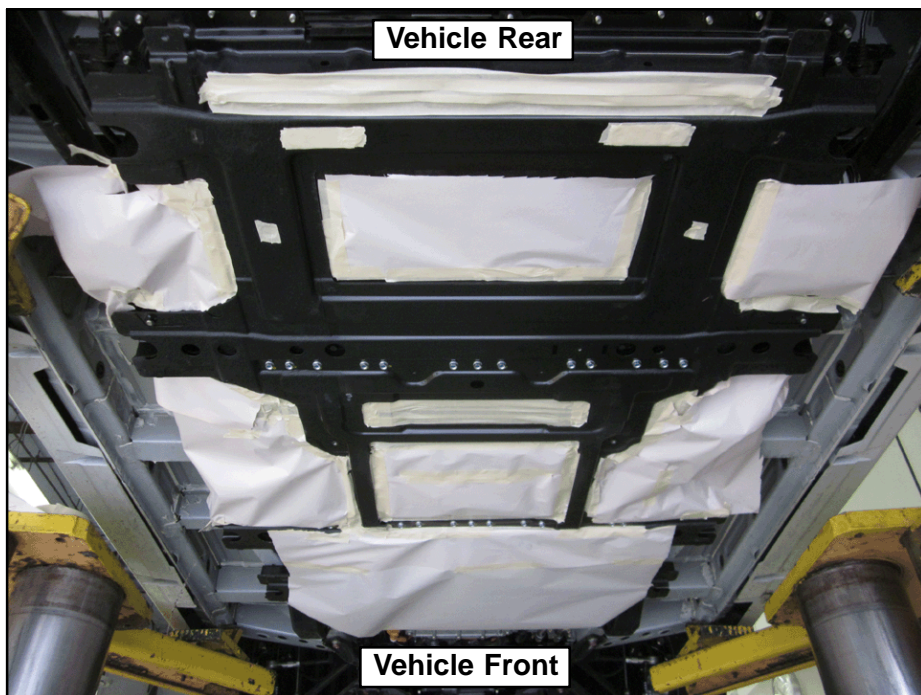
Without proper masking, wax may adhere to the battery tray through the holes

9. To prevent anti-corrosion wax from contacting the resin undercarriage components (harness, battery tray, etc...), mask the indicated areas below with shipping/packaging paper or plastic covers.
