**Document ID:** IK0900104

**Major System:** COOLING

**Title:** Charge Air Cooler (CAC) Leak Test (Air Decay test)

**Applies To:** All Charge Air Coolers

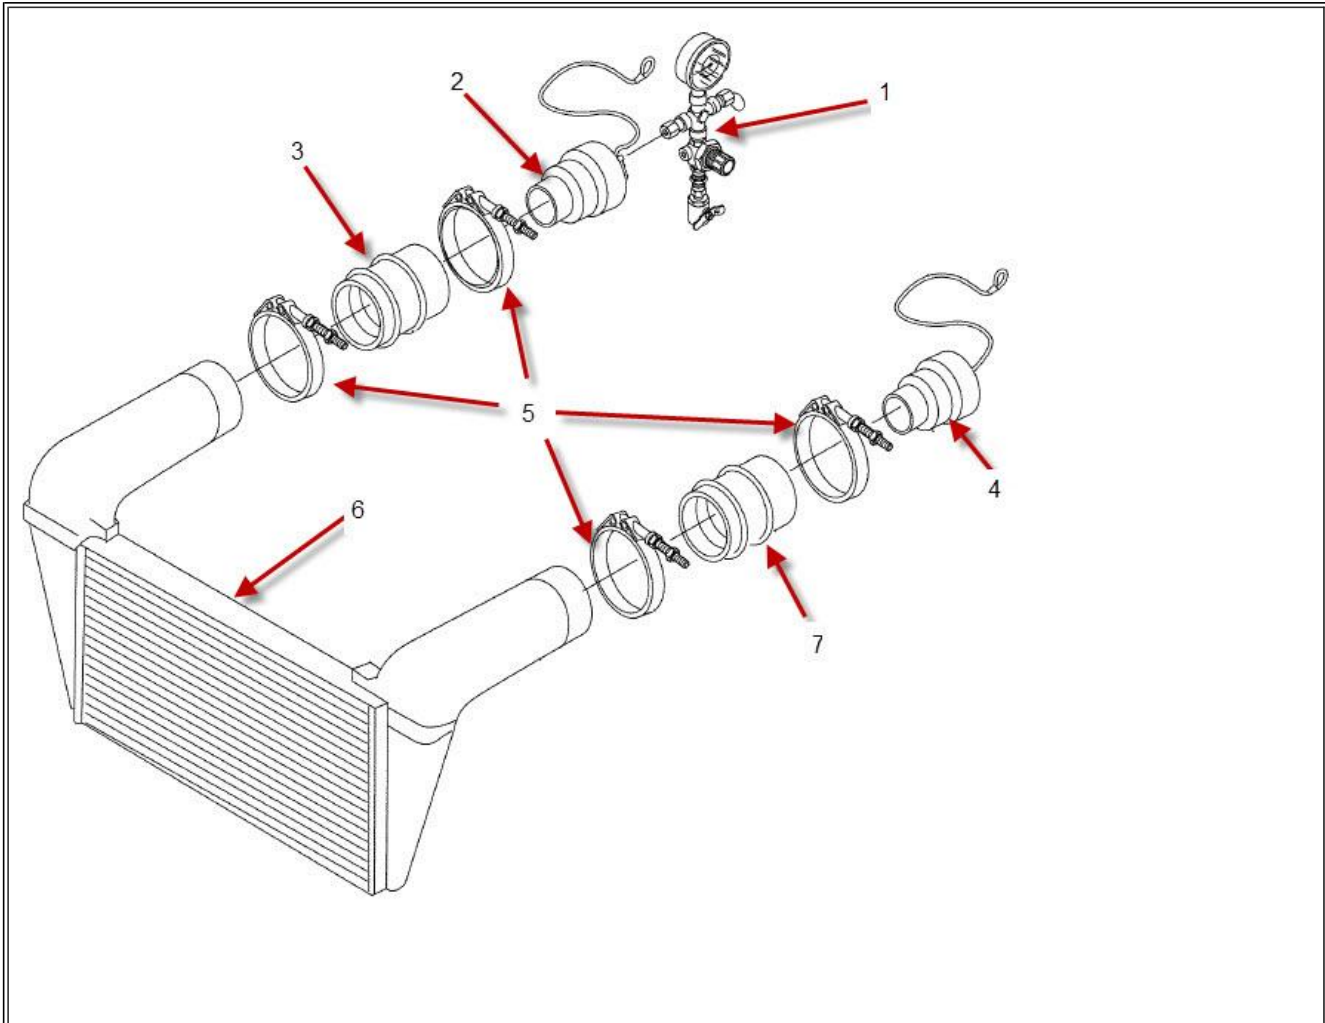
**Figure #1: Installation of Pressure Tester Installation**

1. Remove piping, hump hoses and clamps from the turbocharger and ETV or intake manifold. The charge air cooler can remain in the chassis for this test. Existing hump hoses and clamps on the charge air cooler itself will be used for this test. Double clamp all hump hose connections and tighten all constant torque hose clamps to 100 in-lbs.

2. Double-check all connections to verify that all joints are tight. Close air pressure regulator and drain valve before beginning test.
3. Begin test by slowly opening air pressure regulator until test pressure reaches 30 psi. When 30 psi test pressure has been reached, close the air pressure regulator.

4. Monitor pressure gauge and determine rate of pressure decay with a stopwatch. System pressure should not drop more than 5 psi in 15 seconds.
5. After testing, open the drain valve to release pressure. If pressure drop exceeds 5 psi in 15 seconds, re-check all connections.
6. If a leaky connection is found, tighten the connection and repeat the test. If the leak is within the charge air cooler, repeat the test as many times as necessary to verify the reading. Similar pressure decay readings should be obtained on at least three consecutive tests to confirm the reading.
7. **If pressure decay does not exceed 5 psi in 15 seconds, the charge air cooler is within acceptable performance limits and should not be replaced.**

- **NOTE:** If testing indicates the Charge Air Cooler is leaking beyond the allowable specification, replace the CAC. Do not attempt to repair the CAC, because field repair is difficult and will void the CAC warranty.

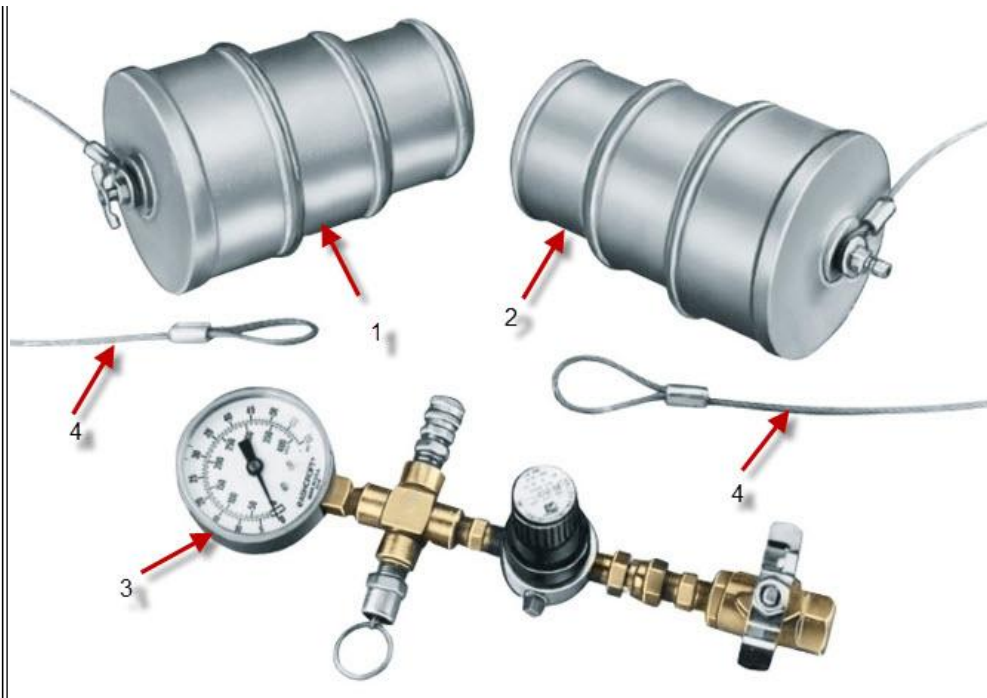
**Figure #2: CAC Pressure Test Kit**

Tool Description	Tool Number
Charge Air Cooler Test Kit (Figure 2)	ZTSE-4341
