# Service Bulletin

**SUBJECT: Special Coverage Adjustment – Nitrogen Oxide (NOx) Sensor**

**MODELS: 2010-2011 Chevrolet Express and GMC Savana  
Equipped with 6.6L Diesel Engine (RPO LGH)**

**2011 Chevrolet Silverado and GMC Sierra 2500/3500  
Equipped with 6.6L Diesel Engine (RPO LML/LGH)**

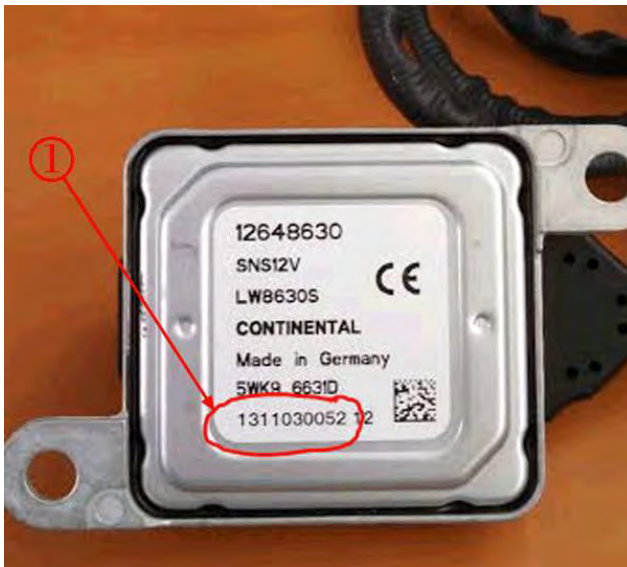
4000071

**Note:** If diagnosis indicates that only one nitrogen oxide sensor requires replacement, inspect the date code of the other nitrogen oxide sensor to determine if it requires replacement. The date code (1) is located on the back side of the NOx sensor module. The first six digits of the code represent the date code. Refer to the photograph. The example in the photograph has a date code of 131103xxxx, which indicates a November 03, 2013 date code. All NOx sensors with a date code prior to 120914xxxx (September 14, 2012) should be discarded and replaced with a new sensor.
