Service Bulletin

SB-10057264-5528

SUBJECT: Special Coverage Adjustment – Ignition Key Removal

MODELS: 2005-2006 Chevrolet Equinox
2006 Pontiac Torrent
2002-2007 Saturn VUE

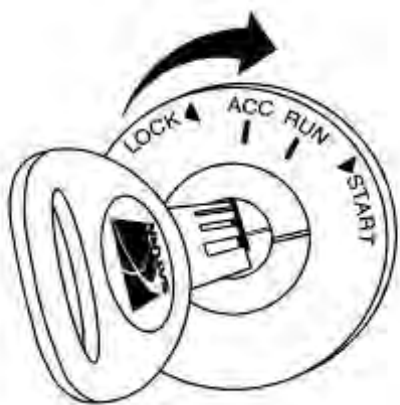
1334808

Note: Some Saturn VUE vehicles may have a condition in which the ignition key can be removed when the ignition is NOT in the LOCK position.

Note: With the key in the ignition switch, you can turn it to four different positions. **You should only be able to remove the key when the ignition is turned to the LOCK position.** Below is a description of the four ignition positions:

1. Determine if the key can be removed from the ignition cylinder in any position other than the LOCK position.
 - If the key **cannot** be removed in any position other than the LOCK position, no further action is required.
 - If the key can be removed from the ignition cylinder while in the ACC, RUN or START position, replace the ignition lock cylinder and key set (2 keys). Proceed to step 2.
2. Remove the ignition lock cylinder. Refer to *Ignition Lock Cylinder Replacement* in SI.
3. Install a new ignition lock cylinder. Refer to *Ignition Lock Cylinder Replacement* in SI.

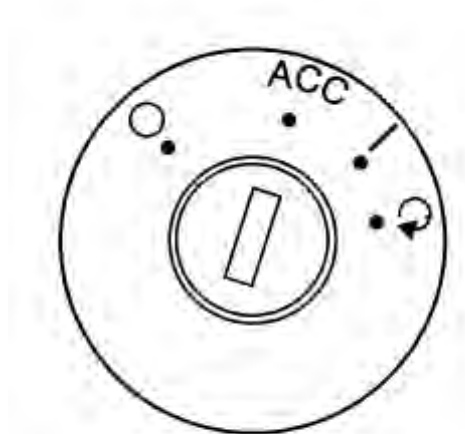
1839823

Note: Some Chevrolet Equinox and Pontiac Torrent vehicles may have a condition in which the ignition key can be removed when the ignition is NOT in the LOCK position.

Note: With the key in the ignition switch, you can turn it to four different positions. **You should only be able to remove the key when the ignition is turned to the LOCK position.** Below is a description of the four ignition positions:

1. Determine if the key can be removed from the ignition cylinder in any position other than the LOCK position.
 - If the key **cannot** be removed in any position other than the LOCK position, no further action is required.
 - If the key can be removed from the ignition cylinder while in the ACC, RUN or START position, replace the ignition lock cylinder and key set (2 keys). Proceed to step 2.
2. Remove the ignition lock cylinder. Refer to *Ignition Lock Cylinder Replacement* in SI.
3. Install a new ignition lock cylinder. Refer to *Ignition Lock Cylinder Replacement* in SI.
