SB-10057338-8937

This Service Information bulletin and attachment supersedes SI B11 16 14 **dated January 2015.**

N63 Engine: Check the Timing Chain

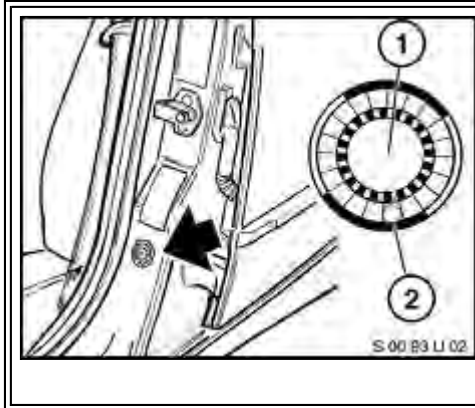
This Service Action has been assigned code number **728**. After the vehicle has been checked and/or corrected, obtain a label (SD 92-464) and:

- A. Emboss your BMW center warranty number in the middle of the label (1);
- B. Punch out code number **728** (2), printed on the label; and
- C. Affix the label to the B-pillar as shown.

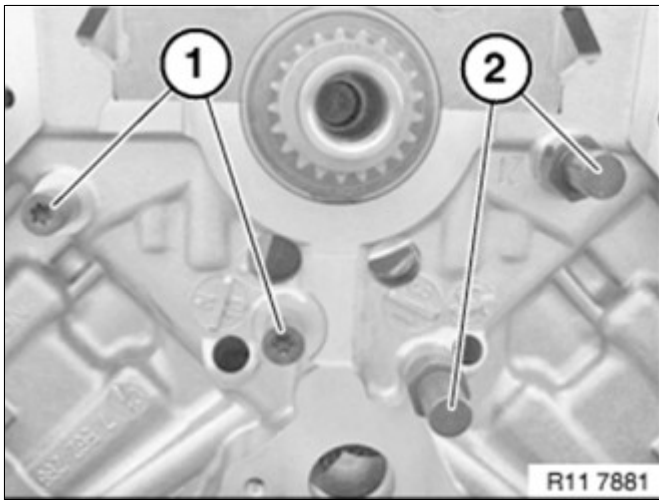
Important Note:

NEW The current ISTA repair manual RA11 31 052 “Replacing both timing chains \ PREMIUM” instructs to release tension on four bearing bolts (indicated as #1 for cylinders 5 to 8; and #2 for cylinders 1 to 4) on the engine block.

NEW IT IS NOT NECESSARY TO DO THIS.

NEW DO NOT release these bolts, because the bearing bolts are micro-encapsulated and they would have to be replaced if loosened up. The repair instructions will be updated soon.

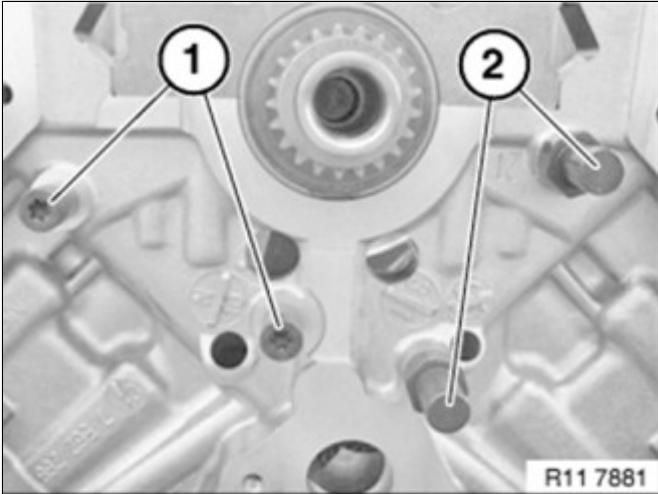
<p>Important Note:</p> <p>NEW The current ISTA repair manual RA11 31 052 “Replacing both timing chains \ PREMIUM” instructs to release tension on four bearing bolts (indicated as #1 for cylinders 5 to 8; and #2 for cylinders 1 to 4) on the engine block.</p> <p>NEW IT IS NOT NECESSARY TO DO THIS.</p> <p>NEW DO NOT release these bolts, because the bearing bolts are micro-encapsulated and they would have to be replaced if loosened up. The repair instructions will be updated soon.</p>
---	---
