SI B11 23 14
Engine

SB-10057339-2098

Service Action: Replace the Thermostat (F10)

F10 (5 Series Sedan)

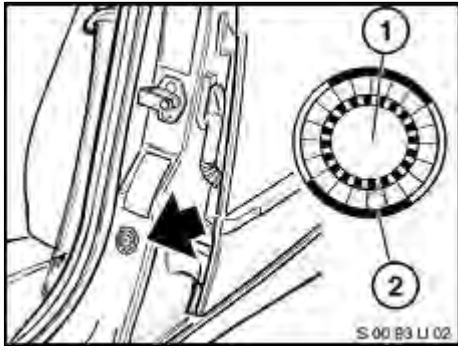
This Service Action has been assigned code number **720**. After the vehicle has been checked and/or corrected, obtain a label (SD 92-453) and:

- A. Emboss your BMW center warranty number in the middle of the label (1);
- B. Punch out code number **720** (2), printed on the label; and
- C. Affix the label to the B-pillar as shown.
