## Draft Entering Cabin from A-Pillar

<b>Classification</b>	Repair Bulletin	<b>Section/Group</b>	11 - Closures	<b>Country/Region</b>	All
<b>Year</b>	2012-2014	<b>Model</b>	Model S	<b>Version</b>	All

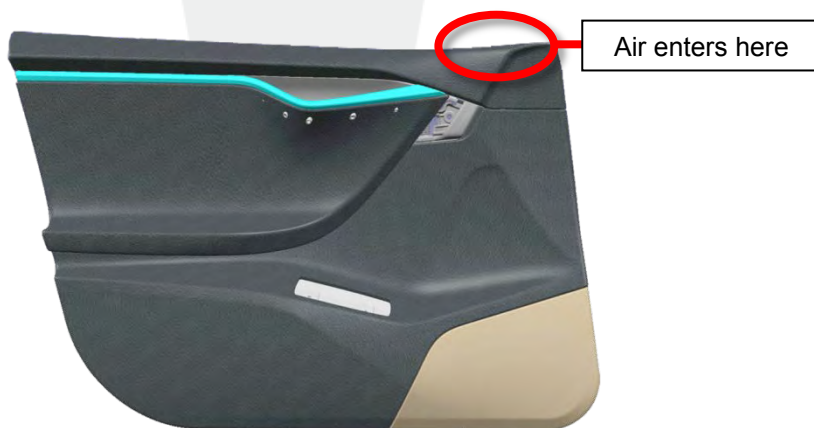
Figure 1

Some Model S customers have complained about air entering the cabin from the fixed glass near the A-pillar. Air enters around the exterior door handles and enters the cabin through the top edge of the door trim panel (Figure 1). This condition is intensified when climate control is set to "Recirculate" or when the vehicle is moving.

**NOTE:** The draft is more noticeable in cold climates.

Upon customer complaint of a draft entering the cabin from either front fixed glass area, remove both front door panels and install upgraded fixed glass seals (Figure 2).

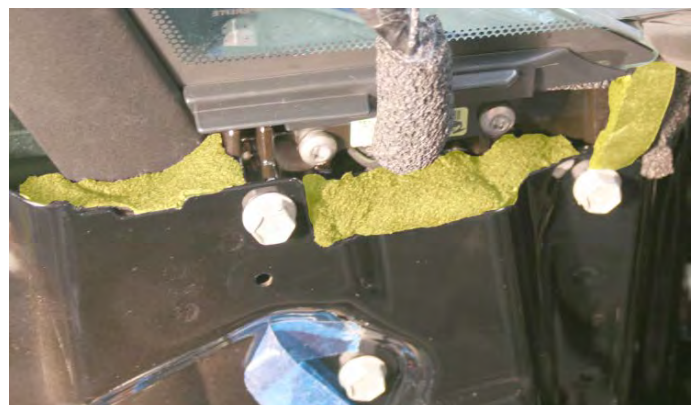
Figure 4 (Foam pieces highlighted)

1. Remove the driver's side front door trim panel (refer to Service Manual procedure 15130201).
2. If equipped, remove and discard the old fixed glass seal (Figure 3) or any foam in the gaps below the fixed glass (Figure 4).

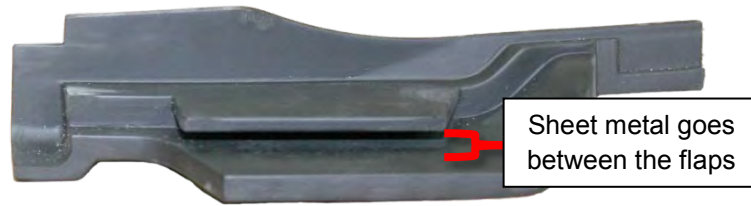
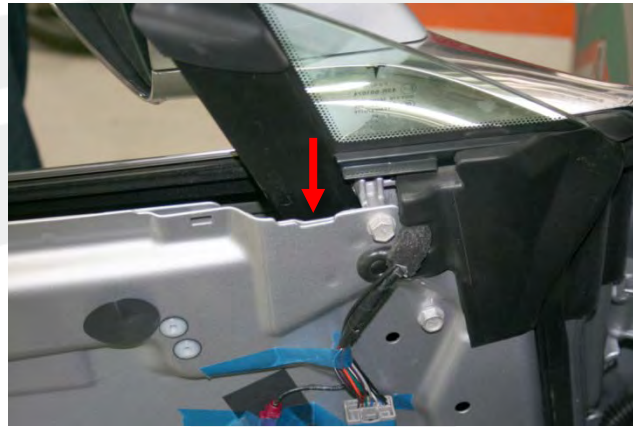
**Figure 5 (Bottom side shown)**

- Place the upgraded fixed glass seal straight down over the gap between the fixed glass and moving glass so that the flaps on the bottom side of the fixed glass seal rests on the edge of the sheet metal (Figures 5 and 6).

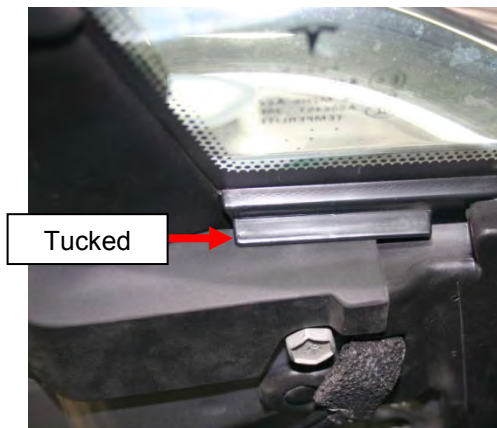
**✓ Figure 7 (Correct)**

- Tuck the front portion of the fixed glass seal under the flap near the fixed glass (Figures 7 and 8).

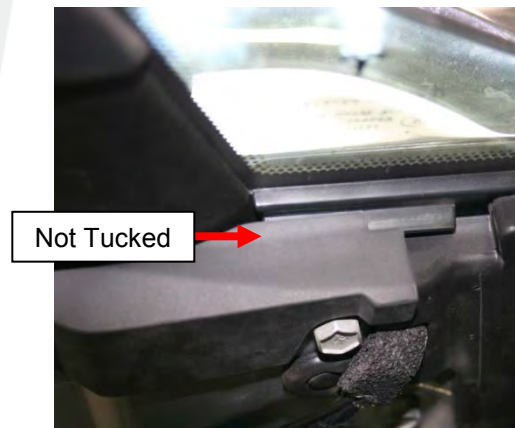
**✗ Figure 8 (Incorrect)**

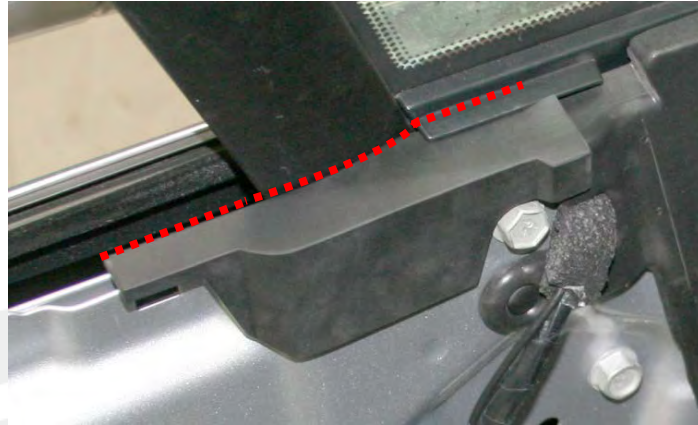
**Figure 9 (Contour of fixed glass seal shown)**

5. Ensure that there are no large gaps between the fixed glass seal and the front windows where air can enter the cabin. The fixed glass seal should follow the contour of the door panel (Figure 9).
