Service Bulletin

SPECIAL COVERAGE

SUBJECT: Special Coverage Adjustment – Negative Battery Cable Loose

MODELS: 2011-2015 Chevrolet Cruze

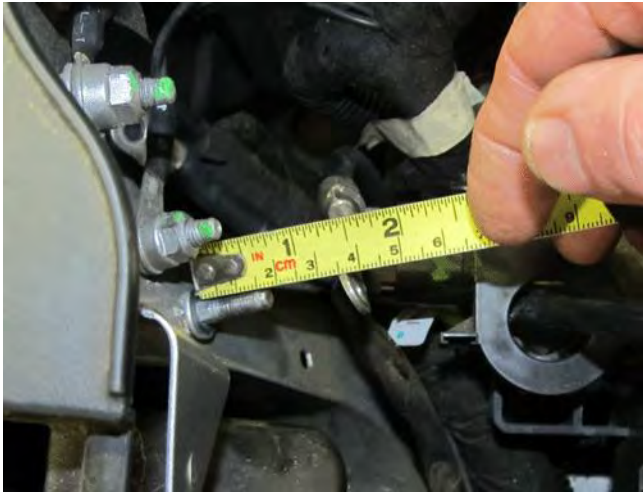
4002404

Note: When installing the body end of the new ground cable, depending on production date, the G100 ground stud could be one of two lengths. The shorter stud length of 17mm is shown in the graphic above.

13. Before installing the negative cable and starter ground cable to the G100 ground stud, measure the length of the stud. The information below will provide direction as to the correct nut to use for attachment
