# Service Bulletin

**SB-10057574-7457**

**SUBJECT: Special Coverage Adjustment – Negative Battery Cable Loose**

**MODELS: 2011-2015 Chevrolet Cruze**

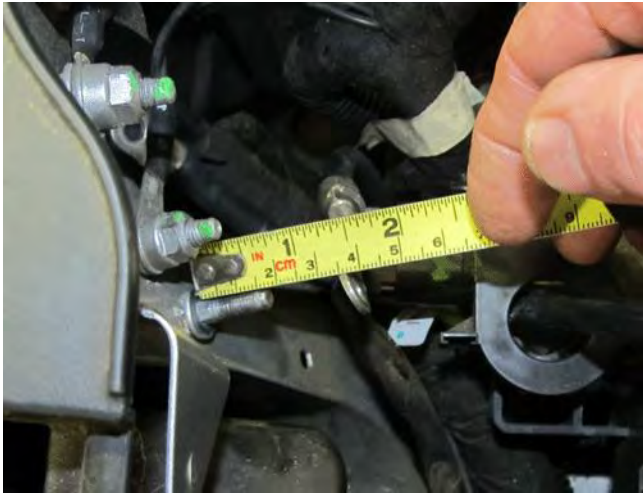
4002404

**Note:** When installing the body end of the new ground cable, depending on production date, the G100 ground stud could be one of two lengths. The shorter stud length of 17mm is shown in the graphic above.

13. Before installing the negative cable and starter ground cable to the G100 ground stud, measure the length of the stud. The information below will provide direction as to the correct nut to use for attachment

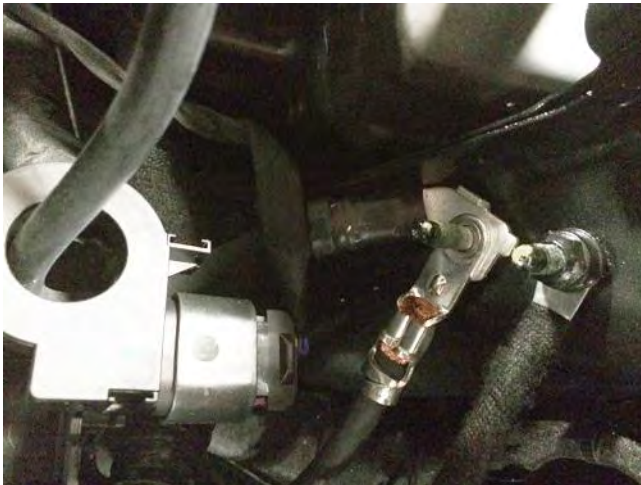
4002406

**Note:** In some cases, the terminal eyelet for ground cable from ground G100 to the starter may have an interference fit to the hex feature at the base of the G100 weld stud. Inspect for this condition during the following step.

- If interference is found, complete the rework procedure in step 15.
15. Rework the eyelet on the ground cable by removing material and opening up the inside diameter of eyelet, just enough so the eyelet will slip fit over the hex feature at the base of the weld stud.
