Service Bulletin

SB-10057574-8899

SUBJECT: Special Coverage Adjustment – Negative Battery Cable Loose

MODELS: 2011-2015 Chevrolet Cruze

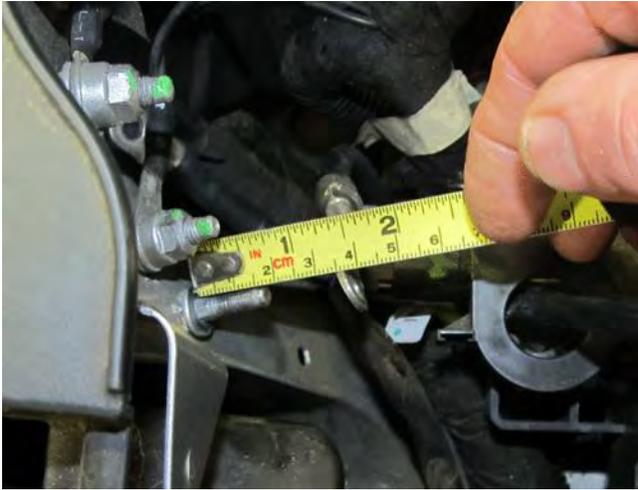
4002404

Note: When installing the body end of the new ground cable, depending on production date, the G100 ground stud could be one of two lengths. The shorter stud length of 17mm is shown in the graphic above.

13. Before installing the negative cable and starter ground cable to the G100 ground stud, measure the length of the stud. The information below will provide direction as to the correct nut to use for attachment

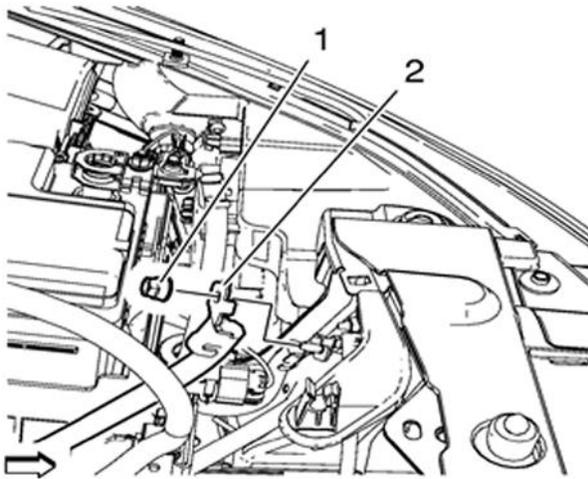
4002395

Note: In some cases, the terminal eyelet for ground cable from ground G100 to the starter may have an interference fit to the hex feature at the base of the G100 weld stud. Inspect for this condition during the following step.

14. Install the battery negative cable (2) onto the G100 ground stud, then install the terminal eyelet for the starter ground cable on top of the negative cable.
 - If no interference is found and the eyelet fully seats on the weld stud, skip step 15, and move ahead to step 16.
