# Service Bulletin

## SPECIAL COVERAGE

**SUBJECT:** Special Coverage Adjustment – Nitrogen Oxide (NOx) Sensor

**MODELS:** 2010-2011 Chevrolet Express and GMC Savana  
Equipped with 6.6L Diesel Engine (RPO LGH)

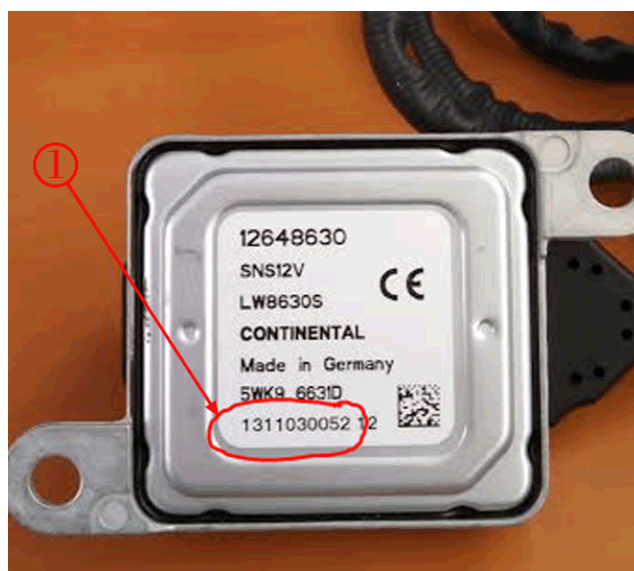
4000071

**Note:** If diagnosis indicates that only one nitrogen oxide sensor requires replacement, inspect the date code of the other nitrogen oxide sensor to determine if it requires replacement. The date code (1) is located on the back side of the NOx sensor module. The first six digits of the code represent the date code. Refer to the photograph. The example in the photograph has a date code of 131103xxxx, which indicates a November 03, 2013 date code. All NOx sensors with a date code prior to 120914xxxx (September 14, 2012) should be discarded and replaced with a new sensor.
