# Service Bulletin

**SUBJECT:** Special Coverage Adjustment – Inadequate Clearance of Fuel Fill Pipe Clamp to Brake Lines

**MODELS:** 2011-2014 Chevrolet Express  
2011-2014 GMC Savana  
Equipped with Hinged Left Side Rear Door (RPO E26)

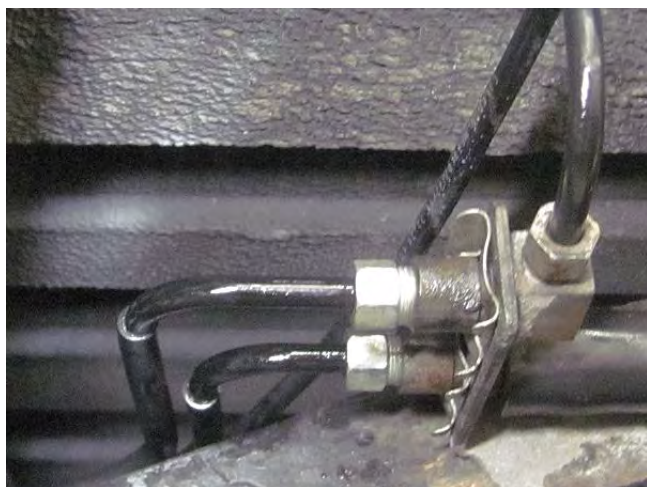
4070668

**Note:** The brake line connection point at the rear of the vehicle is at the rear jounce hose and crossover pipe mounting bracket. The brake line connection point at the front of the vehicle is at the brake pressure modulator valve.

3. Ensure a pan or equivalent is placed on the floor over the leak path of the brake line connection points at the front and rear of the vehicle.

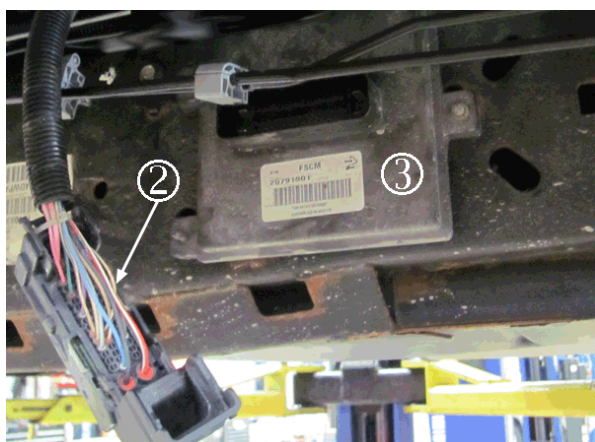
4070703

**Caution:** Remove all dirt and debris from the brake pressure modulator valve (BPMV) before loosening or removing any of the brake lines (1).

7. Disconnect the brake lines (1) from the brake pressure modulator valve.

8. Disconnect the chassis wiring harness electrical connector (2) from the fuel pump flow control module (3).

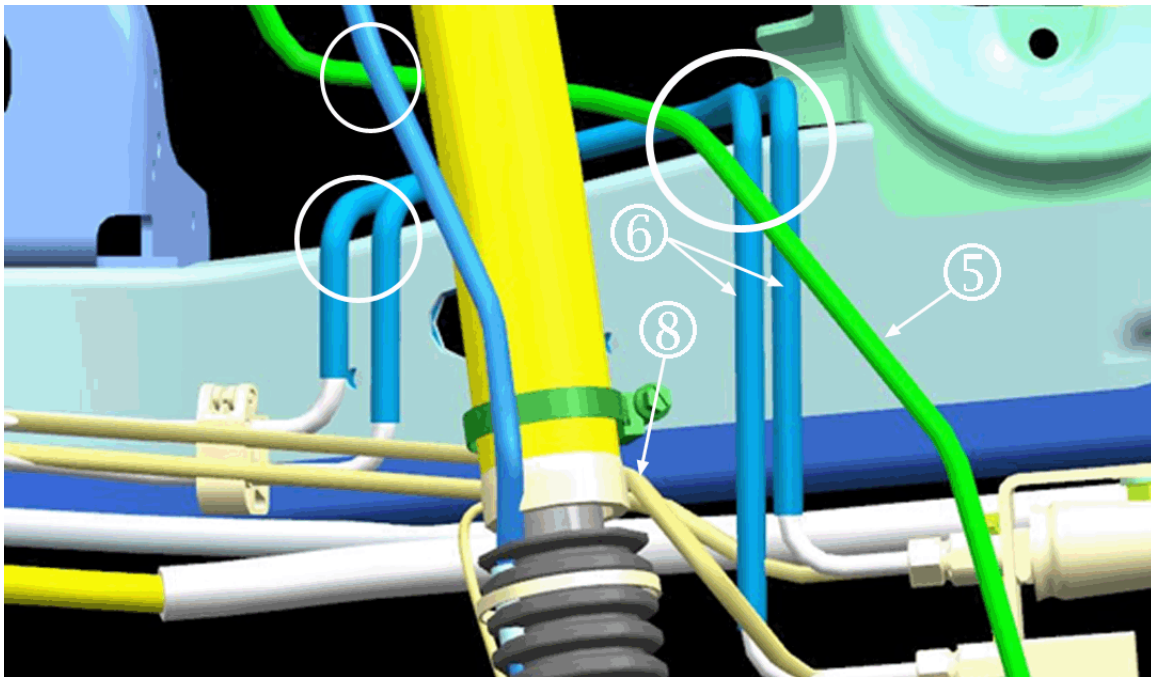
The illustration shows the brake line routing on the inboard side of the frame near the left wheel opening. Inspect the new brake lines (6) for frame contact in the areas that are circled in the illustration. Also ensure the right rear brake line (5) is NOT contacting the new brake line (5) in the circled areas of the illustration as well. The old brake line routing (8) is shown to display the differences between the two brake line designs.

10.4 Inspect the routing of the brake lines in the left rear wheel opening. Ensure the brake lines are NOT in contact with the fuel filler pipe, filler pipe clamp, frame, and rear axle.

- 10.5 Inspect the brake line routing on the inboard side of the frame near the rear left wheel opening. The brake lines should NOT contact the frame and should NOT have a stressed or tight fitment over the frame.
- 10.6 Install the brake line mounting clips in the production positions.
- 10.7 Ensure the brake lines are secured by the mounting clips in the production routing positions.
- 10.8 Tighten the rear jounce hose and crossover pipe mounting bracket bolt.
