Service Bulletin

SPECIAL COVERAGE

SUBJECT: Special Coverage Adjustment – Loss of Steering Due to Water Intrusion (Steering Gear Umbrella Seal Missing)

**MODELS: 2004-2005 Chevrolet Malibu, Malibu Maxx
2005 Pontiac G6**

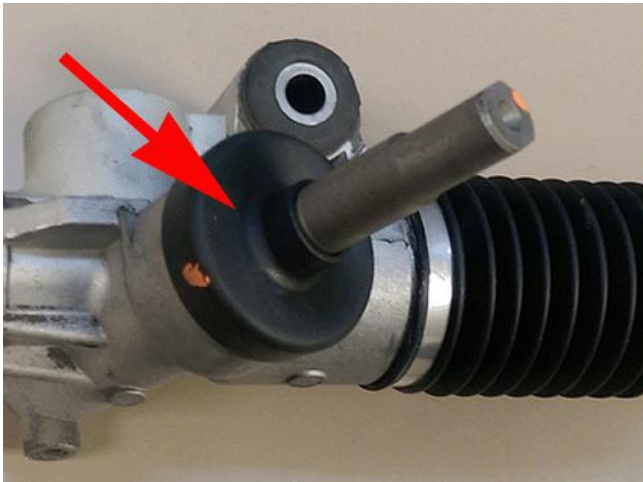
3984329

- If the seal **is** installed, no further action is required. Inform the customer that any additional diagnosis and repairs are not covered under this special coverage.
