Service Bulletin

SB-10057646-5577

SUBJECT: Special Coverage Adjustment – Fuel Pump Module Battery Terminal

MODELS: 2010-2014 Chevrolet Express
2010-2014 GMC Savana

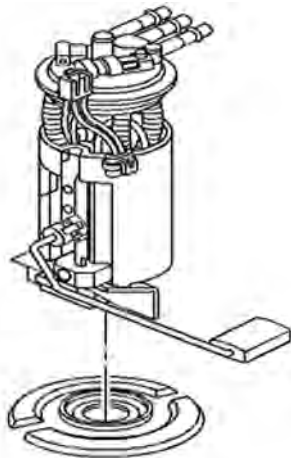
4070283

Note: Inspect the fuel pump connector and see if it shows evidence of discoloring, deformation or poor terminal tension.
