Service Bulletin

SDB-10057649-5812

**SUBJECT: Service Update for Inventory and Customer Vehicles
Body Harness Contact with Park Brake Bracket
Expires with Base Warranty**

**MODELS: 2014-2015 Chevrolet Silverado
2014-2015 GMC Sierra**

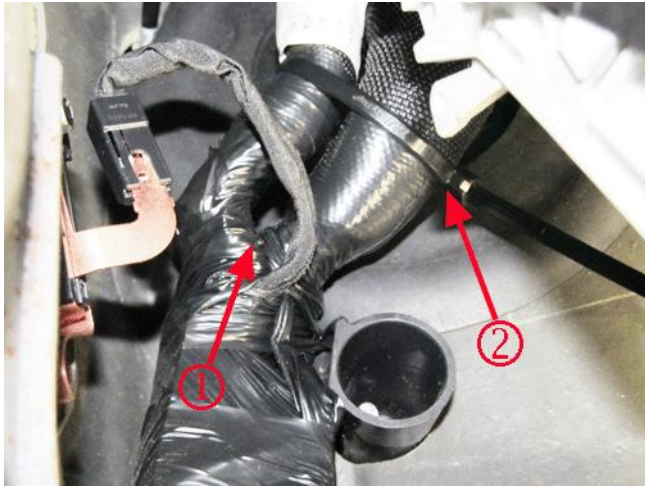
4087276

This bulletin provides a service procedure to tie strap the “Main” and “BCM” branches of the body harness (near the front of dash pass-through inside the vehicle) together to prevent them from coming in contact with park brake bracket on **certain** 2014 and 2015 model year Chevrolet Silverado and GMC Sierra vehicles. These vehicles may have exposed body harness wires in close proximity to the parking brake bracket at the front dash pass-through inside the vehicle. The exposed body harness wires can rub against or be pinched by the brake bracket. While there is no evidence of this happening in customer vehicles, if the wires were to be sufficiently damaged from rubbing against or being pinched by the brake bracket, certain electrical systems could be affected. For example, sufficient damage to the wires could result in the loss of various exterior lights, wipers, the driver’s airbag telltale light, throttle control, defog controls, or trailer brake controls. In addition, while there is no evidence of any stalls resulting from this condition, it is possible that if the run/crank wire was sufficiently damaged, it could result in an engine stall. Depending on which circuit is damaged, a telltale or DIC message may be displayed alerting the customer that an issue exists.

4. Locate the fork (1) of the BCM break-out harness from the body harness.
5. Secure the break-out harness away from the park brake bracket by adding the tie strap (2), approximately 25 mm (1.0 in) above the fork.
6. Verify the increased clearance between the harness and the park brake bracket.
