Bulletin No.: 14732 Date: February 2015

Program Bulletin 5B-10057650-2602

SUBJECT: Exterior Door Handle Binds or Sticks

MODELS: 2015 Chevrolet Impala

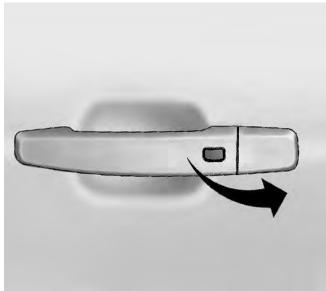
4063151

Direction of pull for door handle inspection.

2. Grasp door handle towards the rearmost edge. Quickly pull the door handle outward and at a rearward angle to check for binding or sticking. Binding or sticking may occur at the maximum travel of the handle.

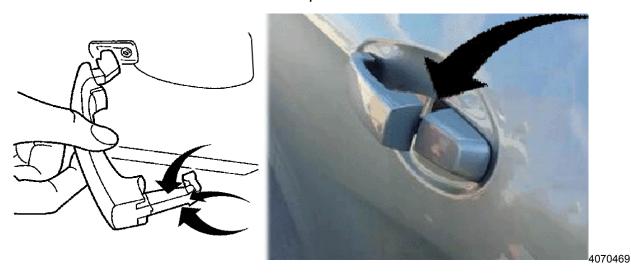
Lubrication points (arrows) on door handle unpainted black tower leg. (Exploded view shown for detail, disassembly not required.)

NOTE: A small amount of lubricant should be applied to the black tower leg of the handle. Use only the AC Delco Super Lube Lubricant identified in the Parts Information section. Substitutions are not allowed.

4. Using a Q-tip or suitable applicator, lubricate all door handles, passive or non-passive entry. Thoroughly apply lubricant on top, bottom and rearmost side of the tower leg.
