Program Bulletin

SB-10057650-2963

SUBJECT: Exterior Door Handle Binds or Sticks

MODELS: 2015 Chevrolet Impala

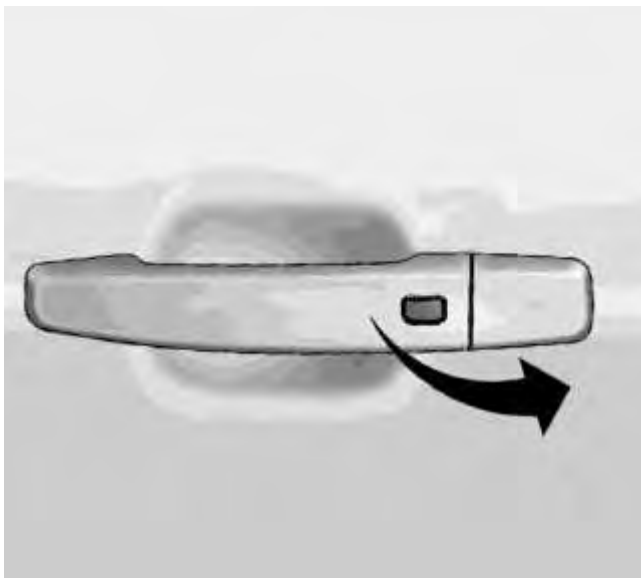
4063151

Direction of pull for door handle inspection.

2. Grasp door handle towards the rearmost edge. Quickly pull the door handle outward and at a rearward angle to check for binding or sticking. Binding or sticking may occur at the maximum travel of the handle.
 - 2.1 Repeat five (5) times.
 - 2.2 If no problem found, proceed to next handle.
 - 2.3 If no problem found on all handles, proceed to Step 4.
 - 2.4 If any handle binds or sticks, proceed to Step 3.

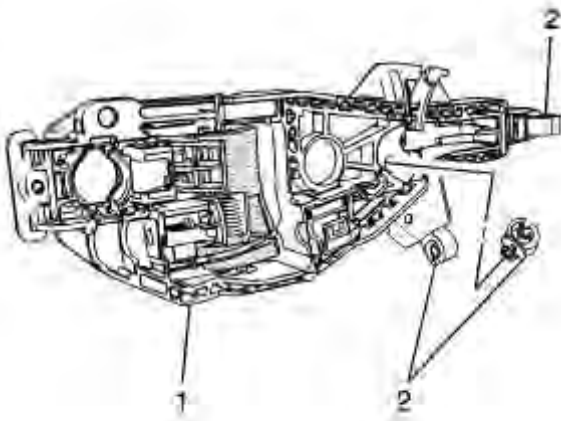
2755846

Door outside handle bracket (1) shown with clips (2), mounted inside door.

Note: Door latch does not have to be removed to replace the bracket in either front or rear replacement procedures. Unclip latch cables during removal.

3. Replace door handle bracket on binding or sticking handle. Refer to *Front Side Door Outside Handle Bracket Replacement* in SI. For replacement of rear door handle bracket, refer to *Rear Side Door Outside Handle Bracket Replacement* in SI.

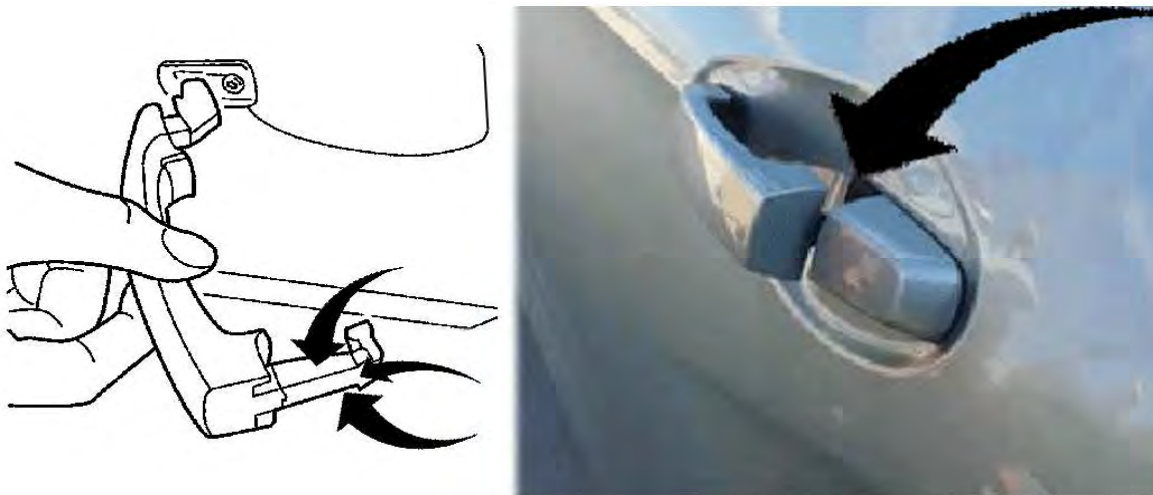
4070469

Lubrication points (arrows) on door handle unpainted black tower leg.
(Exploded view shown for detail, disassembly not required.)

NOTE: A small amount of lubricant should be applied to the black tower leg of the handle. Use only the AC Delco Super Lube Lubricant identified in the Parts Information section. Substitutions are not allowed.

4. Using a Q-tip or suitable applicator, lubricate all door handles, passive or non-passive entry. Thoroughly apply lubricant on top, bottom and rearmost side of the tower leg.
5. Cycle handle five (5) times. Move handle throughout the range of travel, applying light pressure towards front and rear during cycling to work lubricant into the mechanism.
