# Service Bulletin

Bulletin No.: PIT5307A

**Subject:** SES MIL / Service Suspension System / ABS MIL / No Crank (Inspect Engine Harness Chaffing At Vacuum Pump Pulley)

**Models:** 2015 Cadillac Escalade Models  
 2014 Chevrolet Silverado 1500  
 2015 Chevrolet Silverado 1500, Suburban, Tahoe  
 2014 GMC Sierra 1500  
 2015 GMC Sierra 1500, Yukon Models  
 With 5.3L (RPO L83) or 6.2L (RPO L86) Engine

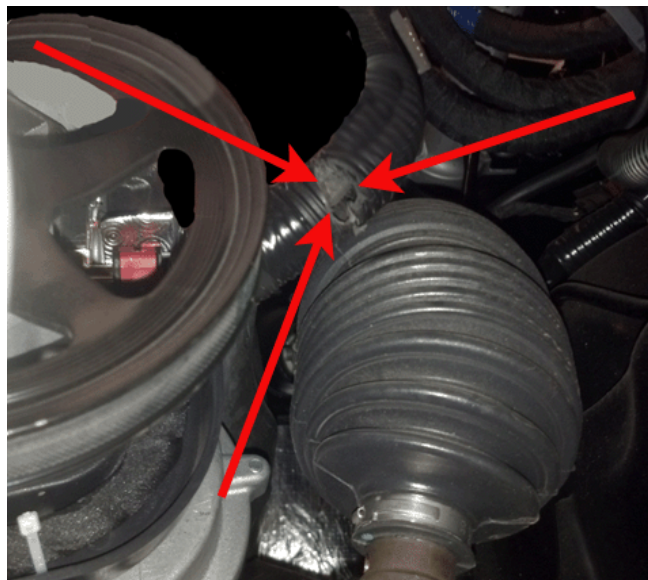
3958681

Some owners may comment on any of the following issues: SES MIL, ABS MIL, Service Suspension System Message, no crank caused by the "STRTR" fuse 11 (F11UA) open, as well as any combination of the following DTCs may be found: C0035, C0040, C0575, C0580, C0615, C0620, C0625, C0630, C0696, P06DA, P06DB, P06DC, P0325, P0327, P0328, P0330, P0332, P0333, P0340, P0341, P0335, P0336, P0641, P0011, P0010, P2088, and/or P2089.

These issues could be caused by the engine harness rubbing on the engine vacuum pump pulley, as shown below.

Repair any damaged circuits, and re-secure the harness away from the pulley to prevent the issue from reoccurring.
