Service Bulletin

Bulletin No.: PIP3694F

Subject: Belt Noise Rough Idle and/or SES Light with DTC P0014 and/or P0017 - Inspect CMP Actuator Solenoid And Crankshaft End Play

Models: 2004-2009 Chevrolet TrailBlazer
2004-2012 Chevrolet Colorado
2004-2011 GMC Envoy
2004-2012 GMC Canyon
2004-2009 Hummer H3
with an Inline 4, 5, or 6 Cylinder Engine
(RPO Codes L52, LK5 LL8 LLR LLV)

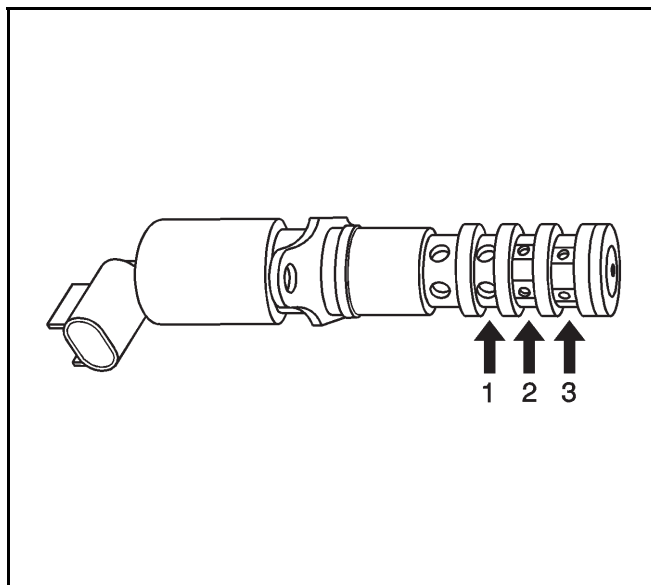
1. Inspect the camshaft actuator solenoid screens below:

- (1) Screen for Advance Pressure to Camshaft Actuator
- (2) Screen for Pressurized Oil from Oil Pump
- (3) Screen for Retard Pressure to Camshaft Actuator

If any of these screens are missing, replace the camshaft actuator solenoid, change the engine oil and filter, and re-evaluate the concern. If none of the screens are missing, proceed to step 2 below.
