# Program Bulletin

## SB-10057679-3041

### CUSTOMER SATISFACTION PROGRAM

**SUBJECT:** Electronic Power Steering Loss of Power Assist

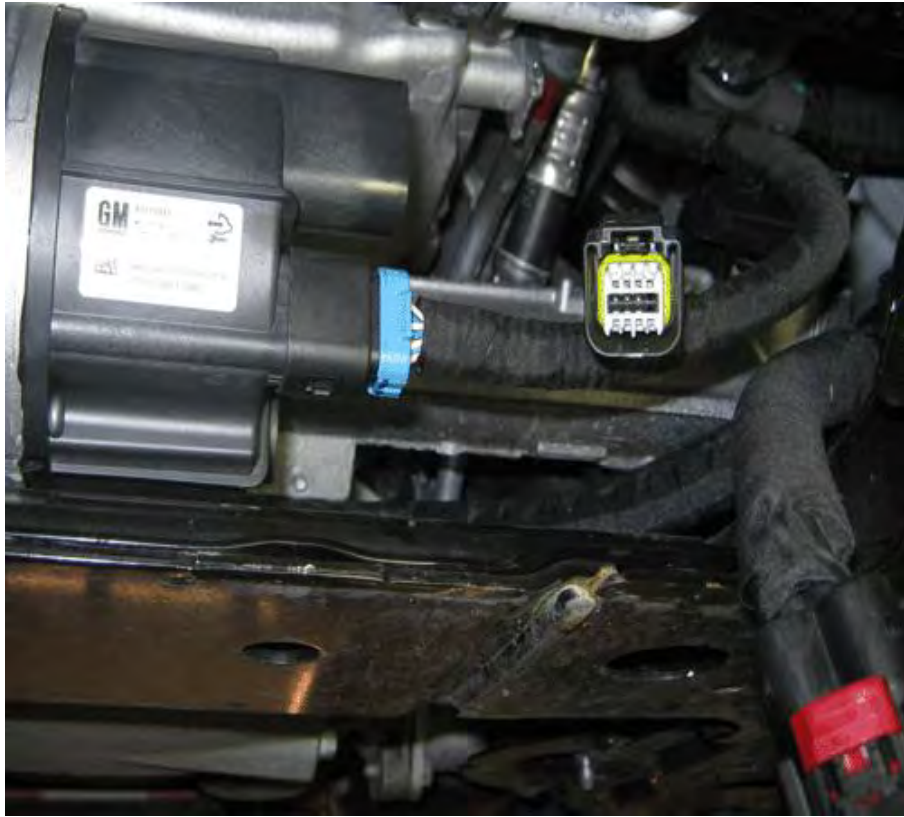
4062462

- 10. Visually inspect the connector for any signs of contamination or damage. If contamination or damage is found, this will need to be repaired as required prior to performing the next step. Refer to *Repairing Connector Terminals (Terminal Repair)* in SI.
