TECHNICAL BULLETIN
JTBO0377NAS1
05 JAN 2015

SB-10057687-7322

Fluid Ingress Into Central Junction Box

XF (X250)

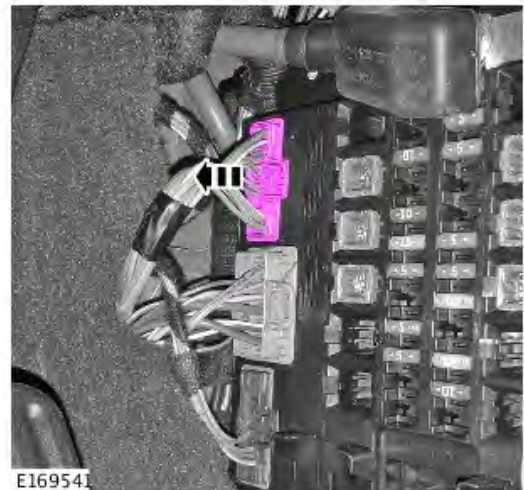
**NOTE: Corrosion is considered to be any discoloration of the Central Junction Box (CJB) or connector terminals; only the lower cavities 5-8 and 15-20 will be affected.**

Disconnect the Central Junction Box (CJB) connector (C3BP01E) and inspect the connector for moisture and/or corrosion.

- If there is no corrosion and/or moisture, **NO** further action required.
- If corrosion and/or moisture is found, continue to the next step.

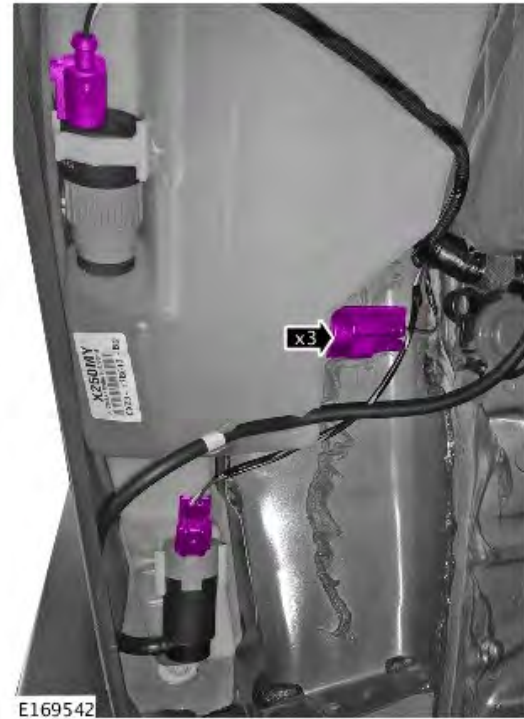
4. Remove the front right-hand fender splash shield, (see TOPIx Workshop Manual, section 501-02).
5. Disconnect all three electrical connectors and inspect for moisture.
