January 2015

Dealer Service Instructions for:

Emissions Recall P35 Diesel Particulate Filter Wiring

- 2013 (DJ) RAM Pick Up Truck (2500 series)
(D2) RAM Pick Up Truck (3500 series)

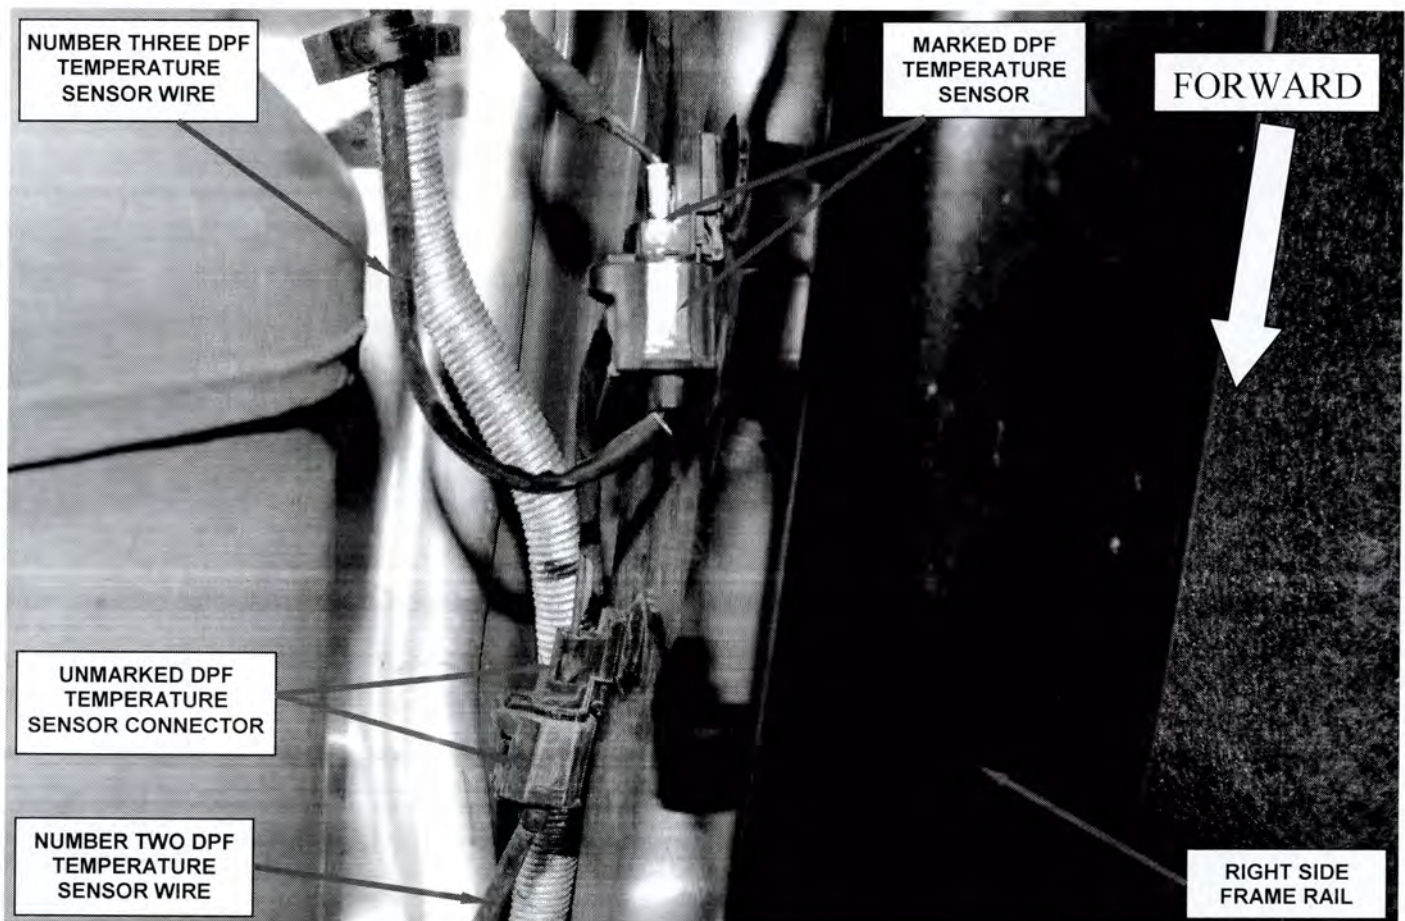
Figure 1 – Mark Number Three DPF Temperature Sensor Connector

1. Lift the vehicle on an appropriate hoist.
2. Using a china marker or equivalent, place an identification mark on both sides of one of the Diesel Particulate Filter (DPF) temperature sensor electrical connectors (Figure 1).

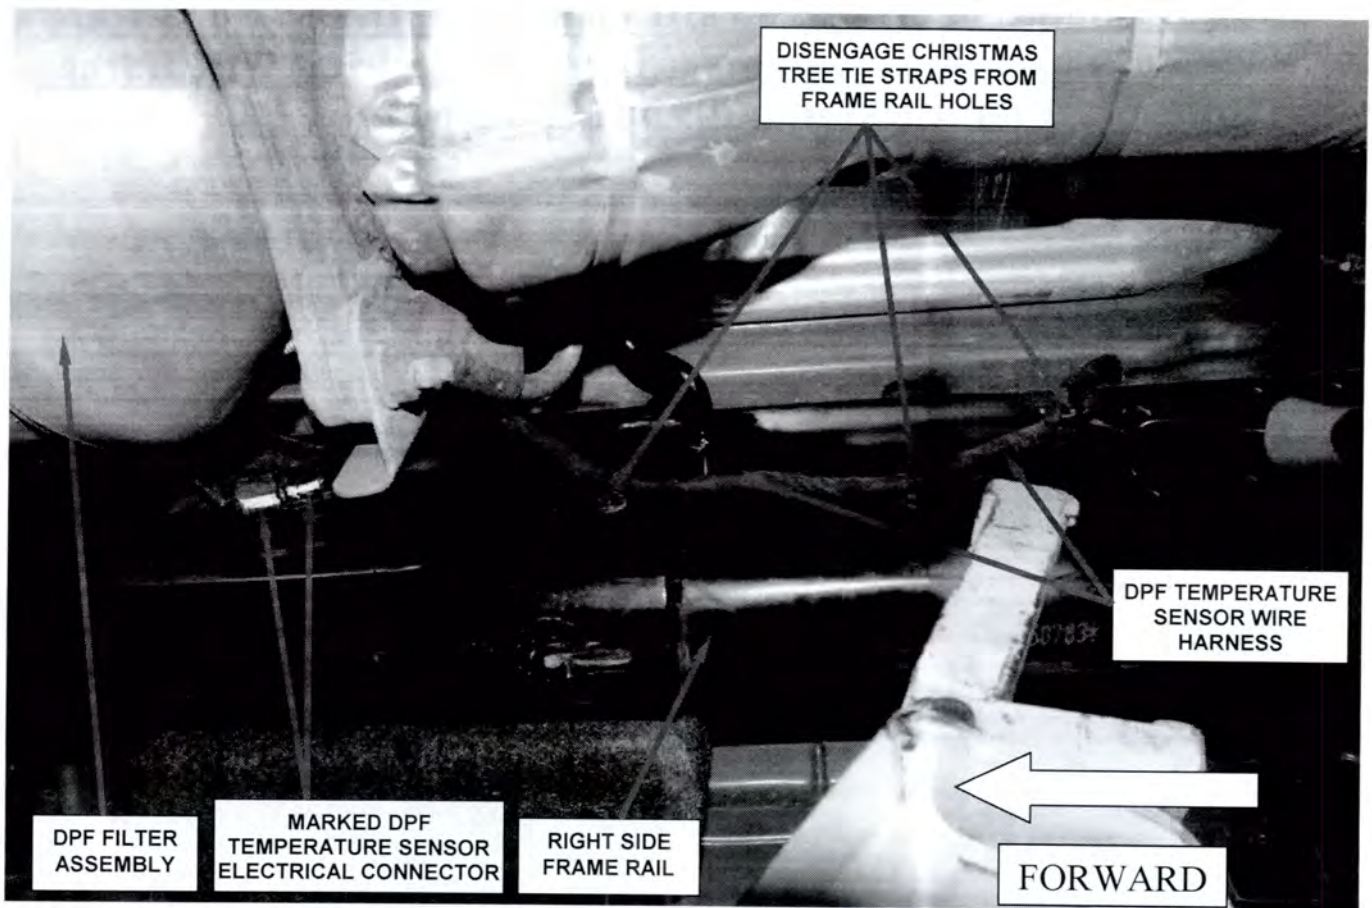
Figure 2 – Detach DPF Temperature Sensor Wire Harness from the Frame Rail

3. Detach the three DPF temperature sensor wire harness Christmas tree tie straps from the frame rail (Figure 2).

4. Cut off and discard the three Christmas tree tie straps from the DPF temperature sensor wire harness (Figure 2).

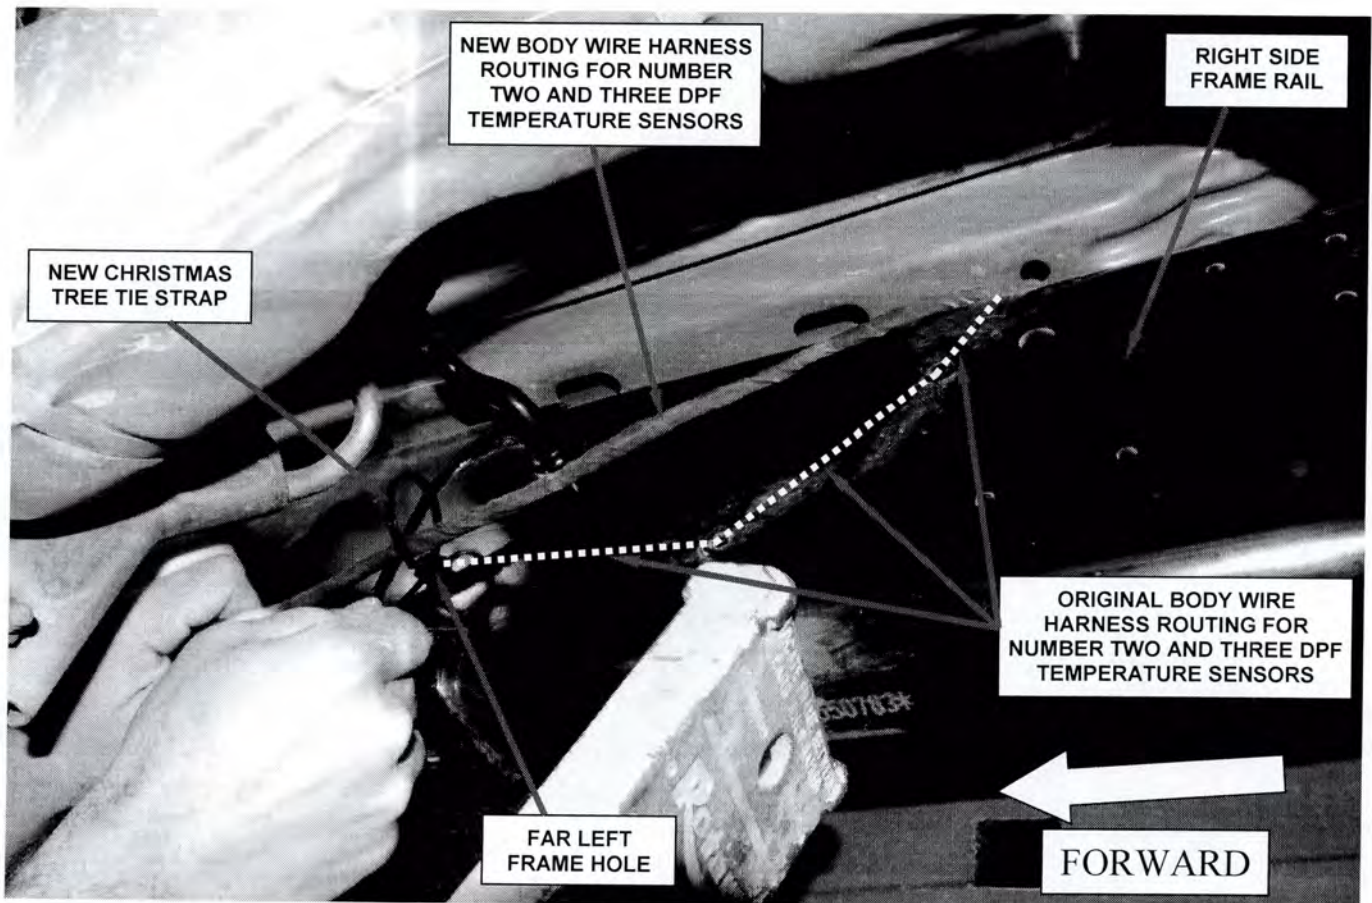
Figure 3 – New Body Wire Harness Routing

5. Insert one Christmas tree tie strap barbed peg into the far left frame hole (Figure 3).
6. Loosely install the DPF temperature sensor electrical connector wire harness to the Christmas tree tie strap installed in Step 5.
7. Route the temperature sensor electrical wire harness as shown in Figure 3 and tighten the new Christmas tree tie strap.
8. Trim off the tail from the new Christmas tree tie strap.

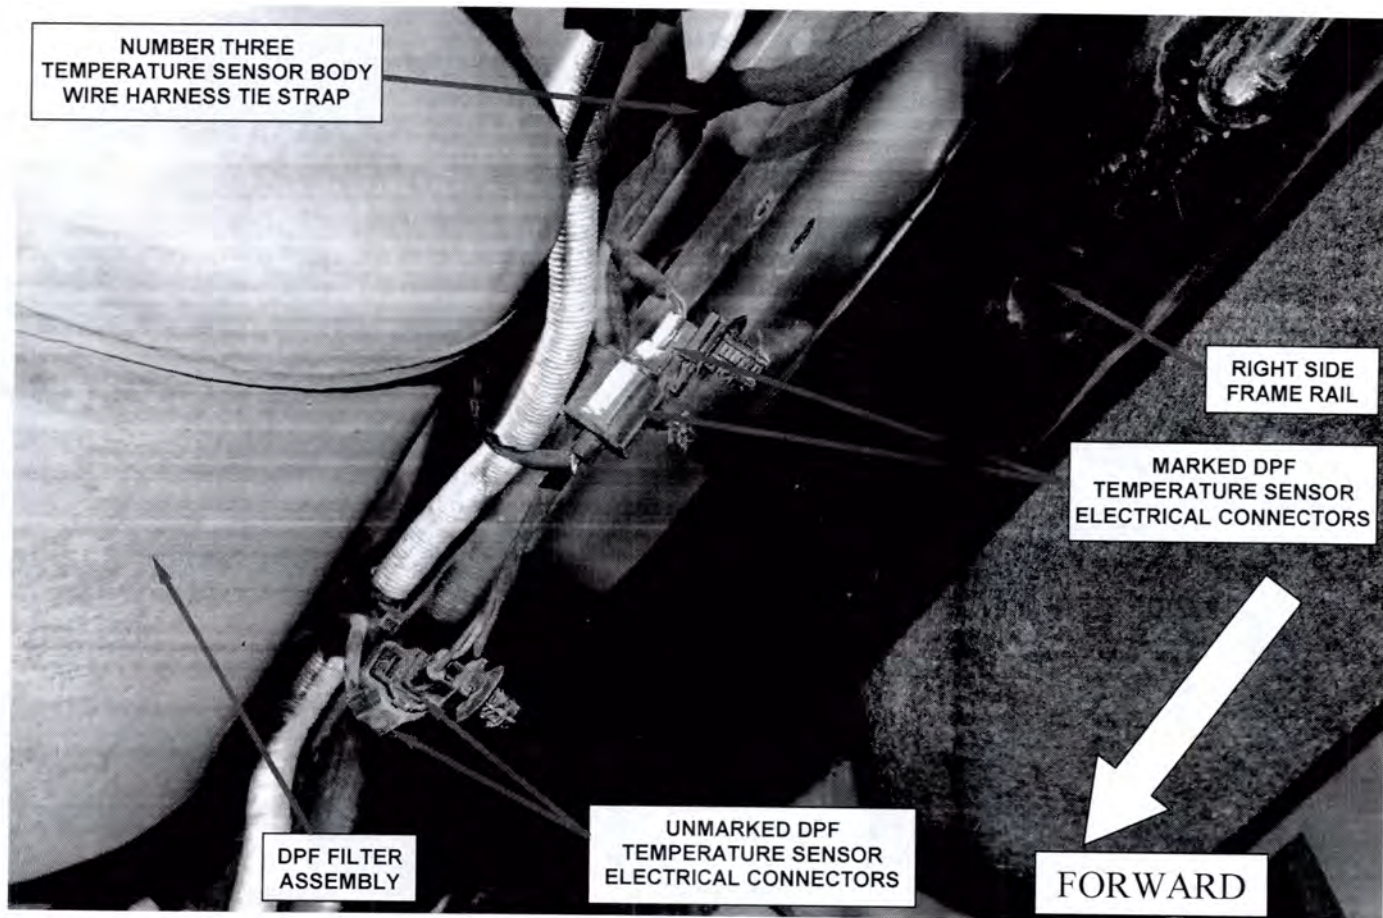
Figure 4 – Detach Both DPF Temperature Sensor Electrical Connectors from the Frame Rail

9. Carefully detach the two DPF temperature sensor electrical connectors from the frame rail (Figure 4).
10. Detach the Christmas tree tie strap from the wire harness for the number three DPF temperature sensor electrical connector wire harness (Figure 4).
11. Disconnect both DPF temperature sensor electrical connectors from the body wire harness connectors.

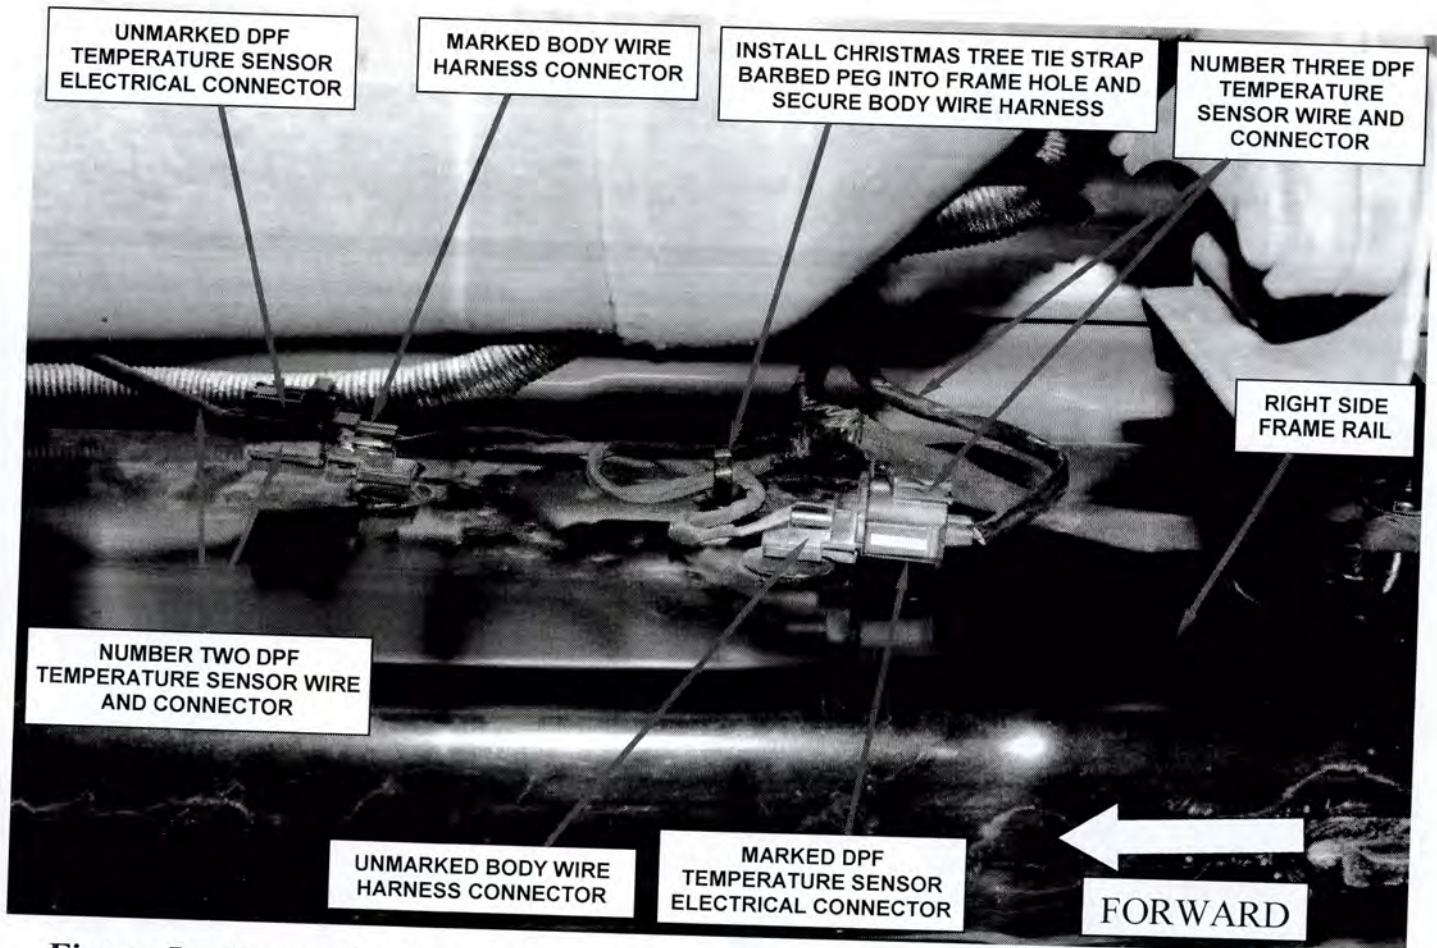
Figure 5 – Correctly Connected and Routed DPF Electrical Connectors and Wire Harness

12. Connect the marked body wire harness connector to the unmarked DPF temperature sensor electrical connector (Figure 5).
13. Connect the unmarked body wire harness connector to the marked DPF temperature sensor electrical connector (Figure 5).
14. Secure the DPF temperature sensor electrical connectors into the frame so that the connectors face away from each other (Figure 5).
15. Install one Christmas tree tie strap in the frame hole (Figure 5).
16. Loop the long body side wire harness and secure it to the frame with the Christmas tree tie strap installed in Step 15 (Figure 5).
17. Continue with **Section C. DPF Orientation Verification Test**

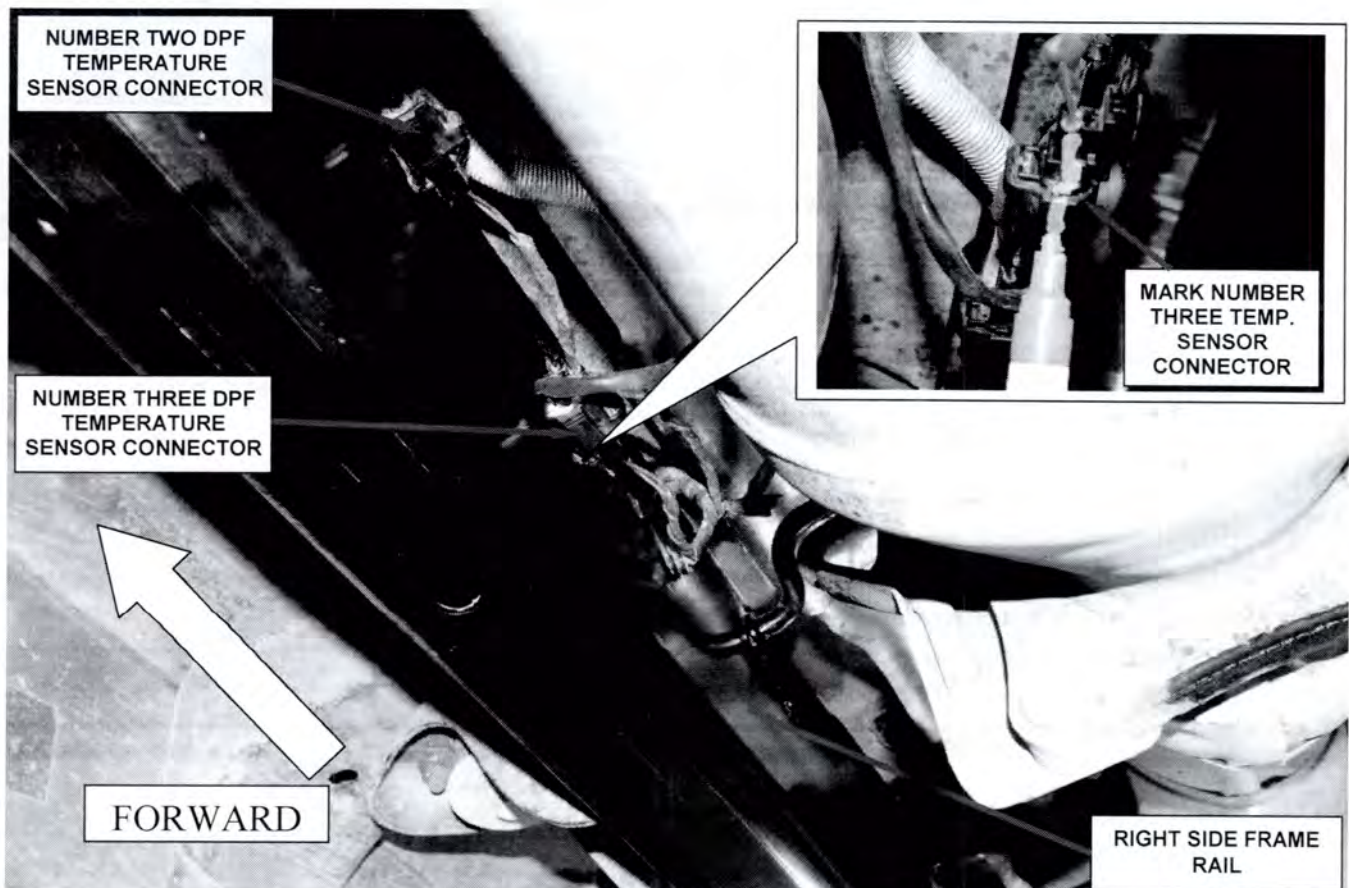
Figure 6 – Mark the Rear Connector

1. Lift the vehicle on an appropriate hoist.
2. Using a china marker or equivalent, place an identification mark on both sides of one of the Diesel Particulate Filter (DPF) temperature sensor electrical connectors (Figure 6).

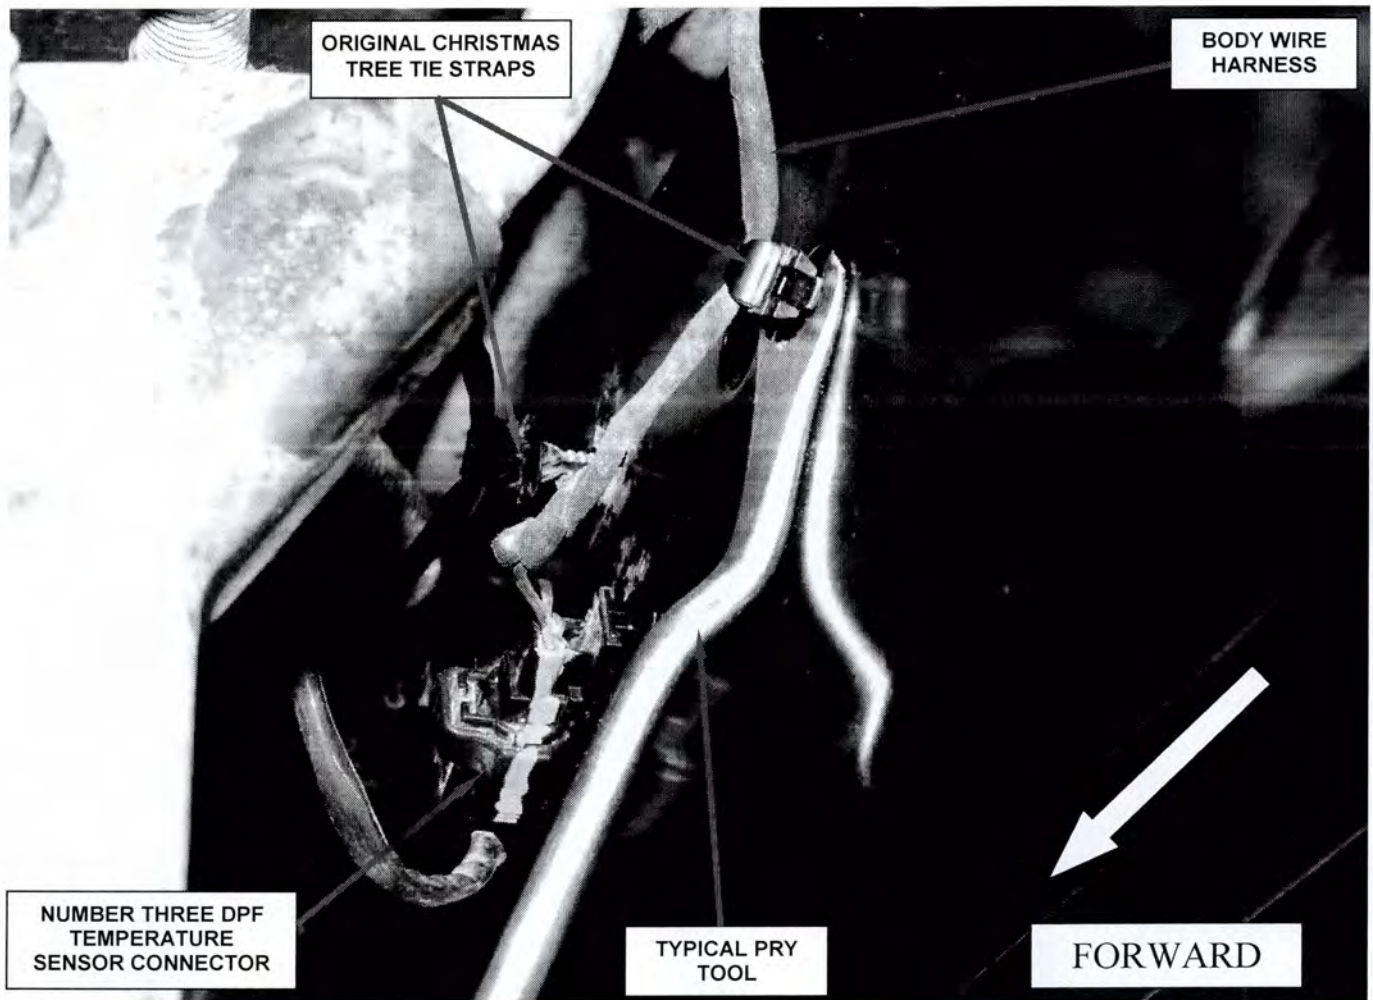
Figure 7 - Detach DPF Temperature Sensor Wire Harness from the Frame Rail

3. Detach the two DPF temperature sensor wire harness Christmas tree tie straps from the frame rail (Figure 7).
4. Cut off and discard the two original Christmas tree tie straps from the DPF temperature sensor wire harness.

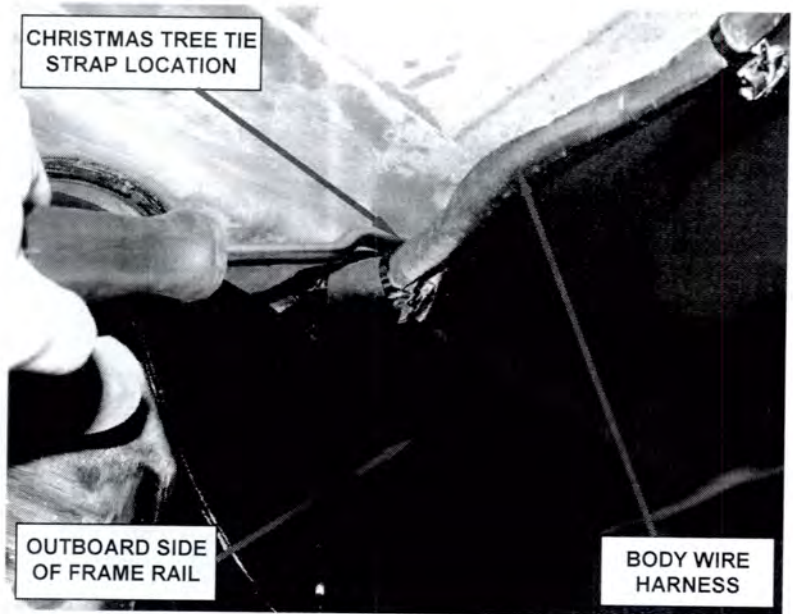
Figure 8 – Detach Christmas Tree Tie Strap From Top of Frame

5. Disconnect the Christmas tree tie strap from the top of the frame rail (Figure 8).

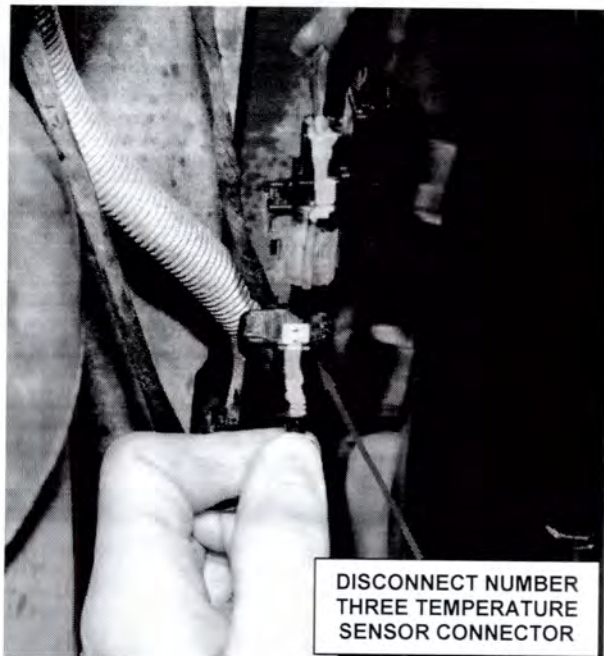
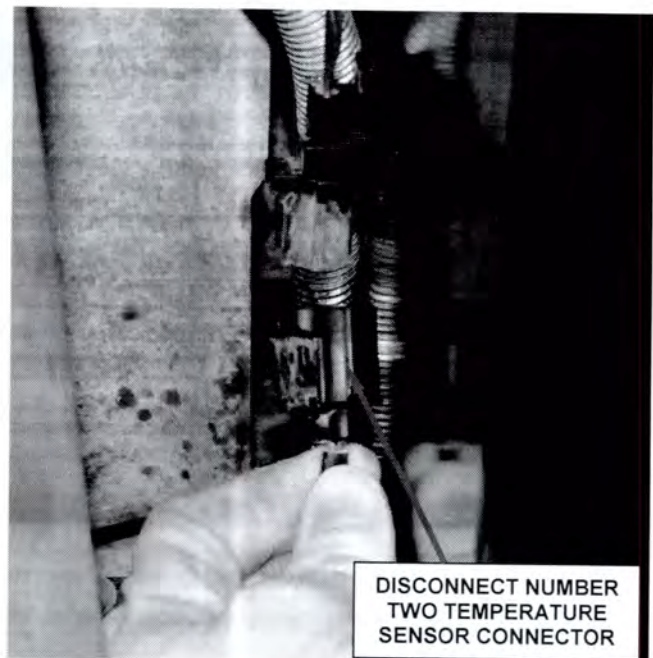
Figure 9 – Disconnect the Marked and Unmarked DPF Electrical Connectors

6. Disconnect the marked and unmarked DPF temperature sensor electrical connectors from the body wire harness connectors (Figure 9).

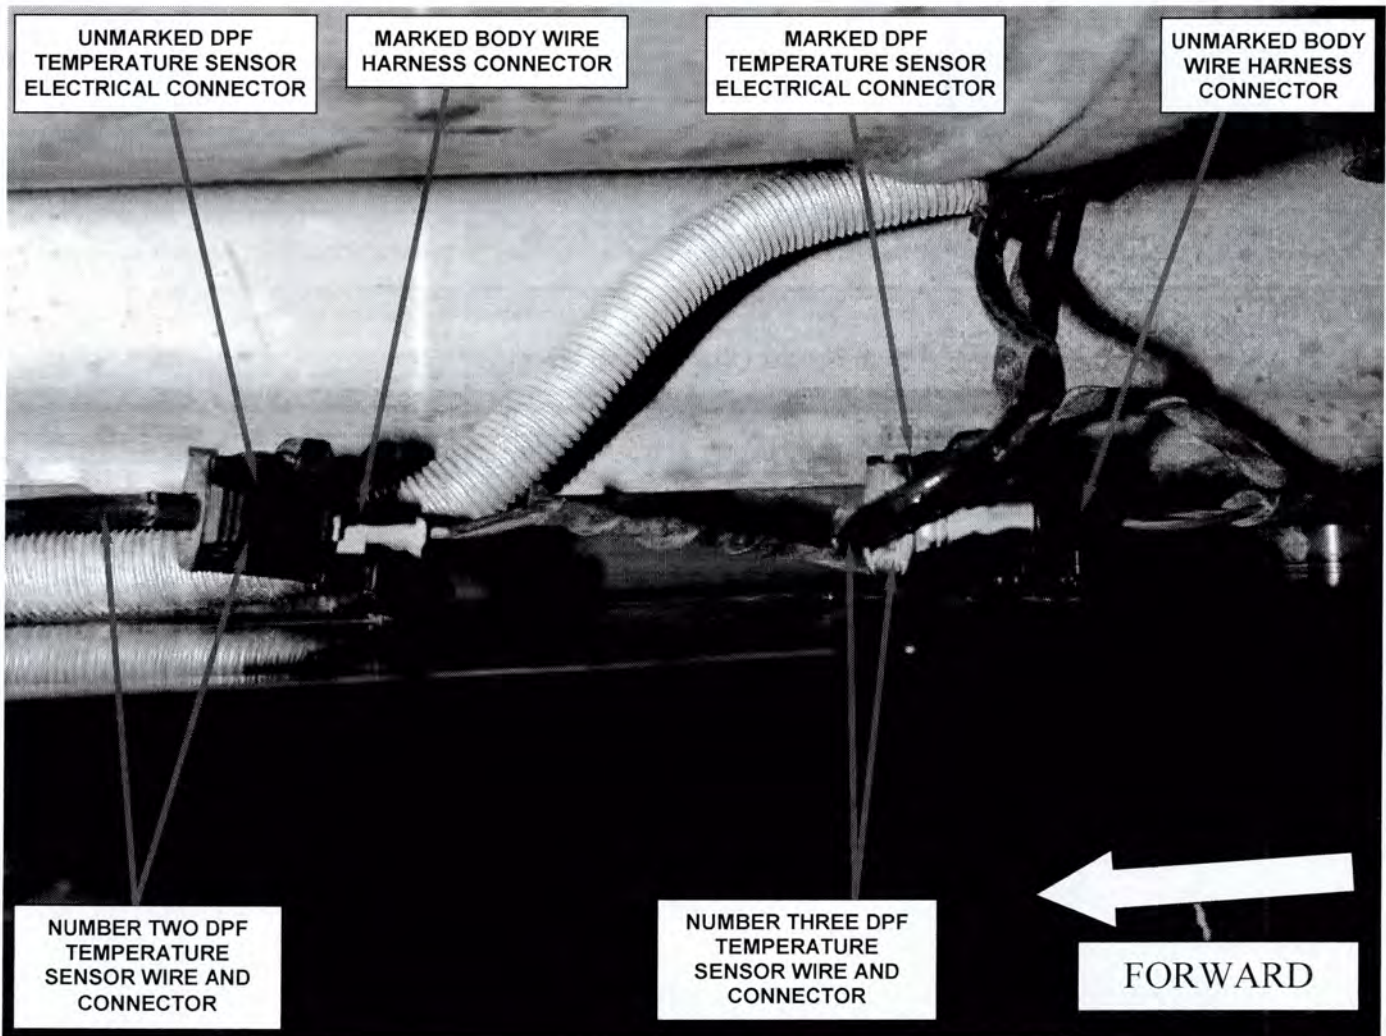
Figure 10 - Correctly Connected DPF Electrical Connectors and Wire Harness

7. Connect the marked body wire harness connector to the unmarked DPF temperature sensor electrical connector (Figure 10).
8. Connect the unmarked body wire harness connector to the marked DPF temperature sensor electrical connector (Figure 10).
9. Secure the DPF temperature sensor electrical connector wires to the frame rail.
10. Continue with **Section C. DPF Orientation Verification Test.**
