## INSTRUCTION TO SERVICE

ITS: 5909	
SECTION:	231 Coolant System
WRITTEN BY:	Mike Pearson
SUBJECT:	Add EMP Radiator Ground Straps

# ITS5909

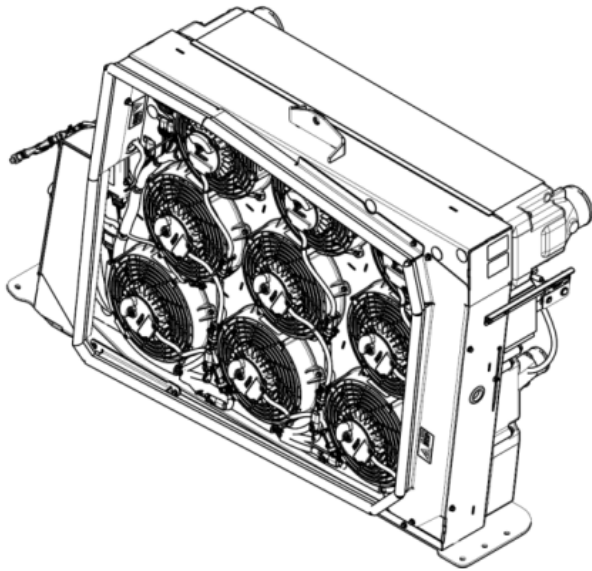
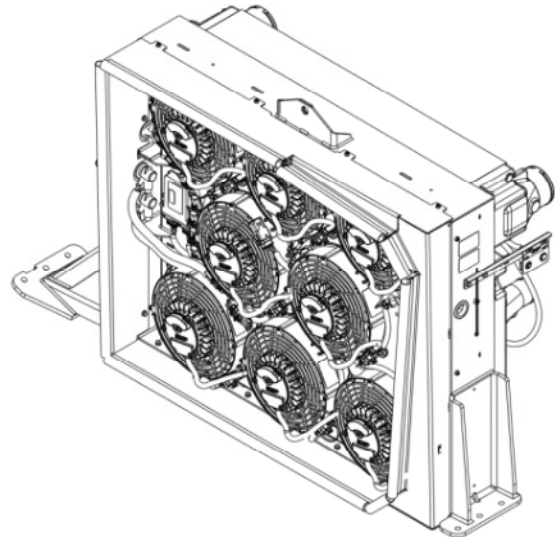
Figure 1: Mini-Hybrid® Cooling Systems

Radiator corrosion has been identified on buses with isolated pipe clamps on vehicles 2010 EPA or newer engines and Mini-Hybrid® cooling systems including:

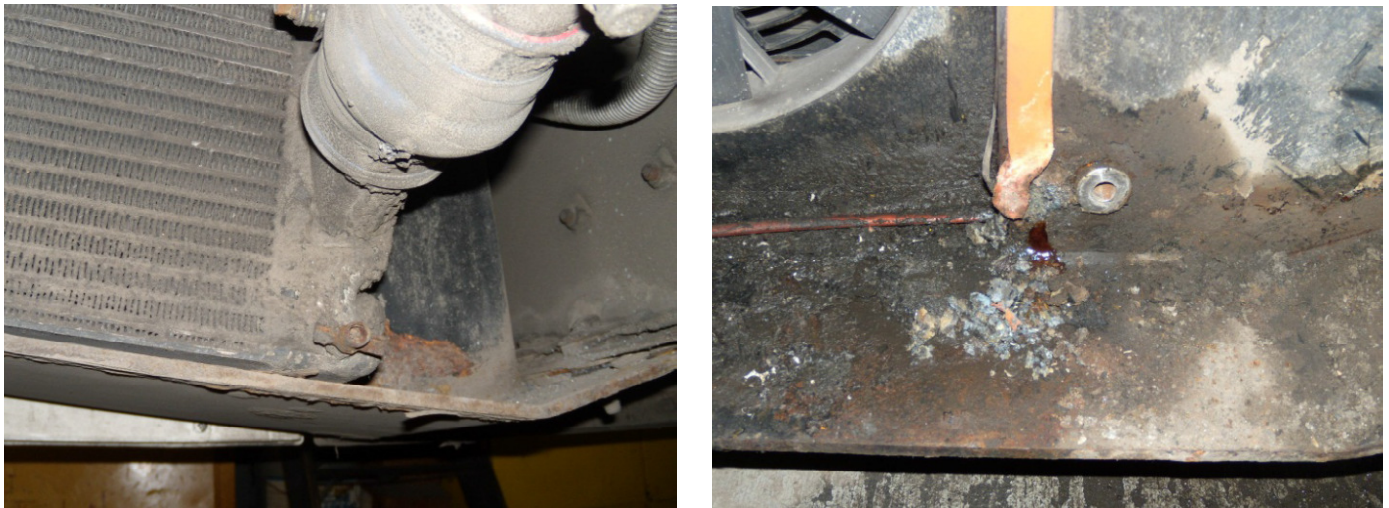
**Figure 2: Gen III Examples.**

Accelerated corrosion was located by the radiator outlet and was limited to vehicles running in icy or snowy winter locations. This corrosion has been determined to be caused by stray voltage carried by the coolant. If the pipes are separated from the radiator via silicone (non-conducting) hoses and the pipes and radiator are not on the same ground plane, electrolysis can occur between the pipes and the radiator. Grounding the radiator and pipes to the vehicle chassis eliminates the electrical potential, stopping the electrolytic corrosion. See Figure 2 for images of accelerated corrosion.

Voltage potential between radiator and coolant pipes can be eliminated by grounding the Mini-Hybrid® cooling system and coolant pipes to the vehicle chassis.
