SERVICE BULLETIN

M-1401

SB-10057784-1093 April 13, 2015

PRODUCT PROGRAM 0919: 2015 STREET MODELS RIGHT SIDE RIDER FOOT CONTROL MOUNTING SCREWS

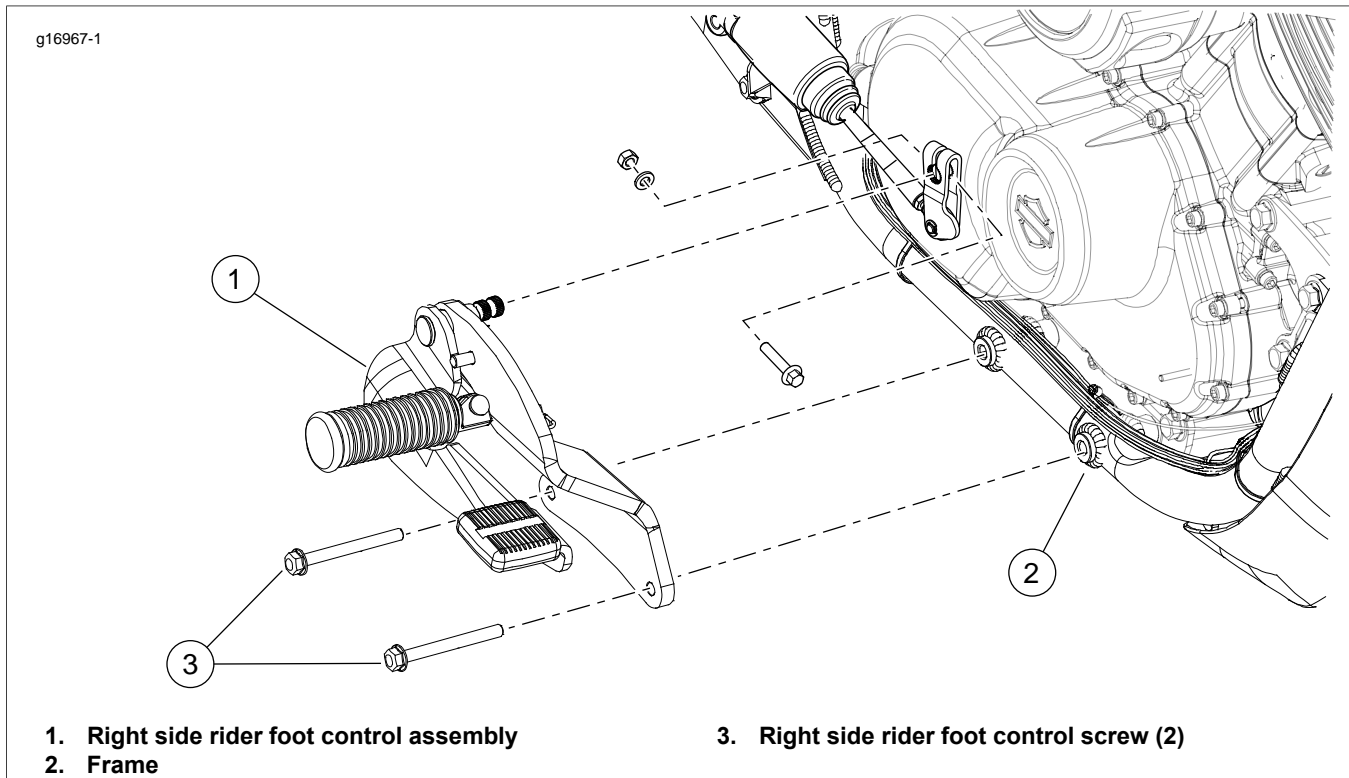
Figure 1. Right Side Rider Foot Control Assembly

Our records indicate you are the owner of a 2015 XG model motorcycle. Harley-Davidson has recently discovered that the rider right foot control mounting bolts on some model year 2015 XG model motorcycles may have been assembled with an improper torque.

2. See Figure 1. Loosen both right side rider foot control mounting screws (3).

3. Retighten screws to 22.0-29.0 Nm (17-21 ft-lbs).
