# **SB-10057787-1777**

## **\* \* TECHNICAL INFORMATION NOTICE \* \***

**DATE:** April 24, 2015  
**TO:** Mitsubishi Motors US Dealer Service Managers  
**RE:** Stumble on Acceleration  
**TIN NO.** TIN-15-23-001

**AFFECTED VEHICLES:** 2015 Outlander Sport Equipped with 2.0L Engine and F1CJC or W1CJC CVT Automatic Transaxle

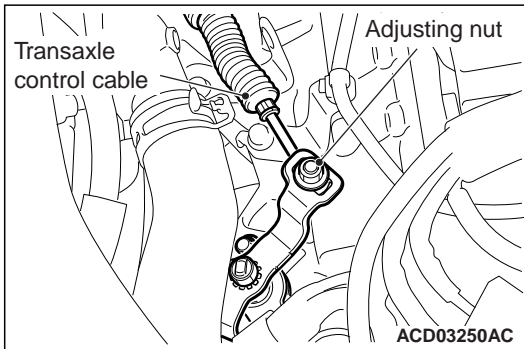
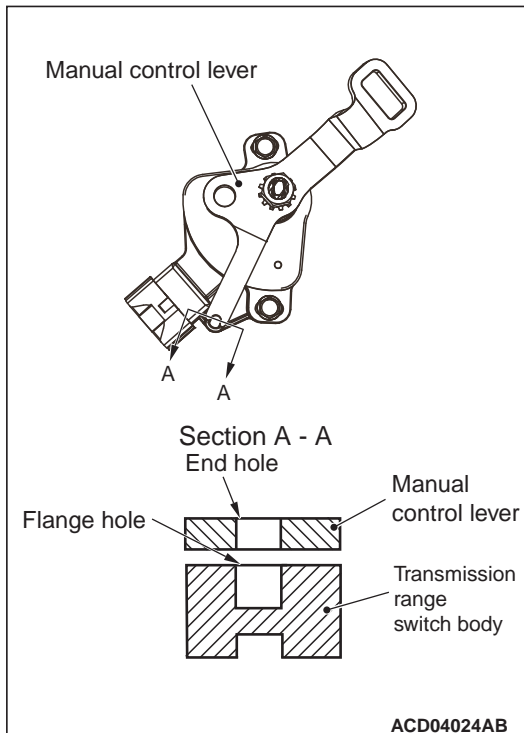
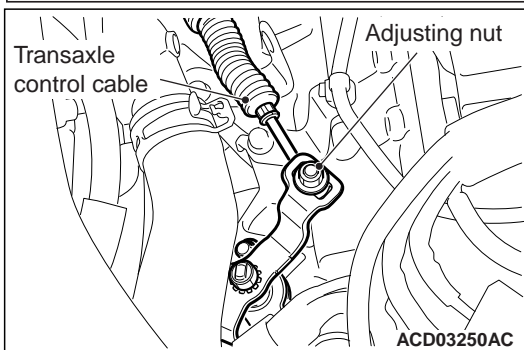
## TRANSMISSION RANGE SWITCH AND CONTROL CABLE ADJUSTMENT

MMNA is investigating an intermittent condition where during acceleration; customers may report a momentary stumble or lack of acceleration at low speeds.

1. Move the selector lever to the "N" range.
2. Loosen the adjusting nut so that the manual control lever moves freely.
3. Move the manual control lever to neutral position.
4. Align the hole at the end of the manual control lever and the hole in the transmission range switch body flange (section A - A).
5. Use the adjusting nut to tighten the transaxle control cable to the specified torque.  
**Tightening torque:  $9.5 \pm 3.5$  N·m ( $84 \pm 30$  in-lb)**
6. Make sure that the selector lever is in the "N" range.
7. Make sure that the transaxle ranges that are corresponding to the selector lever position operate and function properly.
