## INSTRUCTION TO SERVICE

**ITS: 5930**

| <b>SUBJECT:</b> | Add EMP Radiator Ground Straps |

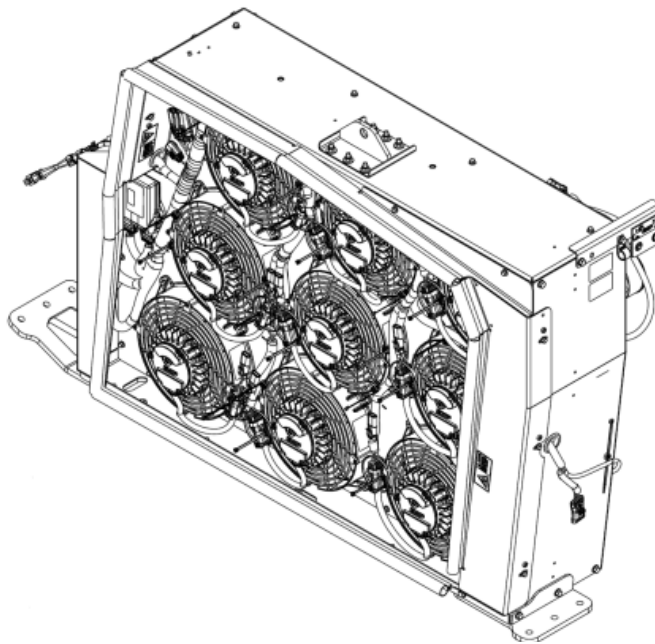
**Figure 1: Mini-Hybrid® VPN 2020049001PA01 Cooling System**

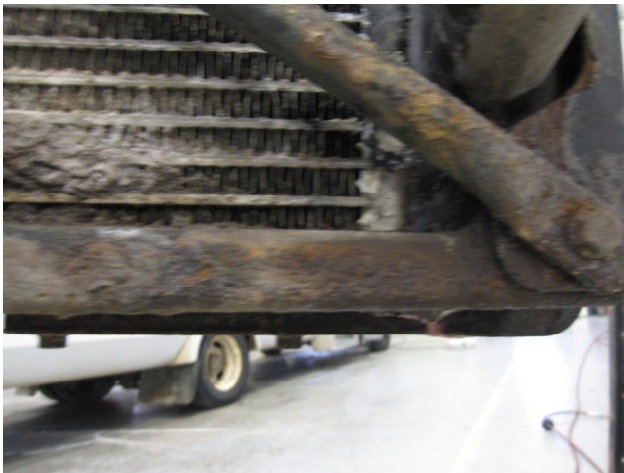
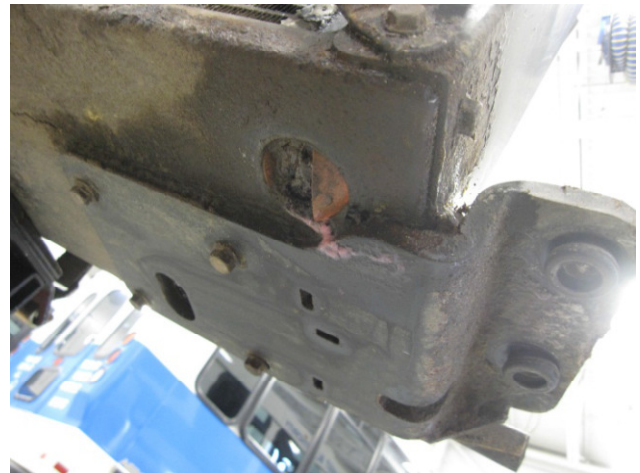
Accelerated corrosion was located by the radiator outlet and was limited to vehicles running in icy or snowy winter locations. This corrosion has been determined to be caused by stray voltage carried by the coolant. If the pipes are separated from the radiator via silicone (non-conducting) hoses and the pipes and radiator are not on the same ground plane, electrolysis can occur between the pipes and the radiator. Grounding the radiator and pipes to the vehicle chassis eliminates the electrical potential, stopping the electrolytic corrosion. See Figure 2 for images of accelerated corrosion.

**Figure 2: Gen II Examples.**

Voltage potential between radiator and coolant pipes can be eliminated by grounding the Mini-Hybrid® cooling system and coolant pipes to the vehicle chassis.

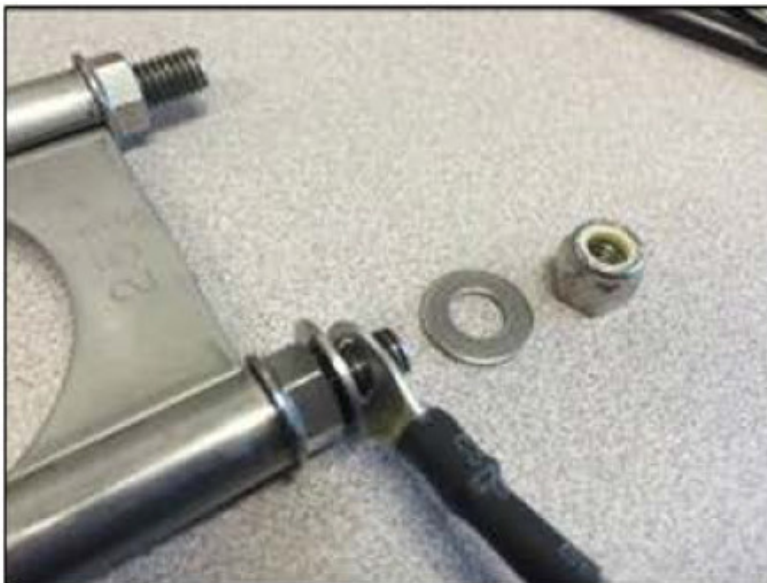
**Figure 3: Ground Strap Mounting Hardware Orientation**

1. Turn the main battery disconnect switch to the "OFF" position.
2. Raise coach in accordance with the New Flyer Service Manual.
3. Typical coolant tube clamp ground strap mounting hardware orientation, see Figure 3.

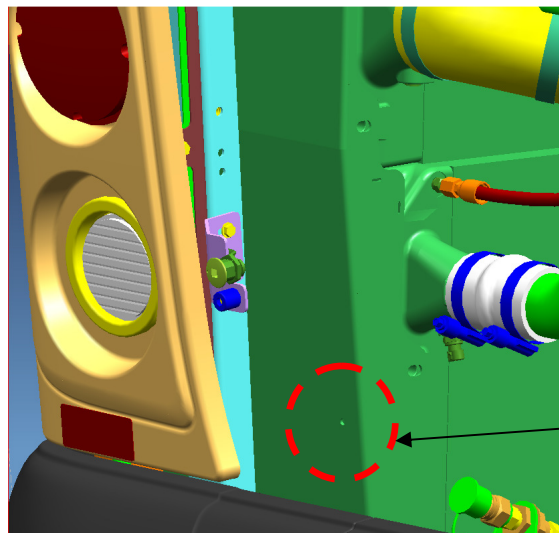
**Figure 4: Fir Tree Mounting Hole**

4. Locate and remove the fir tree insert from the hole located on the rear of the existing radiator as shown in Figure 4. Disconnect any tyrap and or wires from the fir tree insert.
5. Drill out the existing hole from the fir tree insert using a 25/64" (0.390625) drill bit. Care is to be taken not to damage the radiator behind the shroud when drilling.

**Caution:** The use of a drill depth gauge is recommended to limit the depth of the hole to 0.50" or less to avoid any damage to the radiator.

Drill out the existing hole from the fir tree insert using a 25/64" drill bit

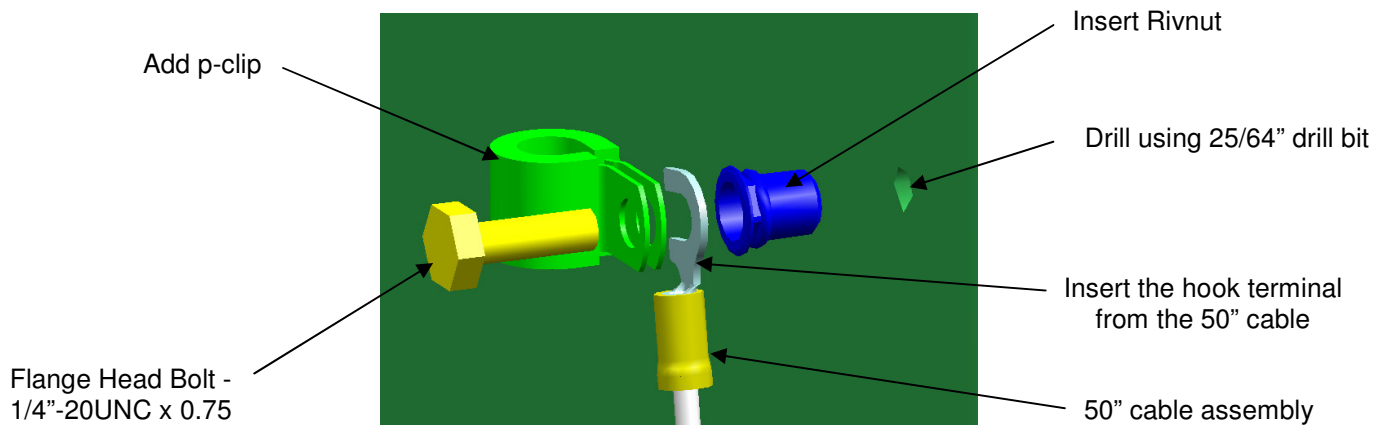
**Figure 5: Rivnut and Cable Installation**

6. Install the rivnut from kit p/n 6449313 into the newly enlarged hole, see Figure 5.
7. To ground Mini-Hybrid® cooling system shroud secure the 1/4" hook terminal end from the supplied 50" cable using a flange head bolt supplied with kit p/n 6449008. If the removed tyrap was used to secure wires, also install the p-clip from kit p/n 6449313 under the bolt head to secure the wires. Torque to 12±2 ft-lbs, see Figure 5.
8. Route ground wire to area approximately 4.5" forward of the welded rail (see Figure 10), routing wire away from any hot surfaces or sharp edges. Use zip ties to secure wire at 18-24" intervals. Adjust cable orientation if necessary.

**Caution:** Grounding to the same welded assembly is required. Grounding to a bolted assembly is NOT acceptable.

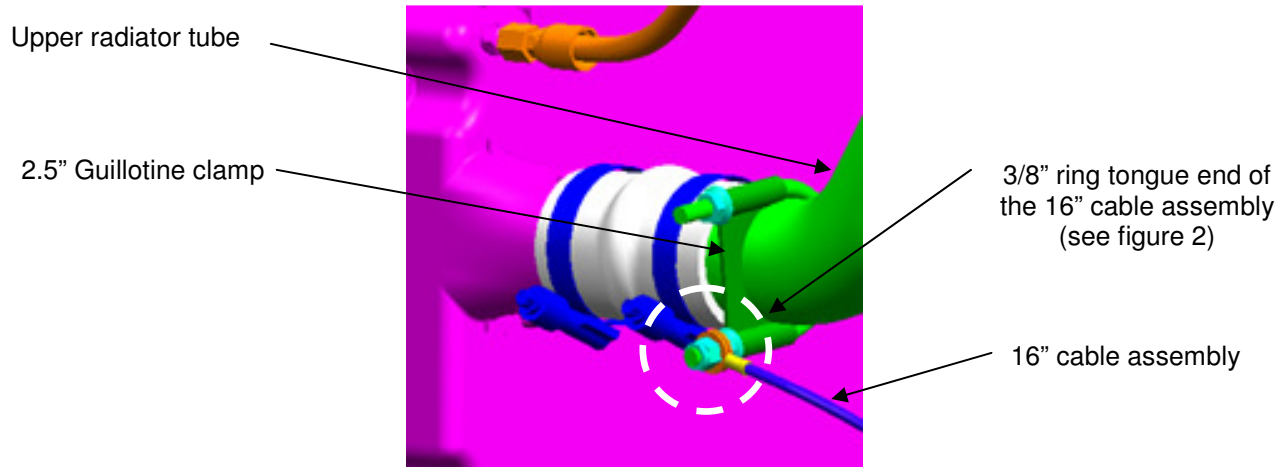
**Figure 6: Radiator and Upper Coolant Tube Ground Strap Installation**

9. Install one of the 2.5" guillotine clamps from the parts kit to the existing upper radiator tube at the approximate location and orientation shown in Figure 6, torque to  $20 \pm 2$  ft\*lbs.
10. Attach the 3/8" ring tongue end of the 16" cable to the bottom stud of the guillotine clamp. Secure and orient the hardware as shown in Figure 3. Torque the hardware to  $20 \pm 2$  ft\*lbs.
11. Route ground wire to area approximately 4.5" forward of the welded rail (see Figure 10), routing wire away from any hot surfaces or sharp edges. Adjust clamp locations on coolant pipes if necessary.

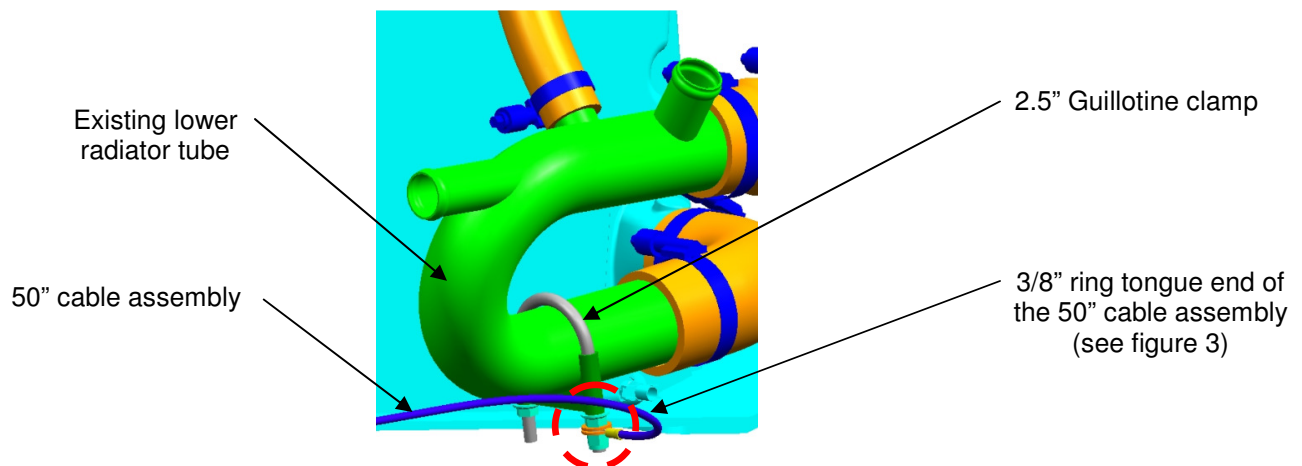
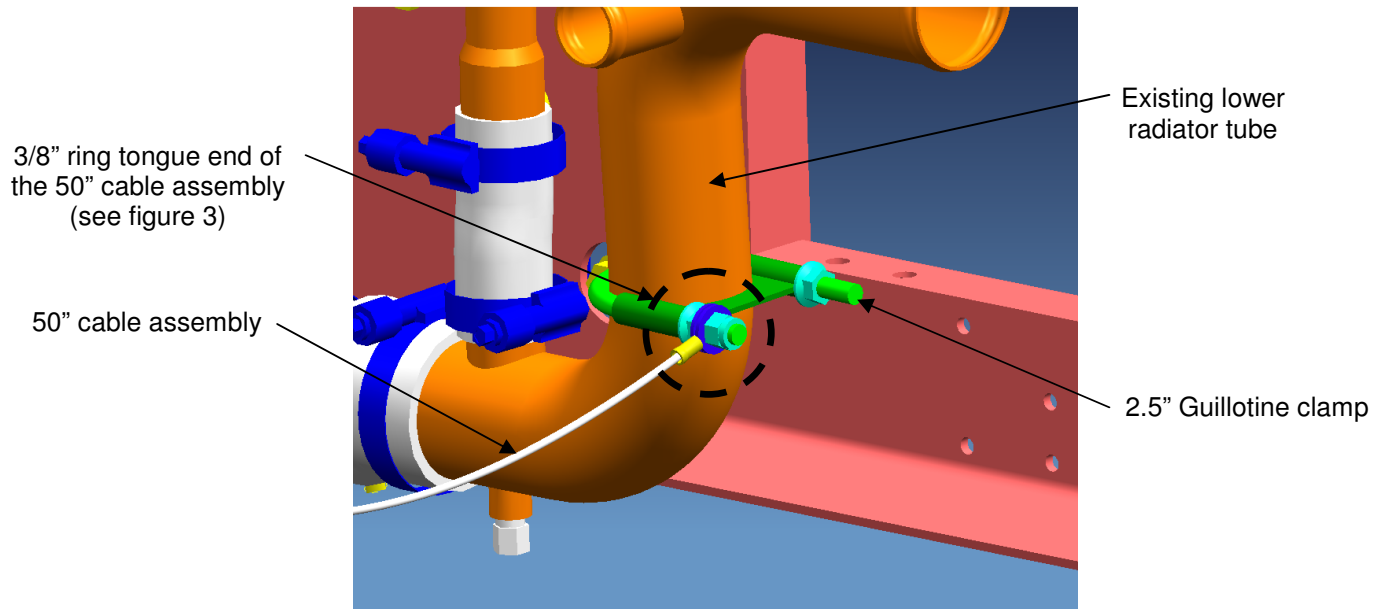
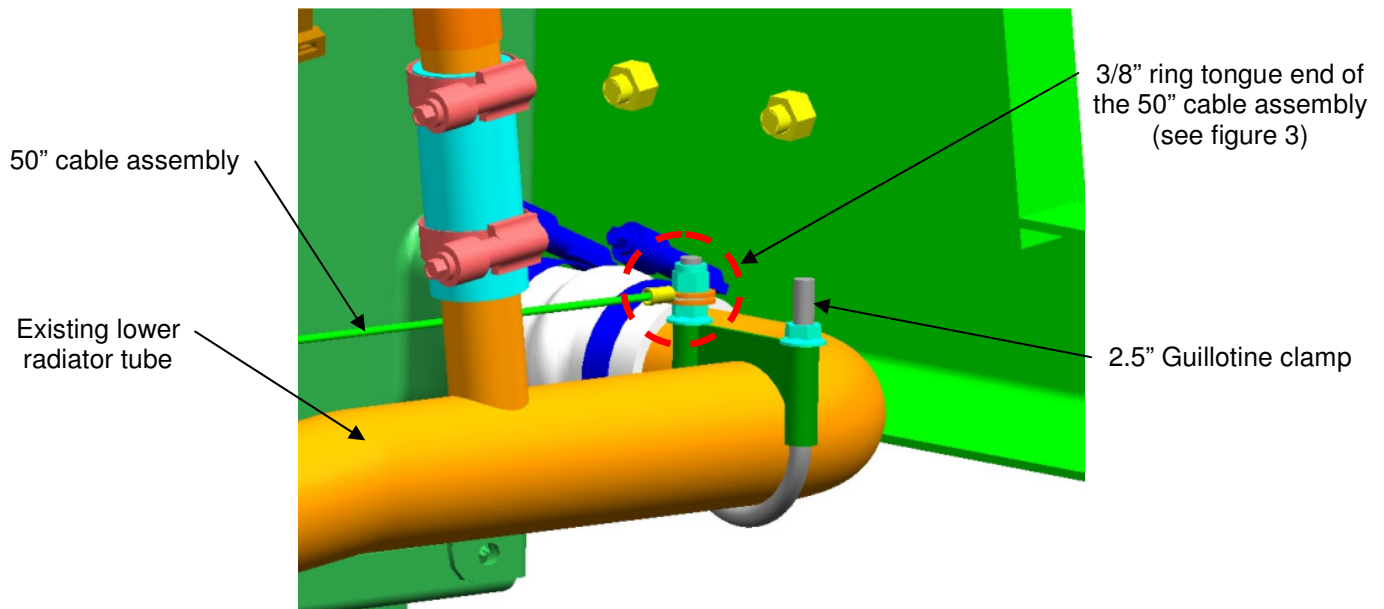
**Figure 7: Lower Radiator Tube Ground Strap**

12. Install one of the 2.5" guillotine clamps from the parts kit to the existing lower radiator tube at the approximate location and orientation shown in Figure 7, 8 and 9. Lower radiator tube may vary in appearance. Torque to  $20 \pm 2$  ft\*lbs.
13. Attach the 3/8" ring tongue end of the 50" cable to the stud of the clamp as per Figure 3. Secure using the hardware supplied with the clamp. Torque the hardware to  $20 \pm 2$  ft\*lbs. See Figure 7, 8 and 9.
14. Route ground wire to area approximately 4.5" forward of the welded rail (see Figure 10), routing wire away from any hot surfaces or sharp edges. Use zip ties to secure wire at 18-24" intervals. Adjust clamp locations on coolant pipes if necessary.

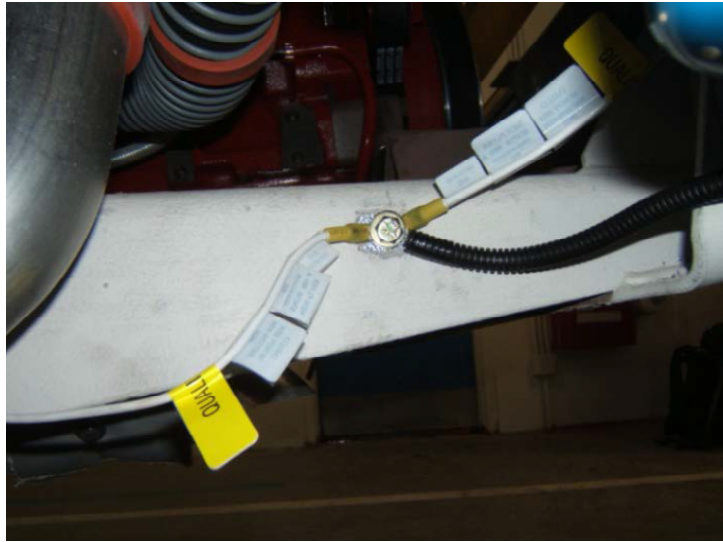
**Figure 10: Common Ground Point on Bus Frame**

15. Route ground wires to area approximately 4.5" forward of the welded rail (See Figure 10), routing wire away from any hot surfaces or sharp edges. Use zip ties to secure wire at 18-24" intervals. Adjust clamp locations on coolant pipes if necessary. Proceed with shroud ground wires before securing pipe grounds.
16. Drill a .281Ø (9/32") hole thru outer wall of the streetside engine rail for grounding stud approximately 4.5" forward of the bumper mount and 1" down from top of the engine rail. Remove structural coating from rail at washer contact to allow for proper ground contact. Attach upper and lower radiator tube and shroud grounding straps. Torque ¼ UNC x 1.00 bolt to 14 ft-lbs.
17. Apply a protective coating over the installation.
