HYUNDAI NEW THINKING. NEW POSSIBILITIES. Technical Service Bulletin	GROUP BODY ELECTRICAL	NUMBER 15-BE-002
	DATE FEBRUARY 2015	MODEL(S) 2006 - 2008 SONATA (NF)
SUBJECT:	AIRBAG MIL ON WITH DTC B1701/B1706

Description: This bulletin provides diagnostic and service procedures to repair the symptom of an airbag warning illuminated with DTC (Diagnostic Trouble Code) B1701 and/or B1706. The service procedure includes inspection of the seat belt buckle pretensioner connector and adding a cable tie to secure the connector.

SUBJECT: REPAIR PROCEDURE FOR AIRBAG MIL WITH DTC B1701/B1706

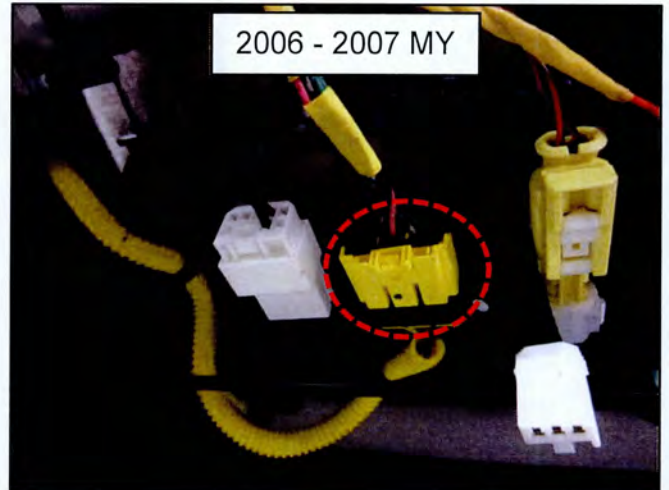
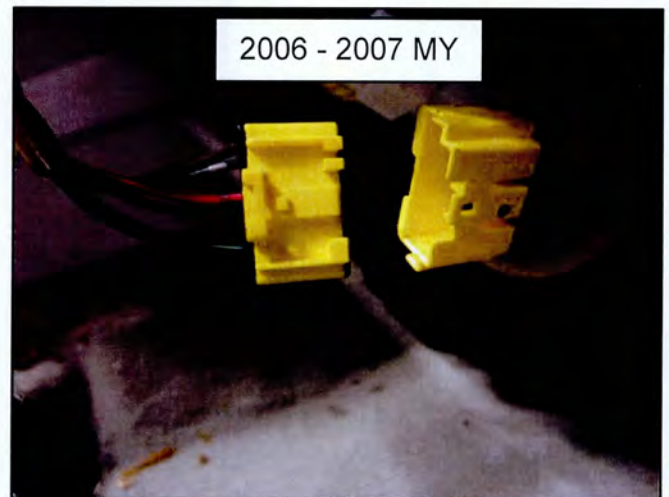
8. Disconnect the buckle pretensioner connector.

Inspect the connector pins for any abnormalities or indications of damage. Replace any damaged components.

Using compressed air, remove any debris from the connectors.

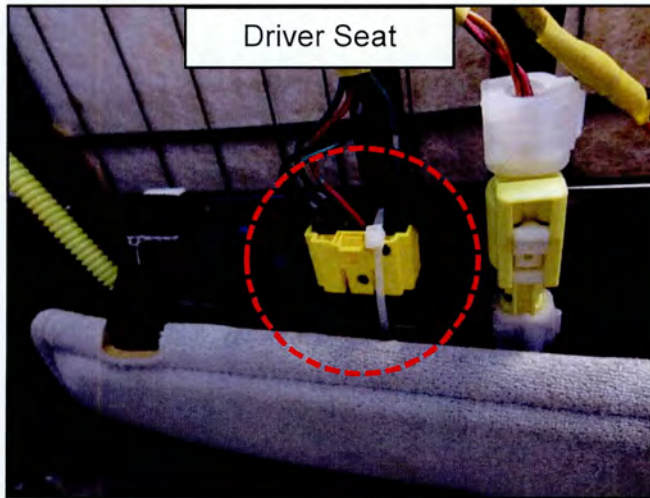
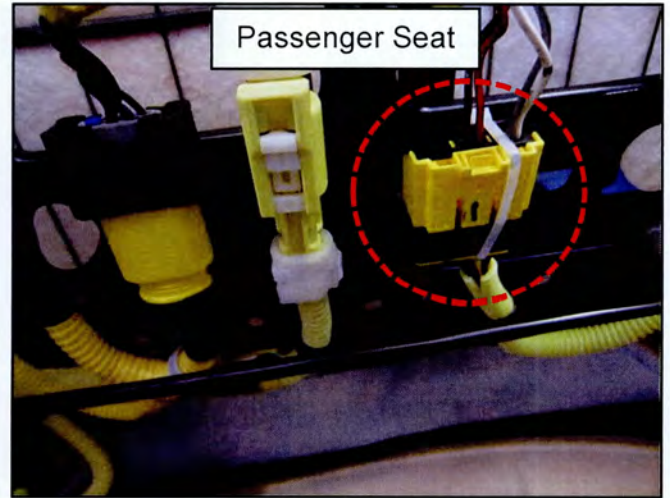
2006 – 2007 MY

Cable Tie Installed
