ENERGI - INTERMITTENT NO START DUE TO DISCHARGED 12 VOLT BATTERY

TSB 15-0028

2013 Fusion

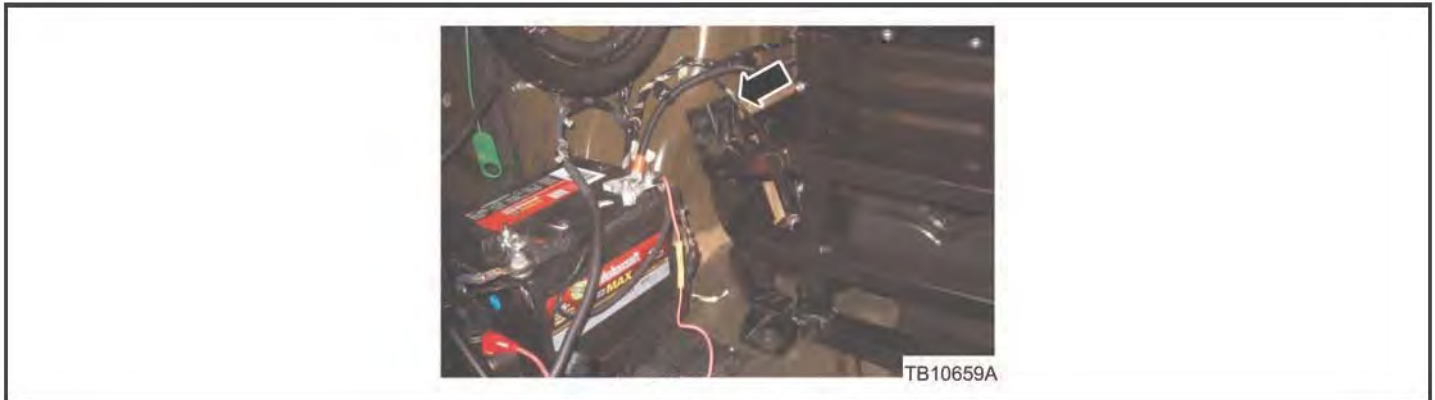
Figure 1 - Article 15-0028

4. Inspect the fan wiring from the high voltage battery pack, located at the interior left hand quarter panel, up to the fan motor(s) for damage or chafing on the metal bracket that attaches the battery cage to the vehicle body. Is chafing present? (Figure 1)

- a. Yes - repair the circuits as needed. Refer to Wiring Diagram, Section 5-1. After the repair, wrap affected area with 3M™ Temflex™ Cotton Friction Tape or equivalent to prevent future concerns. Reinstall the driver's side trunk liner and battery access cover and proceed to Step 5.
 - b. b. No - wrap the affected area with 3M™ Temflex™ Cotton Friction Tape or equivalent to prevent future concerns. Reinstall the driver's side trunk liner and battery access cover, and proceed to Step 5.
5. Replace the Telematics Control Unit (TCU) module. Refer to WSM, Section 415-00.
