## Reroute Power Steering Harness

<b>Classification</b>	Campaign Bulletin	<b>Section/Group</b>	17 - Electrical	<b>Country/Region</b>	United States, Canada
<b>Year</b>	2014-2015	<b>Model</b>	Model S	<b>Version</b>	Dual Motor

*This Service Bulletin supersedes SB-15-17-001, dated 5-Feb-14. Each content change is marked by a vertical line in the left margin. Discard the previous version and replace it with this one.*

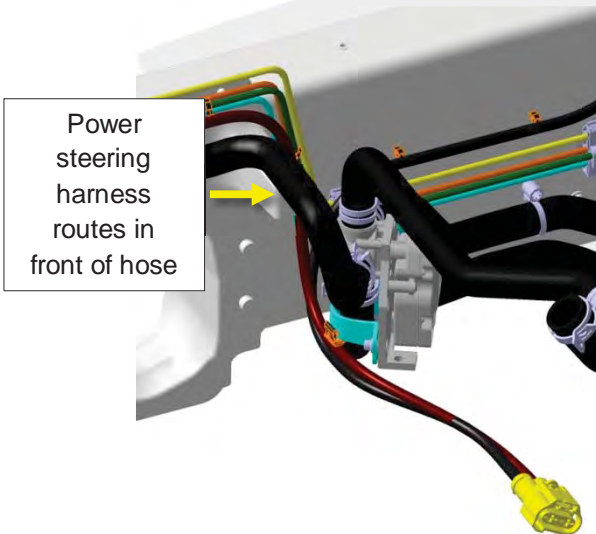
✓ Figure 1

- If the power steering harness routes in front of or next to the hose (Figure 1), skip to the “Inspect Clips and Ties” section of this document.
- If the power steering harness routes behind the hose (Figure 2), continue this procedure to reroute it.
