## Reroute Power Steering Harness

<b>Classification</b>	Campaign Bulletin	<b>Section/Group</b>	17 - Electrical	<b>Country/Region</b>	United States, Canada
<b>Year</b>	2014-2015	<b>Model</b>	Model S	<b>Version</b>	Dual Motor

# Reroute Power Steering Harness

*This Service Bulletin supersedes SB-15-17-001, dated 5-Feb-14. Each content change is marked by a vertical line in the left margin. Discard the previous version and replace it with this one.*

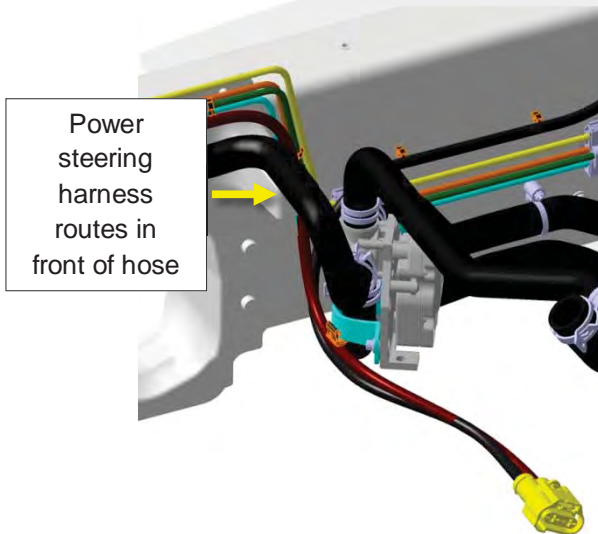
✓ Figure 1

- If the power steering harness routes in front of or next to the hose (Figure 1), skip to the “Inspect Clips and Ties” section of this document.
- If the power steering harness routes behind the hose (Figure 2), continue this procedure to reroute it.

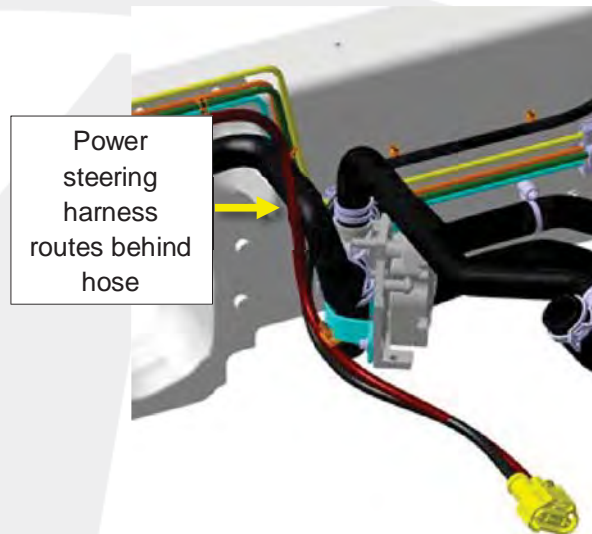
✗ Figure 2

On some vehicles, the LH halfshaft might contact the power steering harness. This might result in an alert message on the instrument cluster.

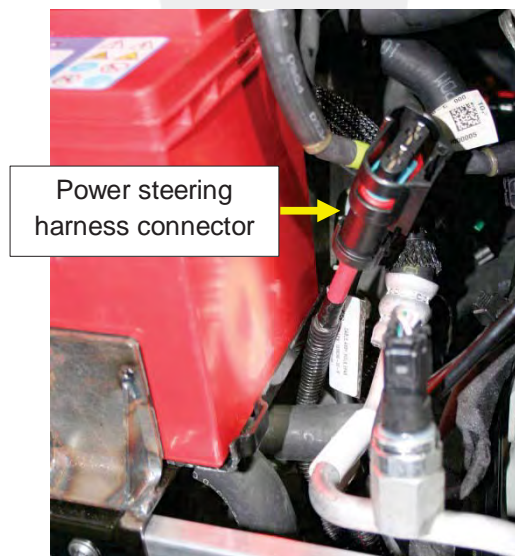
**Figure 4**

**⚠ CAUTION:** Carefully inspect the power steering harness for damage. If any damage is present, the harness must be replaced. Discontinue this procedure and contact Service Engineering.

6. Gently pull the free end of the power steering harness out from behind the coolant hose (Figure 4).

**NOTE:** An edge clip secures the power steering harness to either the 4-way valve or the bracket behind the 4-way valve. Do not damage the edge clip during removal.

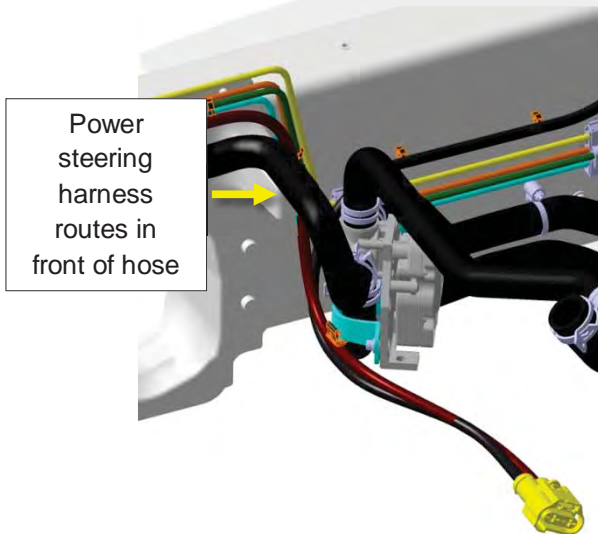
✓ Figure 1

- If the power steering harness routes in front of or next to the hose (Figure 1), skip to the “Inspect Clips and Ties” section of this document.
- If the power steering harness routes behind the hose (Figure 2), continue this procedure to reroute it.

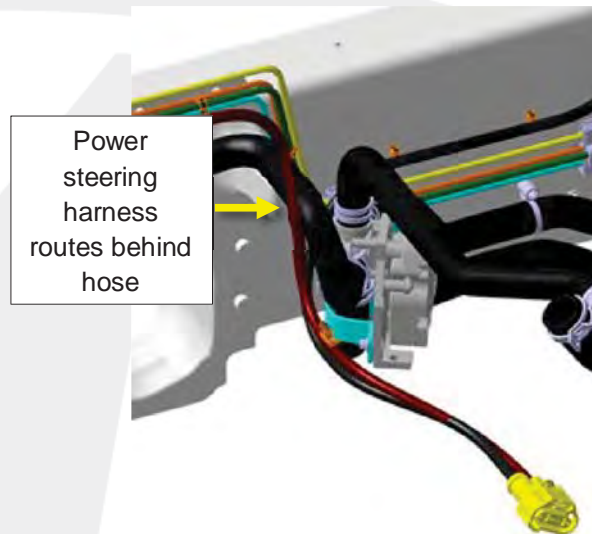
✗ Figure 2

On some vehicles, the LH halfshaft might contact the power steering harness. This might result in an alert message on the instrument cluster.

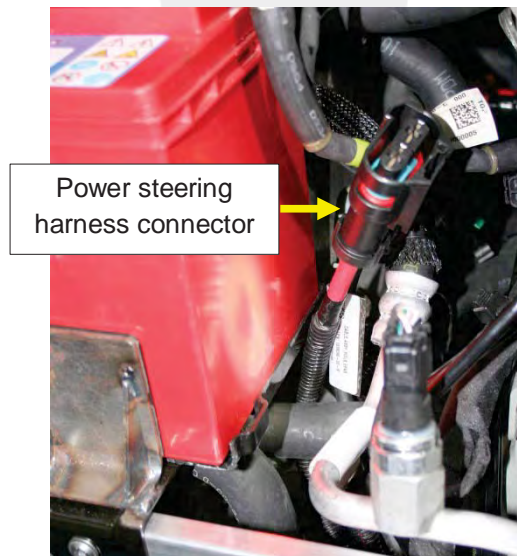
**Figure 4**

**⚠ CAUTION:** Carefully inspect the power steering harness for damage. If any damage is present, the harness must be replaced. Discontinue this procedure and contact Service Engineering.

6. Gently pull the free end of the power steering harness out from behind the coolant hose (Figure 4).

**NOTE:** An edge clip secures the power steering harness to either the 4-way valve or the bracket behind the 4-way valve. Do not damage the edge clip during removal.
