SERVICE CAMPAIGN BULLETIN

SUBJECT: i-MiEV UNDERCARRIAGE RUST – SERVICE CAMPAIGN – REVISED			No: SC-14-003REV
			DATE: April, 2015
			MODEL: 2012 i-MiEV
CIRCULATE TO:	<input checked="" type="checkbox"/> GENERAL MANAGER	<input checked="" type="checkbox"/> PARTS MANAGER	<input checked="" type="checkbox"/> TECHNICIAN
<input checked="" type="checkbox"/> SERVICE ADVISOR	<input checked="" type="checkbox"/> SERVICE MANAGER	<input checked="" type="checkbox"/> WARRANTY PROCESSOR	<input checked="" type="checkbox"/> SALES MANAGER

The undercarriage on certain 2012 i-MiEV vehicles, along with the bolts securing the Main Drive Lithium-ion battery under covers and non-essential ground connections, may be susceptible to rust.

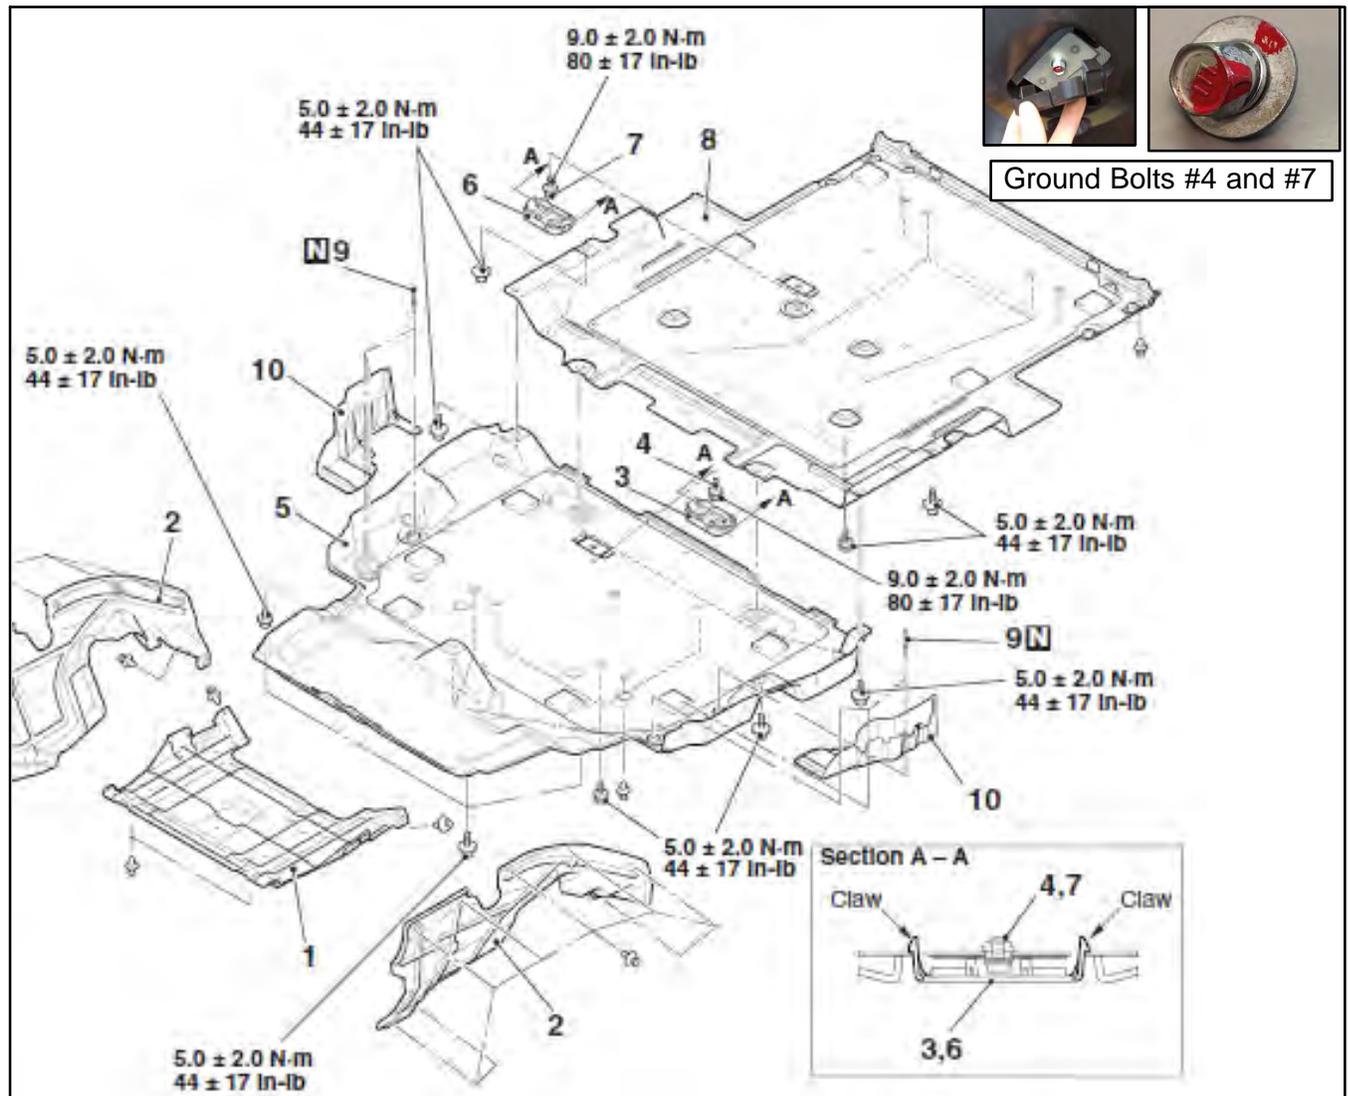
1. Place the vehicle on a lift, shift the selector to PARK, set the parking brake, and turn the electric motor switch to the OFF position. Raise the vehicle.
2. Remove the front and rear plug covers (#3 and #6 – refer to the diagram below) and the non-essential ground bolts (#4 and #7 – refer to the diagram below).
3. Remove the front under cover (#5 – refer to the diagram below), then remove the rear under cover (#8 – refer to the diagram below).

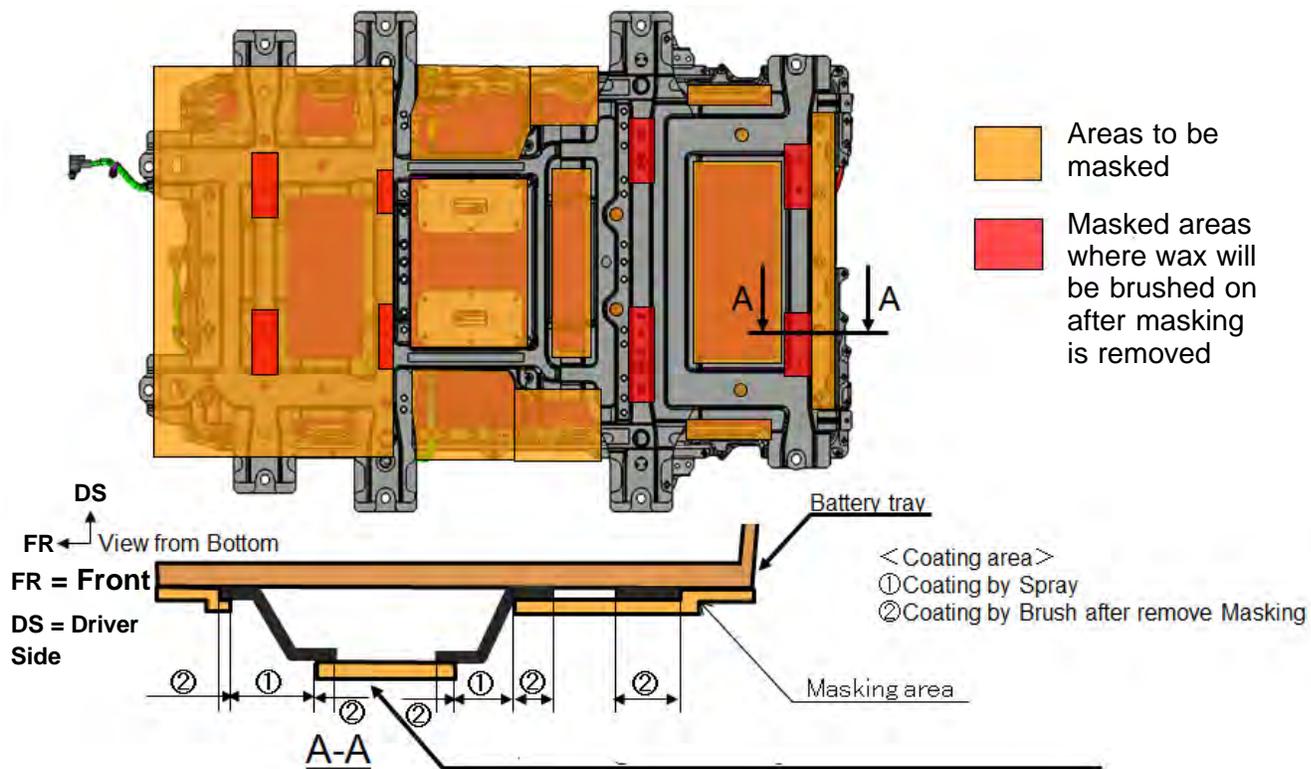
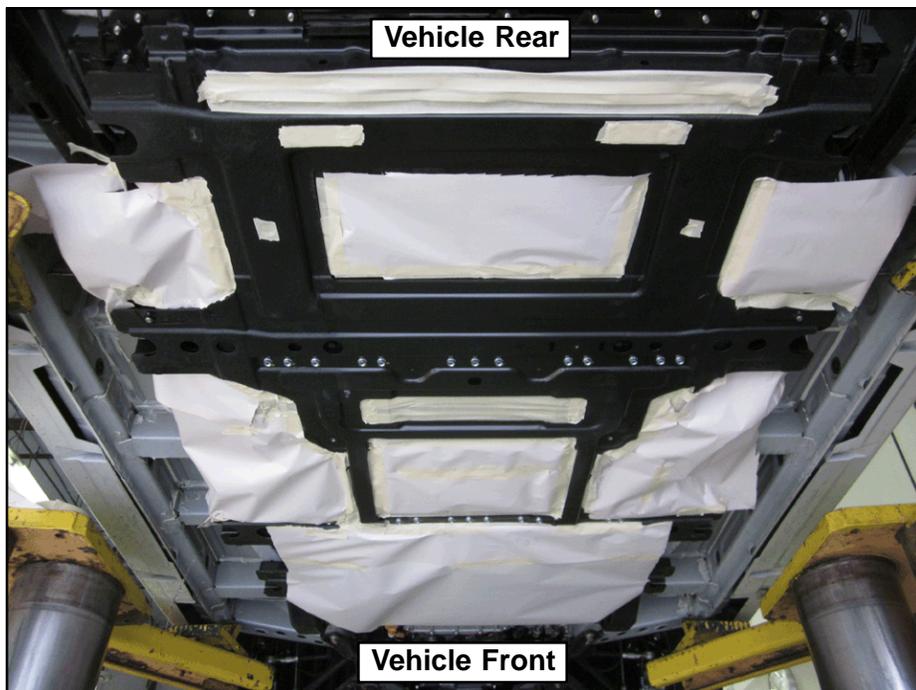
Without proper masking, wax may adhere to the battery tray through the holes

9. To prevent anti-corrosion wax from contacting the resin undercarriage components (harness, battery tray, etc...), mask the indicated areas below with shipping/packaging paper or plastic covers.

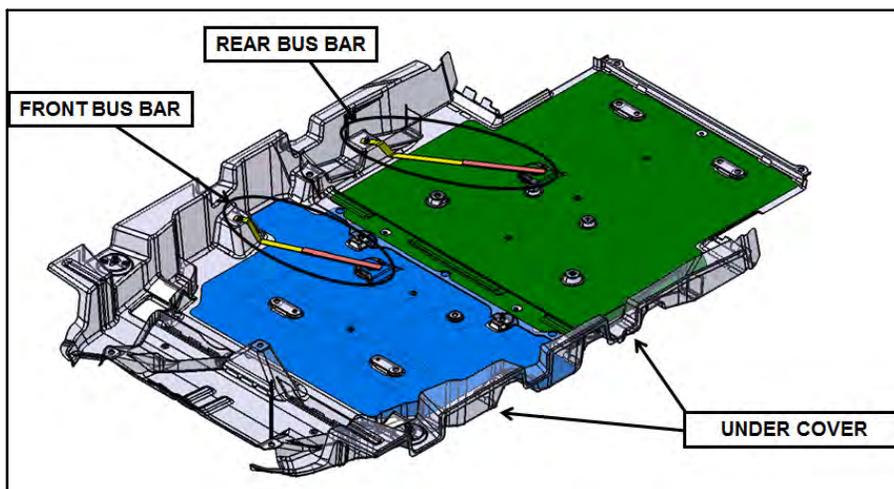
16. New under covers with ground bus bars installed.
