# Technical Service Bulletin

## SB-10057904-1731

SUBJECT:			No: TSB-15-13-001REV
<b>ENGINE STALL/PCV HOSE DISCONNECTION (LOW ENGINE SPEED, HIGH AMBIENT TEMPERATURE)</b>			DATE: July, 2015
			MODEL: 2014-15 Mirage
CIRCULATE TO:	<input type="checkbox"/> GENERAL MANAGER	<input type="checkbox"/> PARTS MANAGER	<input checked="" type="checkbox"/> TECHNICIAN
<input checked="" type="checkbox"/> SERVICE ADVISOR	<input checked="" type="checkbox"/> SERVICE MANAGER	<input checked="" type="checkbox"/> WARRANTY PROCESSOR	<input type="checkbox"/> SALES MANAGER

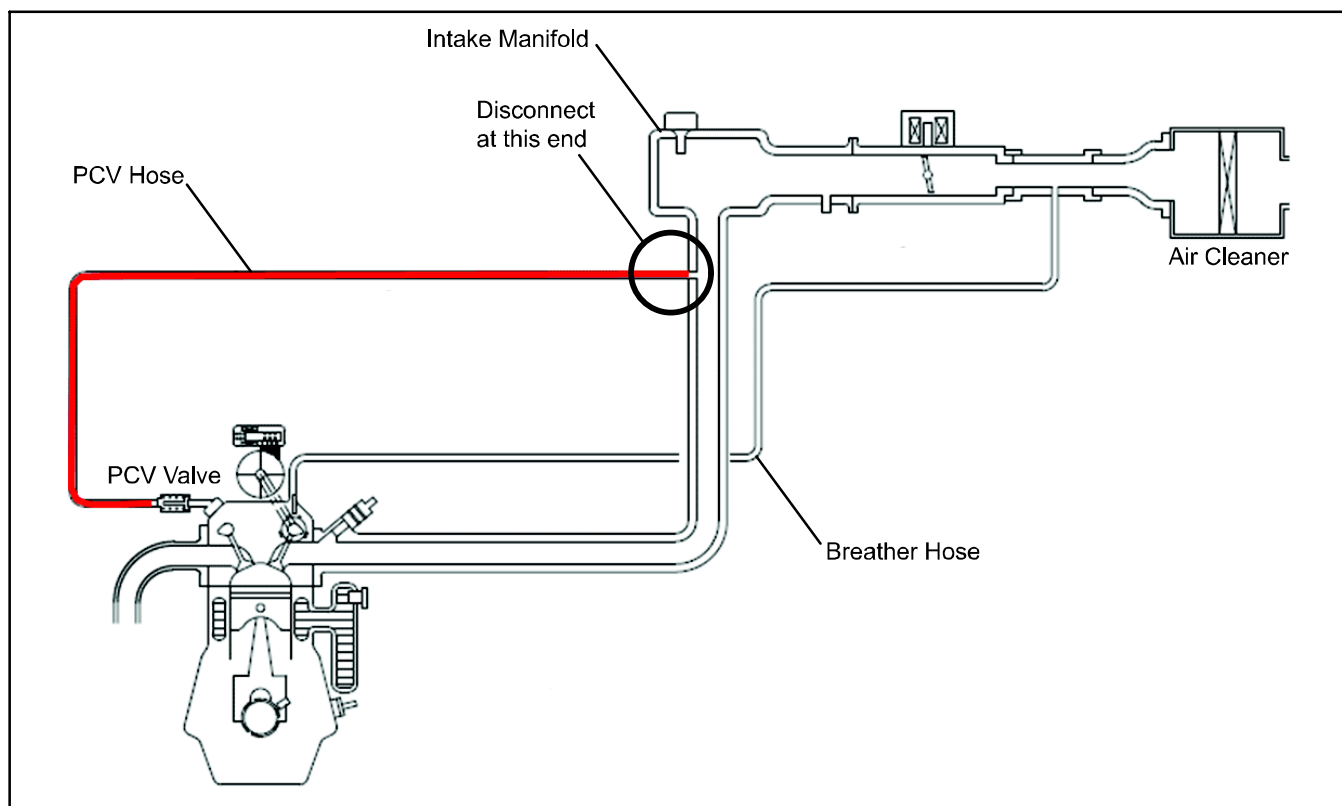
Due to a rich air fuel ratio, affected vehicles may experience engine stalling at low engine speed, just prior to stopping or during idling, when operated in high ambient temperature conditions, *which may lead to PCV hose disconnection*. If this condition were to occur, a stalled engine can immediately be restarted.

1. If the PCV hose is detached at either end (usually at intake manifold end), and is not damaged, reconnect it (red hose in illustration). Only replace the hose if it is damaged.
