**NUMBER:** 19-003-15**GROUP:** Steering**DATE:** April 10, 2015

Intermittent Power Steering Noise And/Or Slight Loss Of Assist

2015 (LA) Dodge Challenger

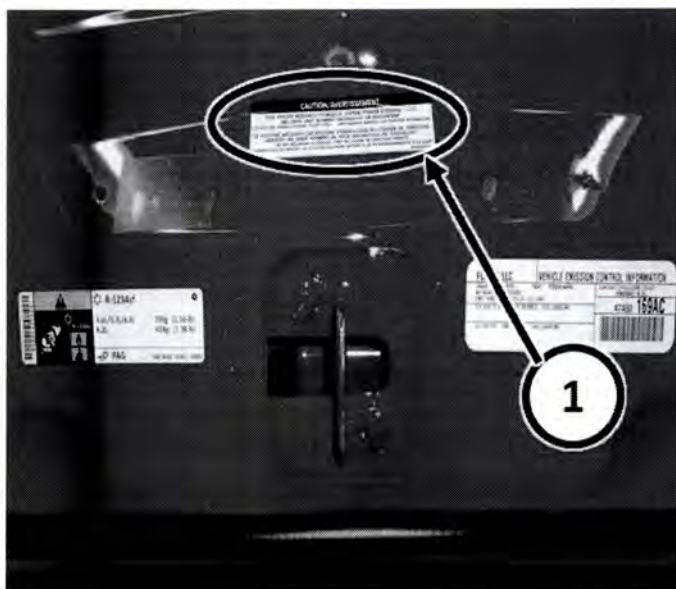
**Fig. 1 Underhood View**

1 - Power steering label installation location.

- Install the low pressure return line and tighten to 38 nm (28 ft lb).
- Install the belly pan. Refer to the detailed service procedures available in DealerCONNECT/TechCONNECT Service Info section 13 - Frame and Bumpers> Under Body Protection> BELLY PAN, Engine> Installation.
- Fill the system with the specified MS-10838 (pn# 68234631AA) fluid and bleed the system of all air. Refer to the detailed service procedures available in DealerCONNECT/TechCONNECT Service Info section 19 - Steering> Standard Procedure> Power Steering System Bleeding.
- Install the new power steering caution label under hood. Refer to (Fig. 1).
